Subject: **Update on Queen Mary Lease Management & Information Request**

CRITICAL STRUCTURAL REPAIRS STRUCTURAL ANALYSIS: STRESS RESULTS & TANK TOP REPAIR

QUEEN MARY LONG BEACH, CALIFORNIA

Queen Mary Aft Mast Repair Structural Narrative

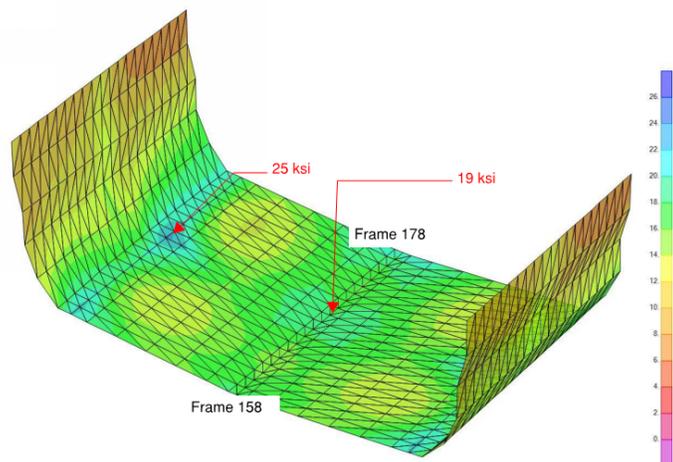
Figure 36. Von Mises stresses in the interior hull of the model with 20 ft of water behind bulkhead 112 [Max stress = 25 ksi].

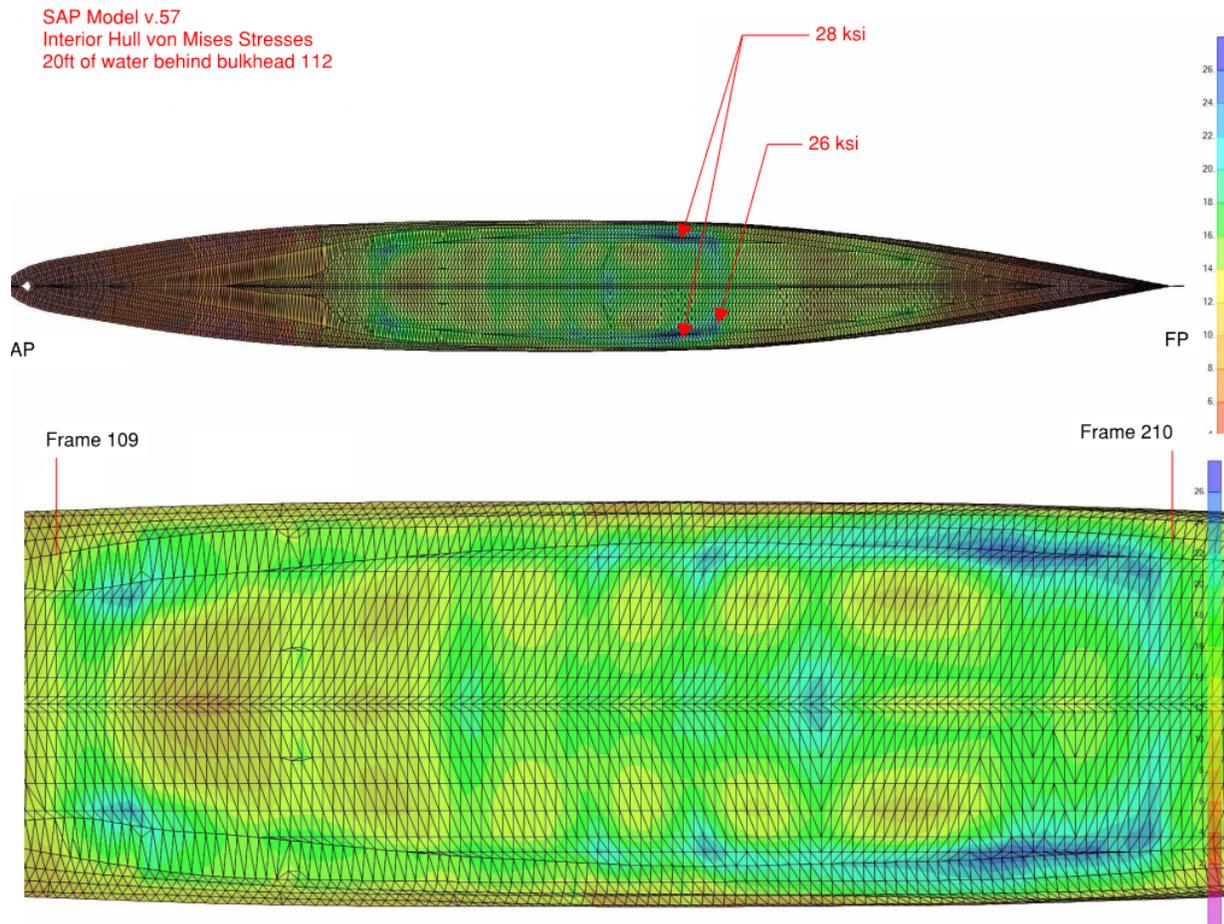
Figure 39. Von Mises heat map showing locations where allowable stresses on exceeded on the interior hull in the case with 20 ft. of water behind bulkhead 112.

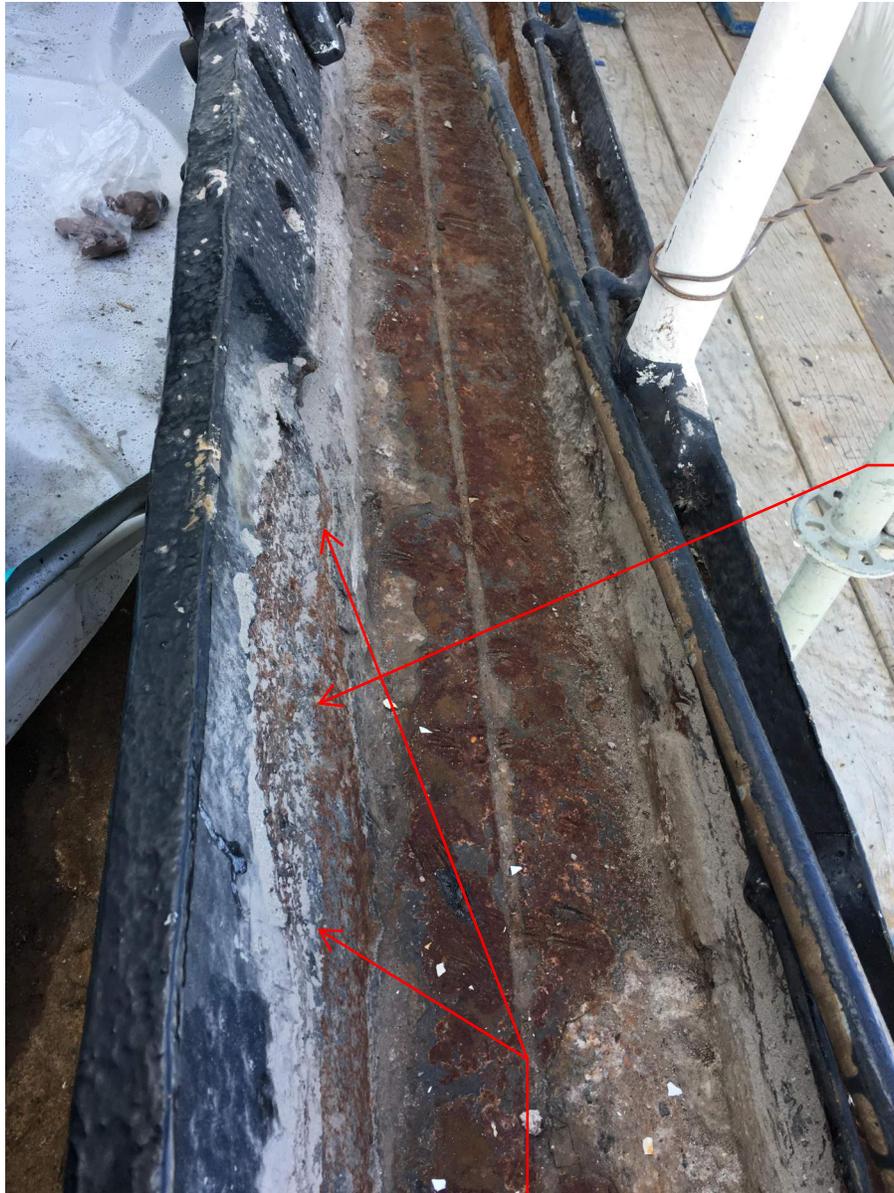
Photo 1 - Existing continuous bent plate corrosion

This photo was taken on the starboard side which was in far better shape than the port side.

Visible corrosion

On the port side, the steel plate had several areas where it had rusted completely through. (Only the thinner plate, not the thick gusseted portions where the clevis attached).

The primary concern is this plates integrity and the integrity of the plate's connection to the ship.

NOTE: REMOVE ALL PAINT AND CORROSION FROM EXISTING PLATE AND NEW BENT PLATE, EOR TO REVEIW EXISTING CONDITION OF EXISTING BENT PLATE AND BASE SUPPORT CONDITION PRIOR TO INSTALLING NEW BENT PLATE

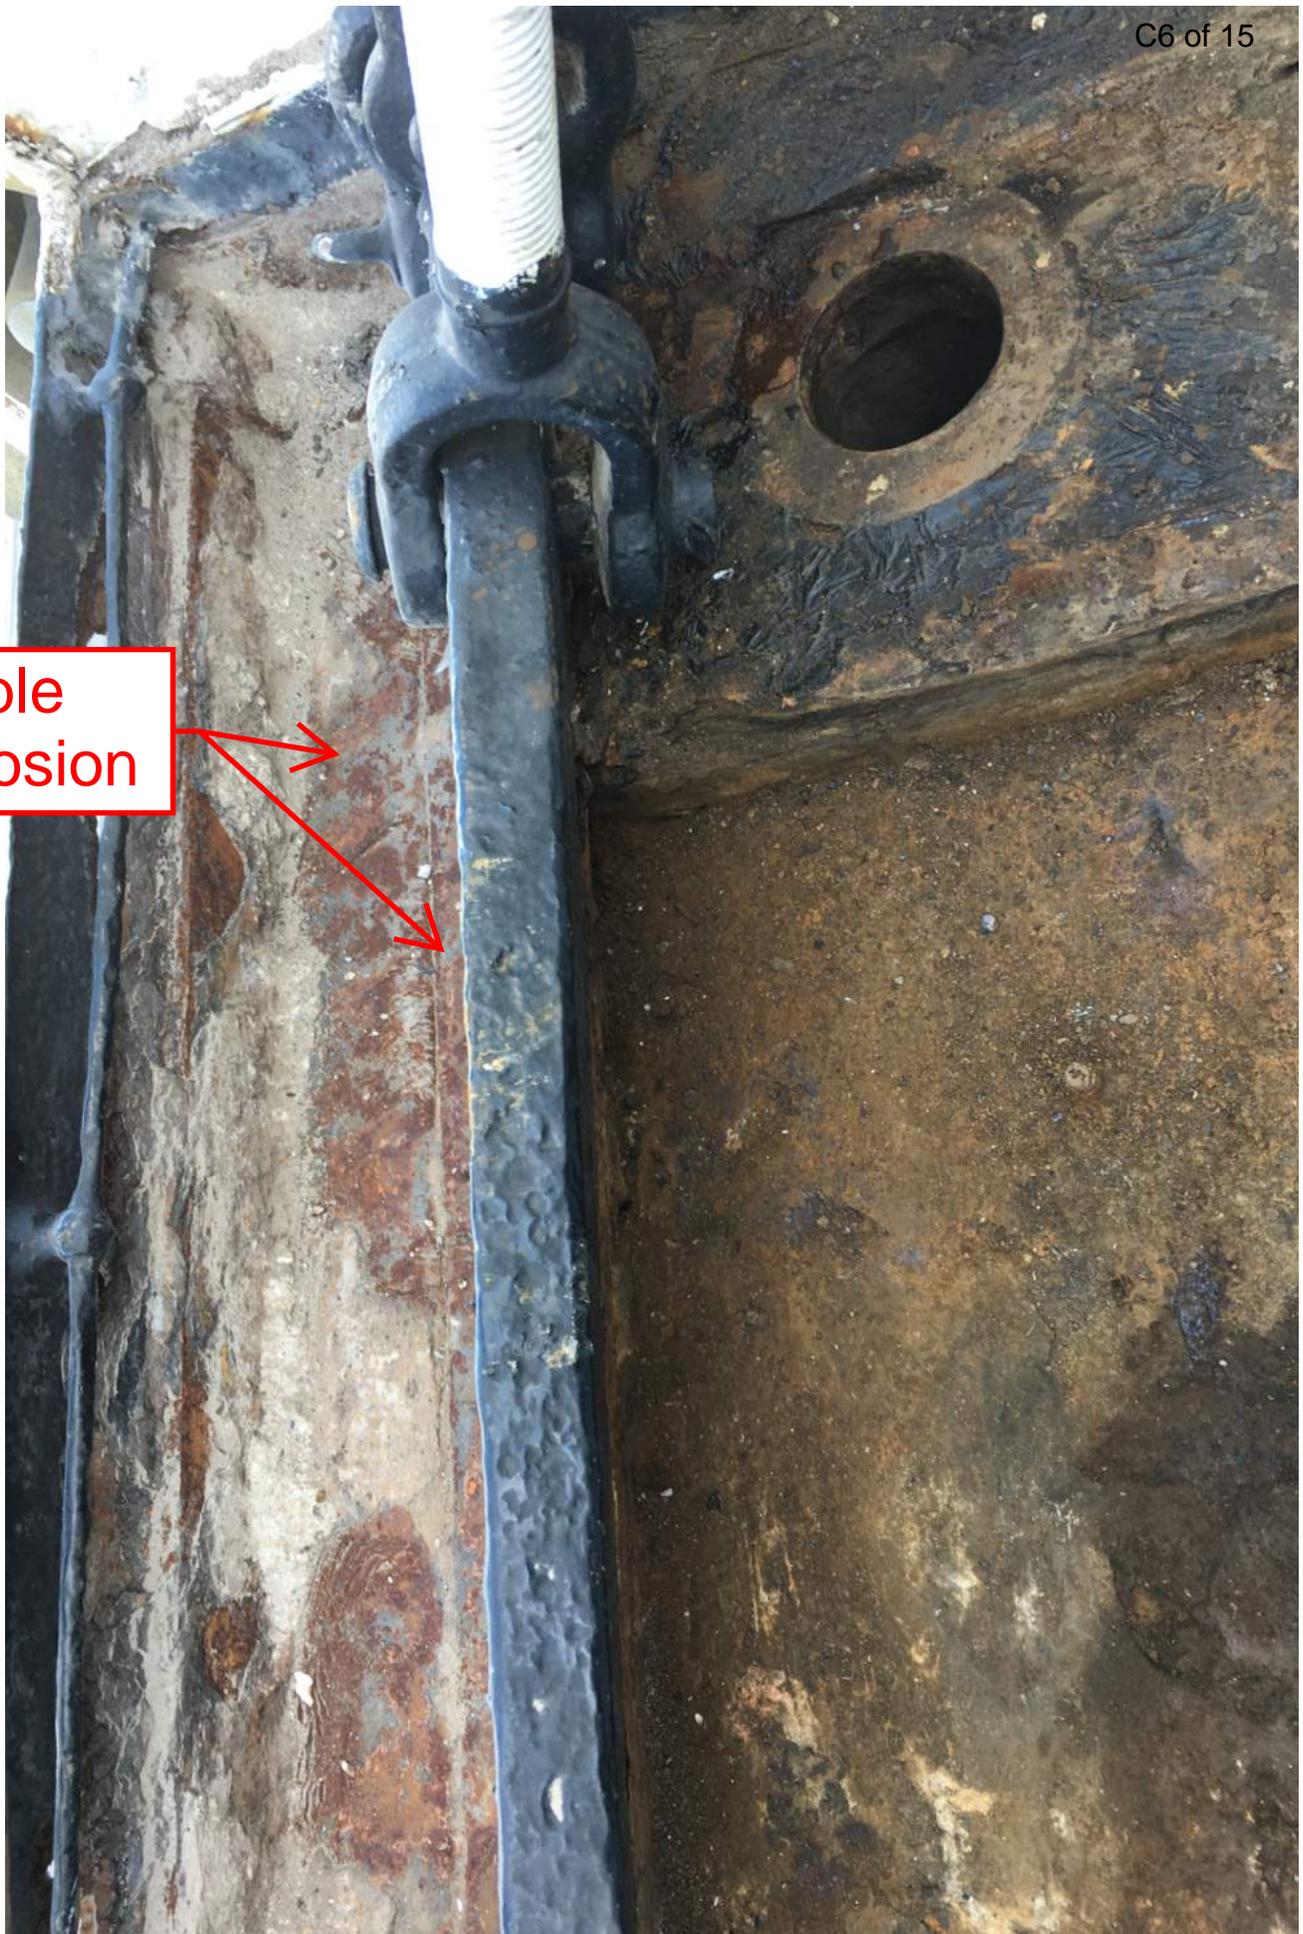
Photo 2 - Existing continuous bent plate corrosion

Visible corrosion

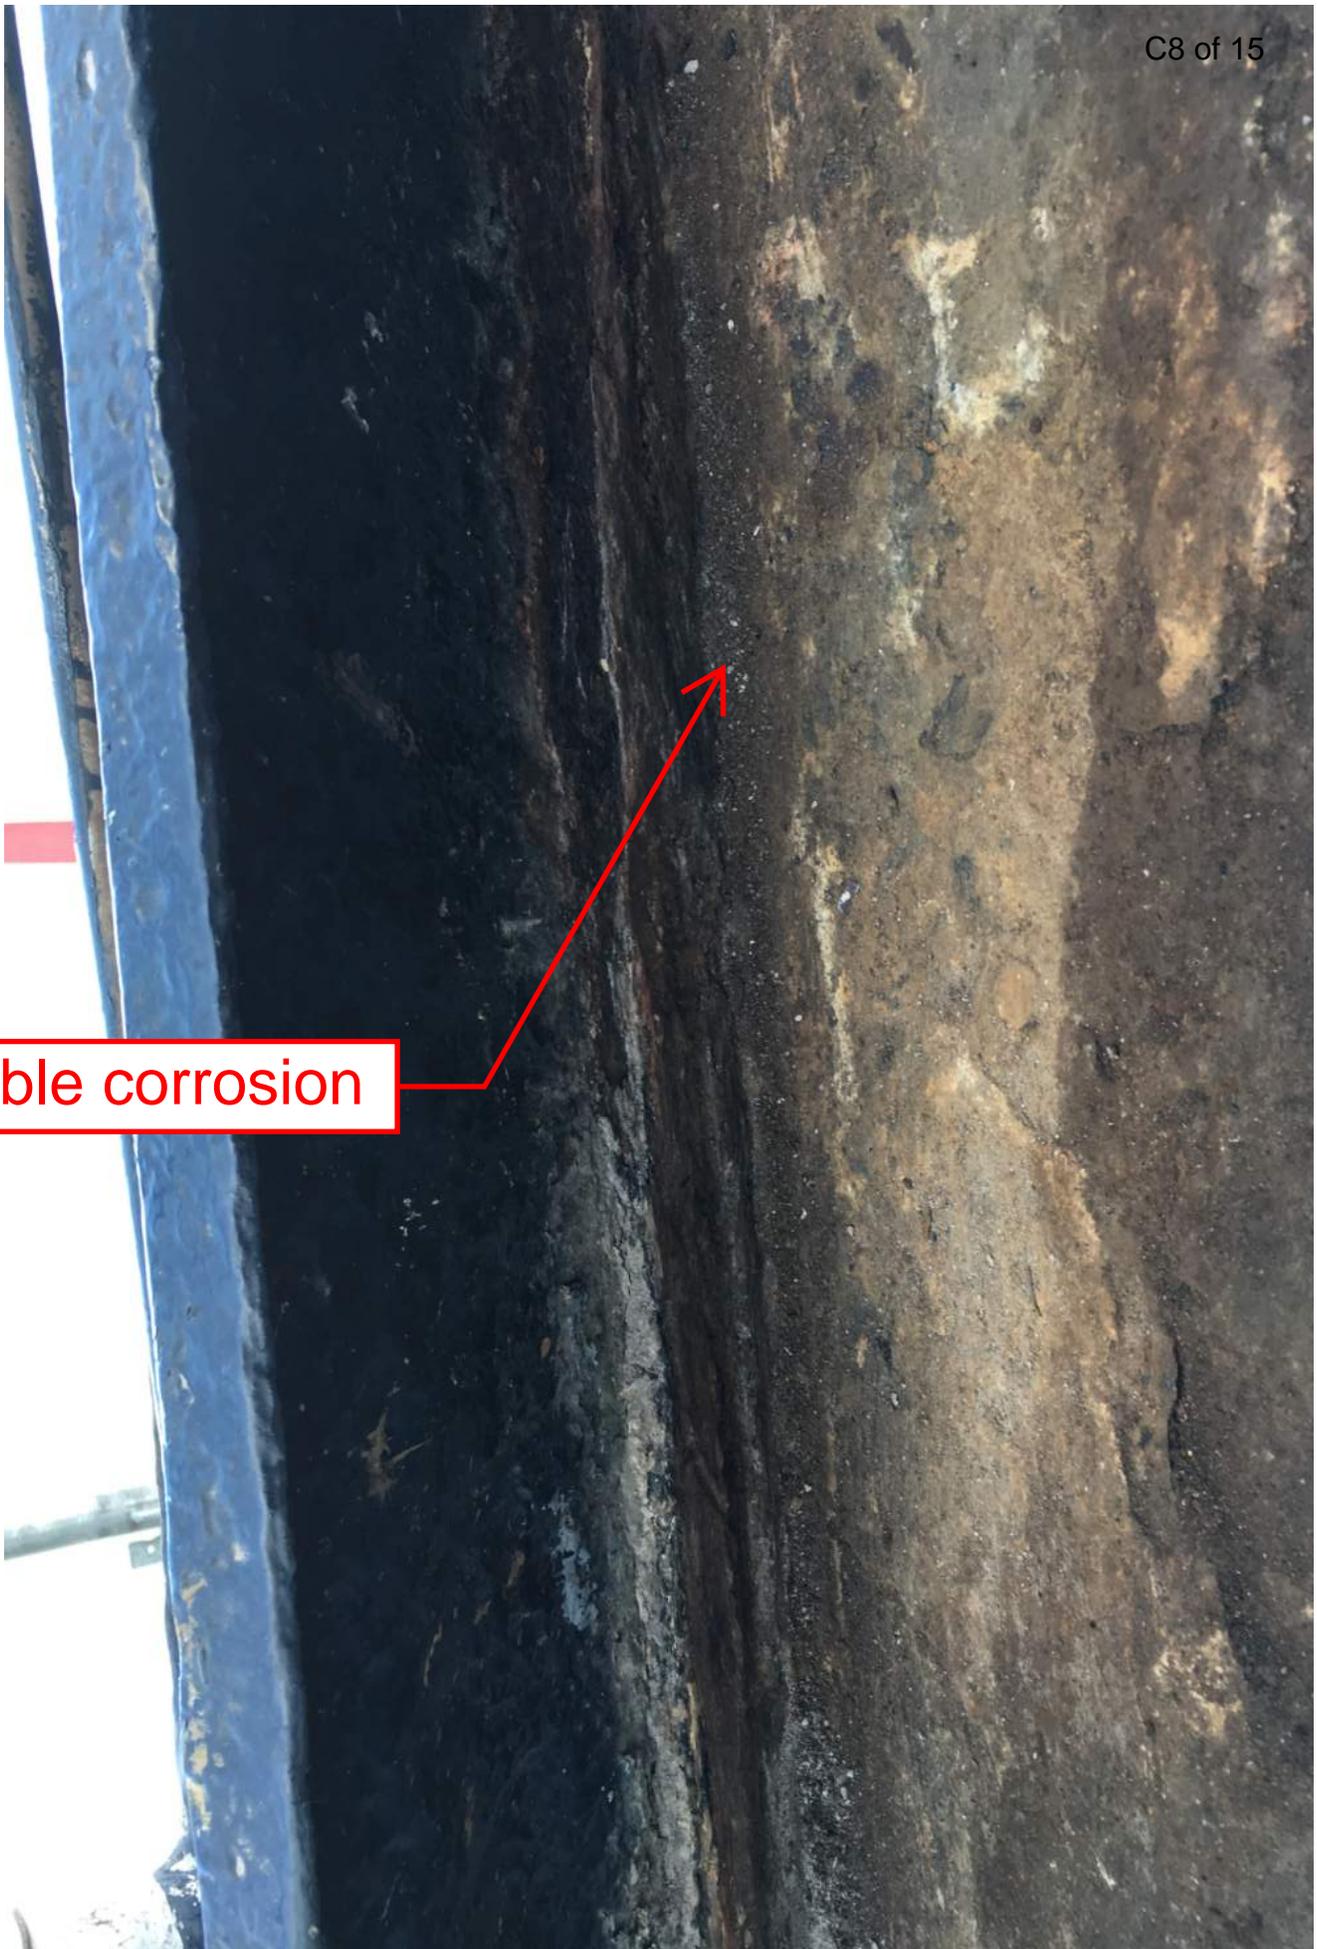
Photo 4 - Existing continuous bent plate corrosion

Visible corrosion

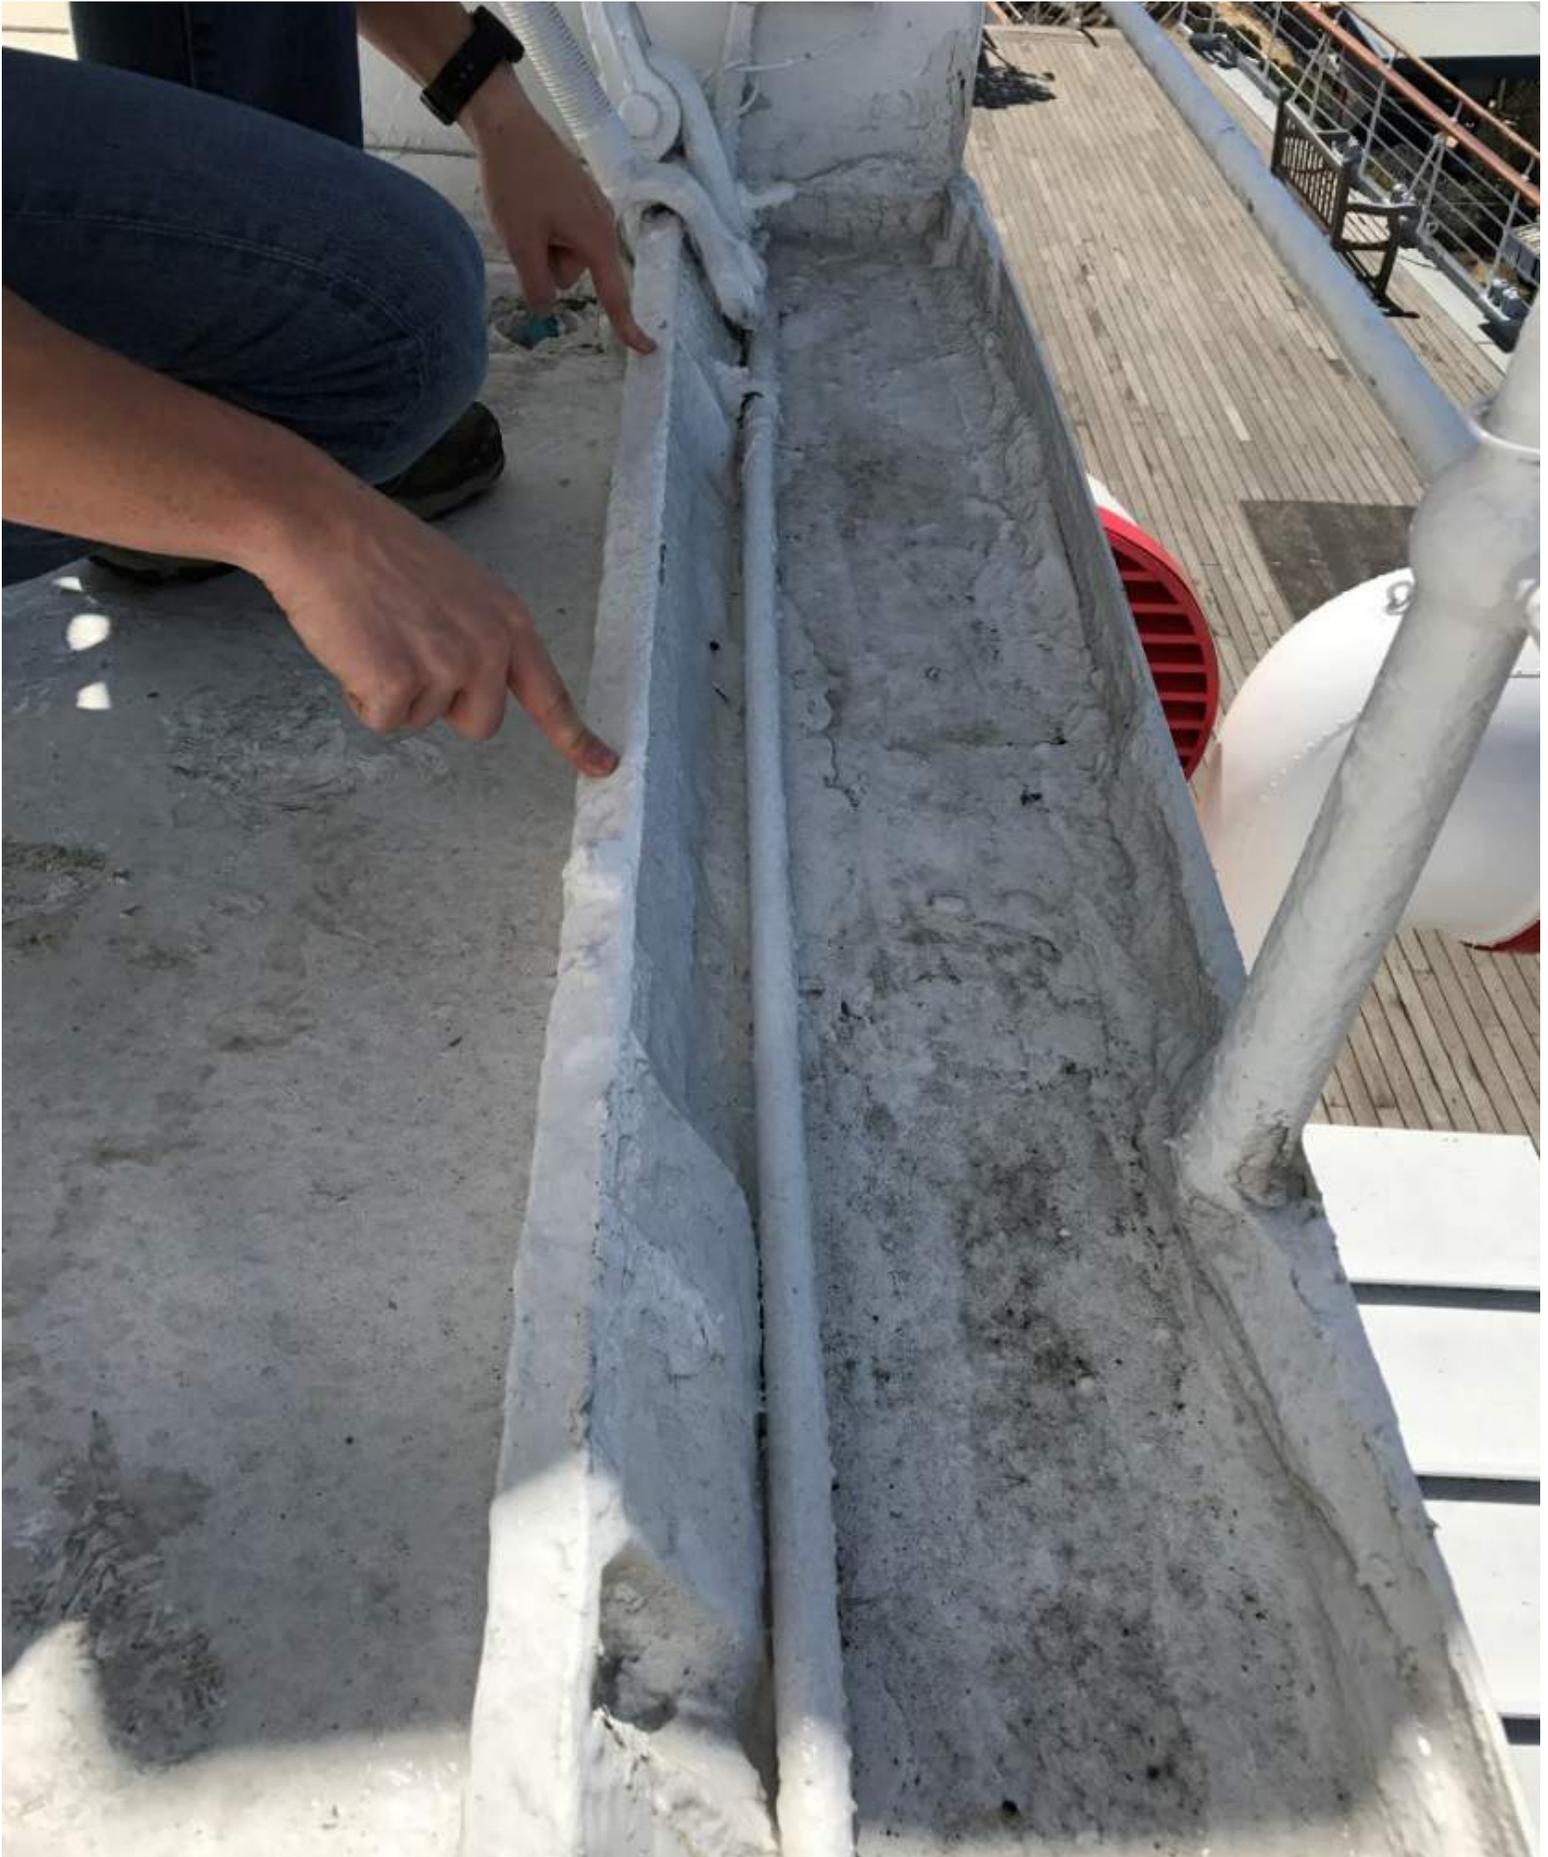
Photo 5 - Existing continuous bent plate in current weatherproofed condition

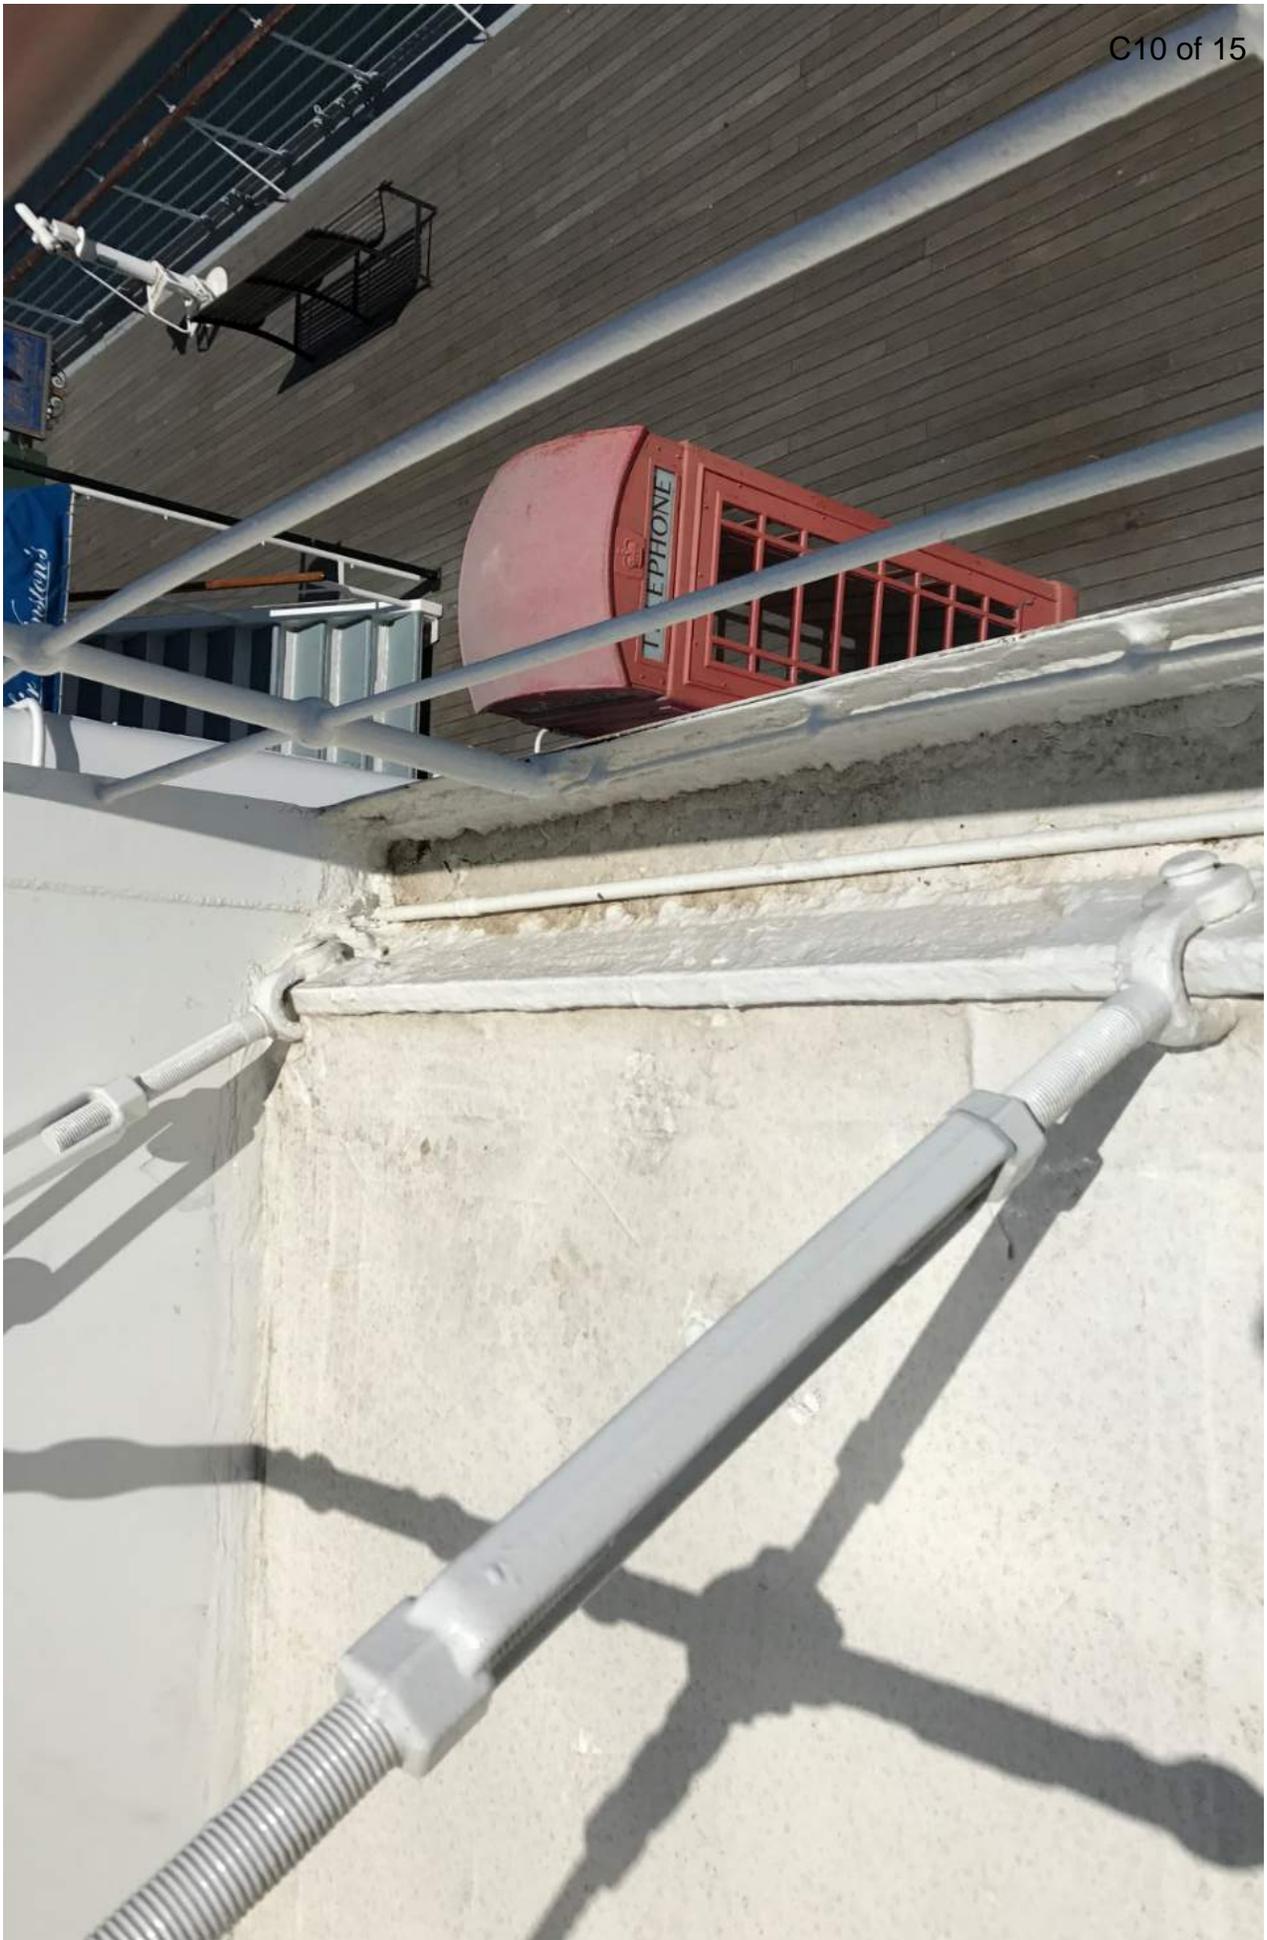
Photo 6 - Existing continuous bent plate in current weatherproofed condition

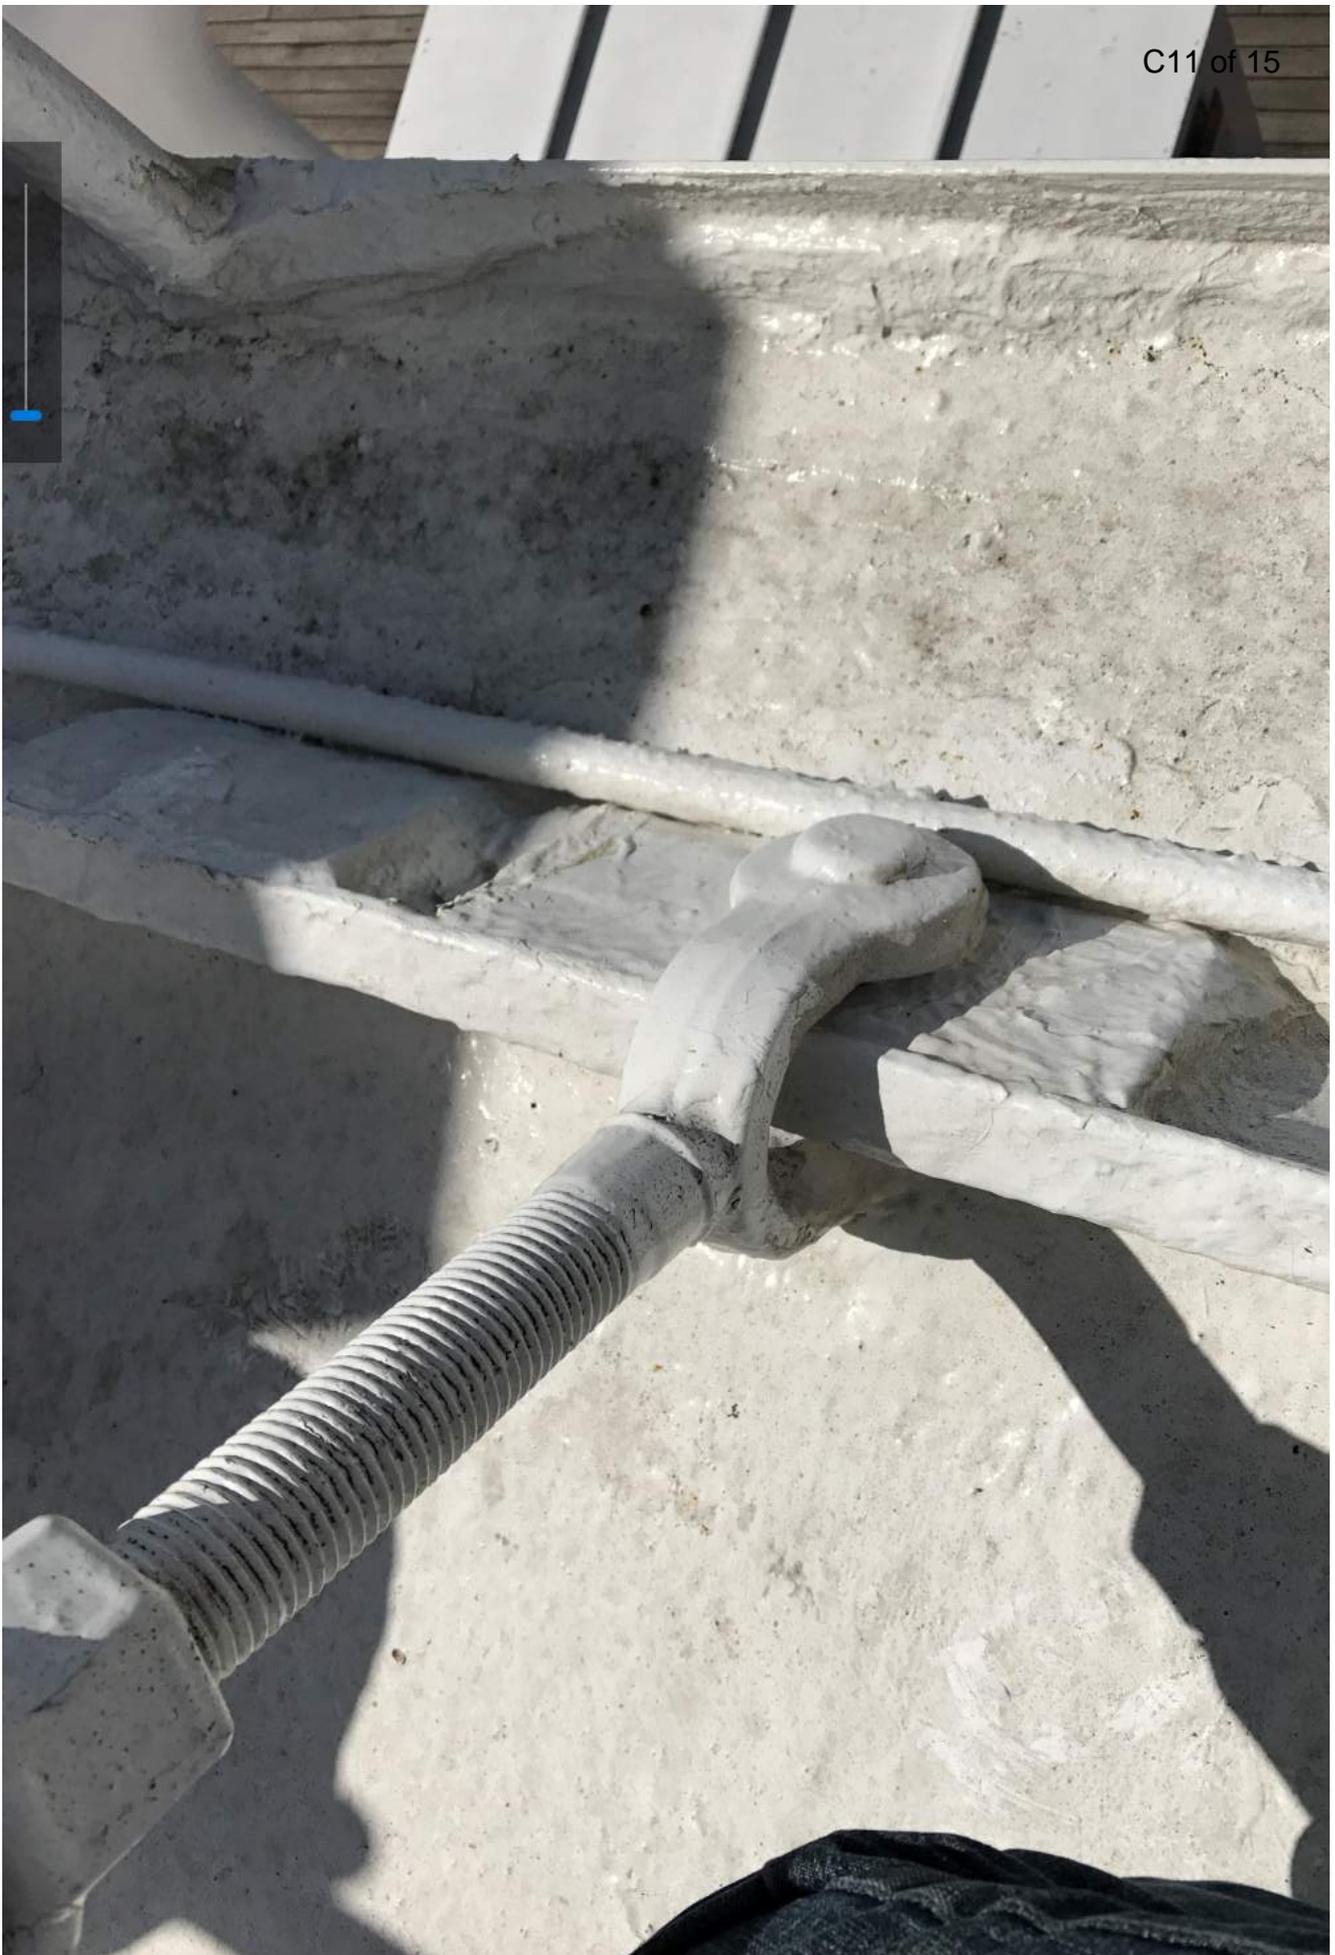
Photo 7 - Rod, clevis, and pin attachment to weatherproofed plates
