**GEOTECHNICAL STUDY
PROPOSED SLOPE IMPROVEMENTS
BLUFF PARK
E. OCEAN BLVD. BETWEEN LOMA AVE.
AND LINDERO AVE.
LONG BEACH, CALIFORNIA**

Project No. 107104

April 30, 2010

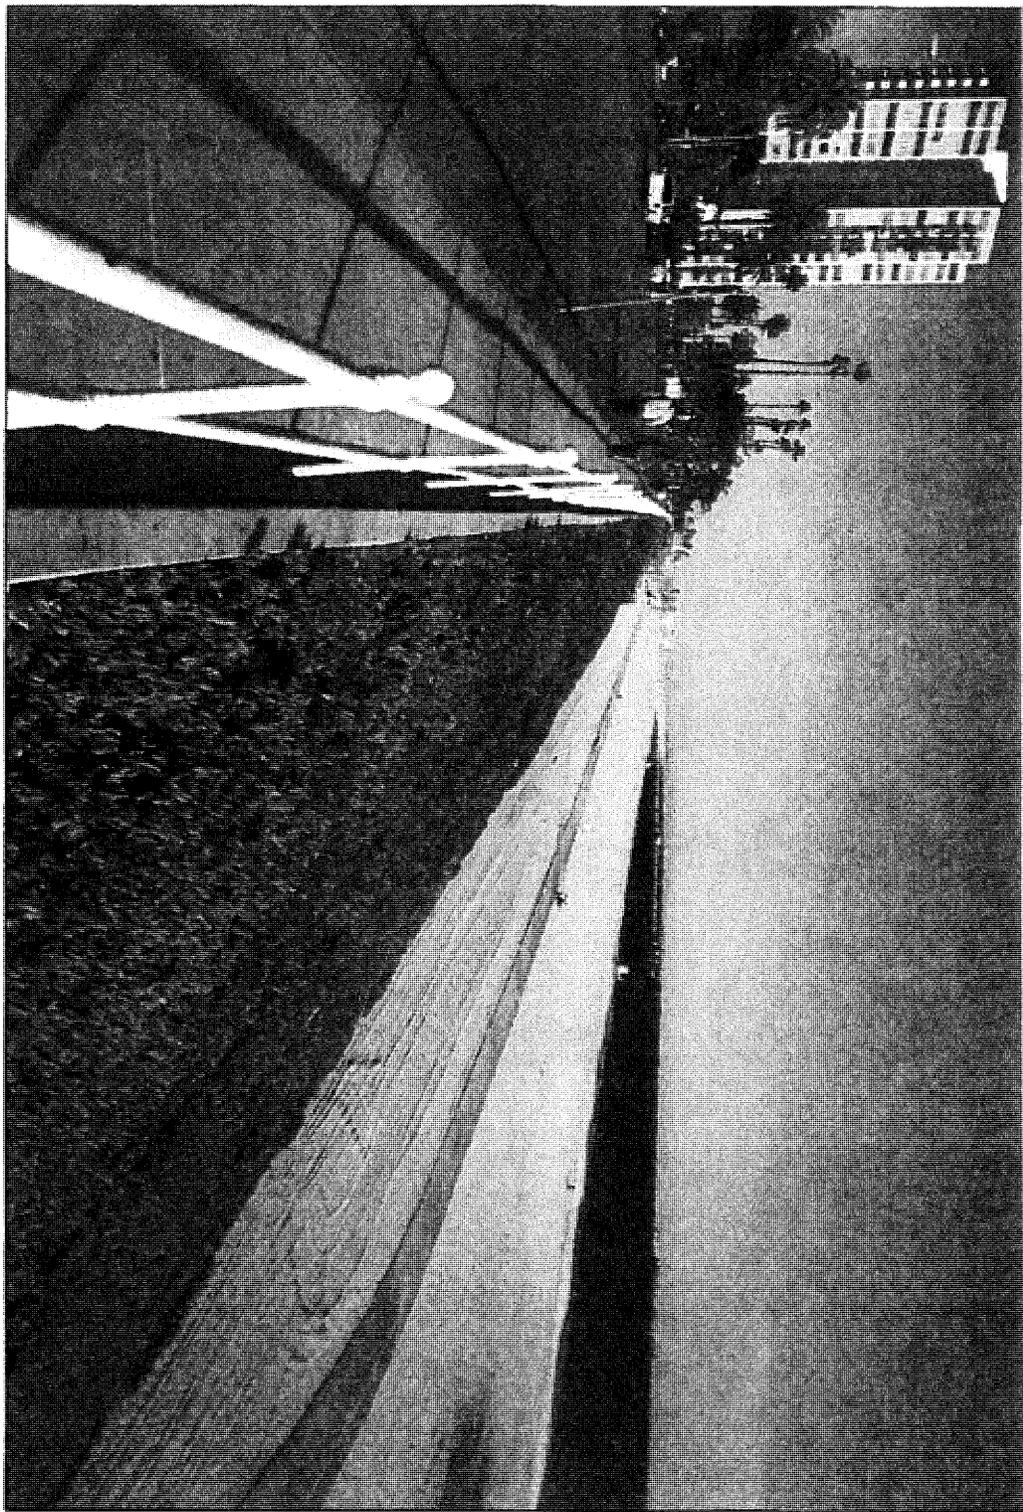
OVERVIEW IN MID PORTION OF THE PARK LOOKING EAST.

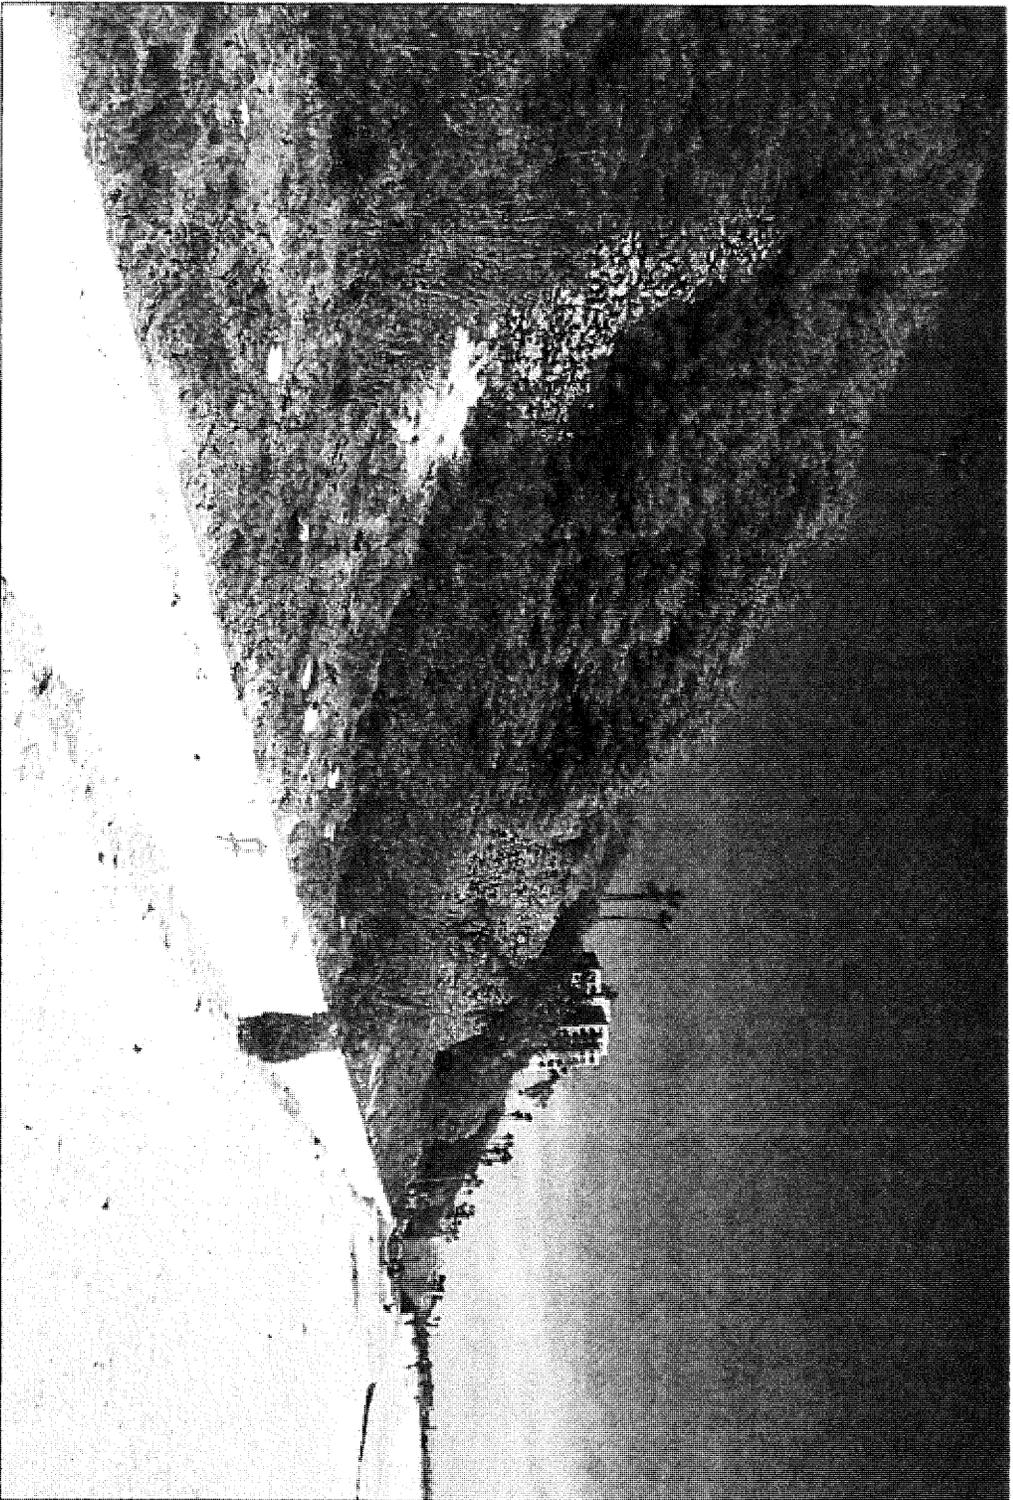
ILLUSTRATE TOE WALL, GABION WALL PARTIALLY COVERED WITH SHRUB AND STORM DRAIN OUTLET.

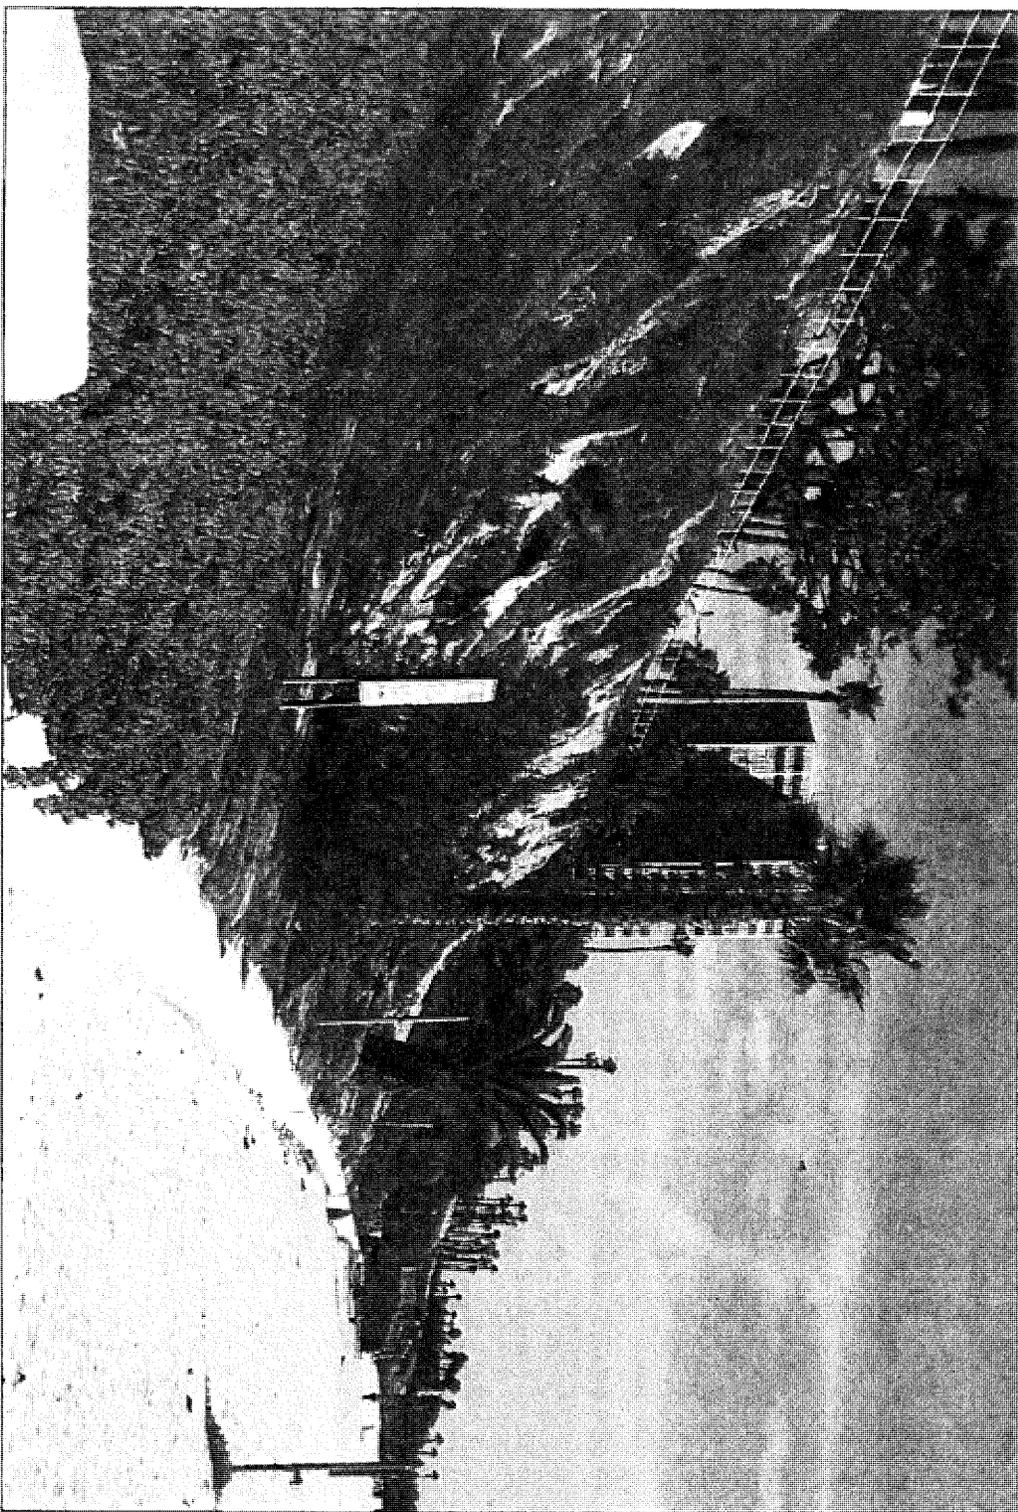
The bluff slope face has an uneven surface and inclination due to previous failures, accumulations of slump debris, on going erosion, and past grading in localized areas. The slope has composite gradients ranging from about 4½:1 (horizontal:vertical) to near vertical (See Photo 3 in Appendix D). Generally the lower portion of the slope has a gentle gradient as compared to the middle or upper segments. The lower third of the slope generally has a gradient between 1¾:1 and 3½:1. The middle third of the slope generally has gradient ranging between ¾:1 and 1½:1 with an average of about 1¼:1. The upper third of the slope generally has gradients ranging between ¾:1 and 1½:1 with an average of about 1.1:1. Portions of the slope have 10 feet of higher segments with ½:1 gradient. The gabion faces are near vertical or slightly tilted toward the slope.

UNEVEN SLOPE CONDITION, NEAR VERTICAL SEGMENT IN UPPER PORTION AND ABOUT 4.5:1 IN LOWER PORTION.

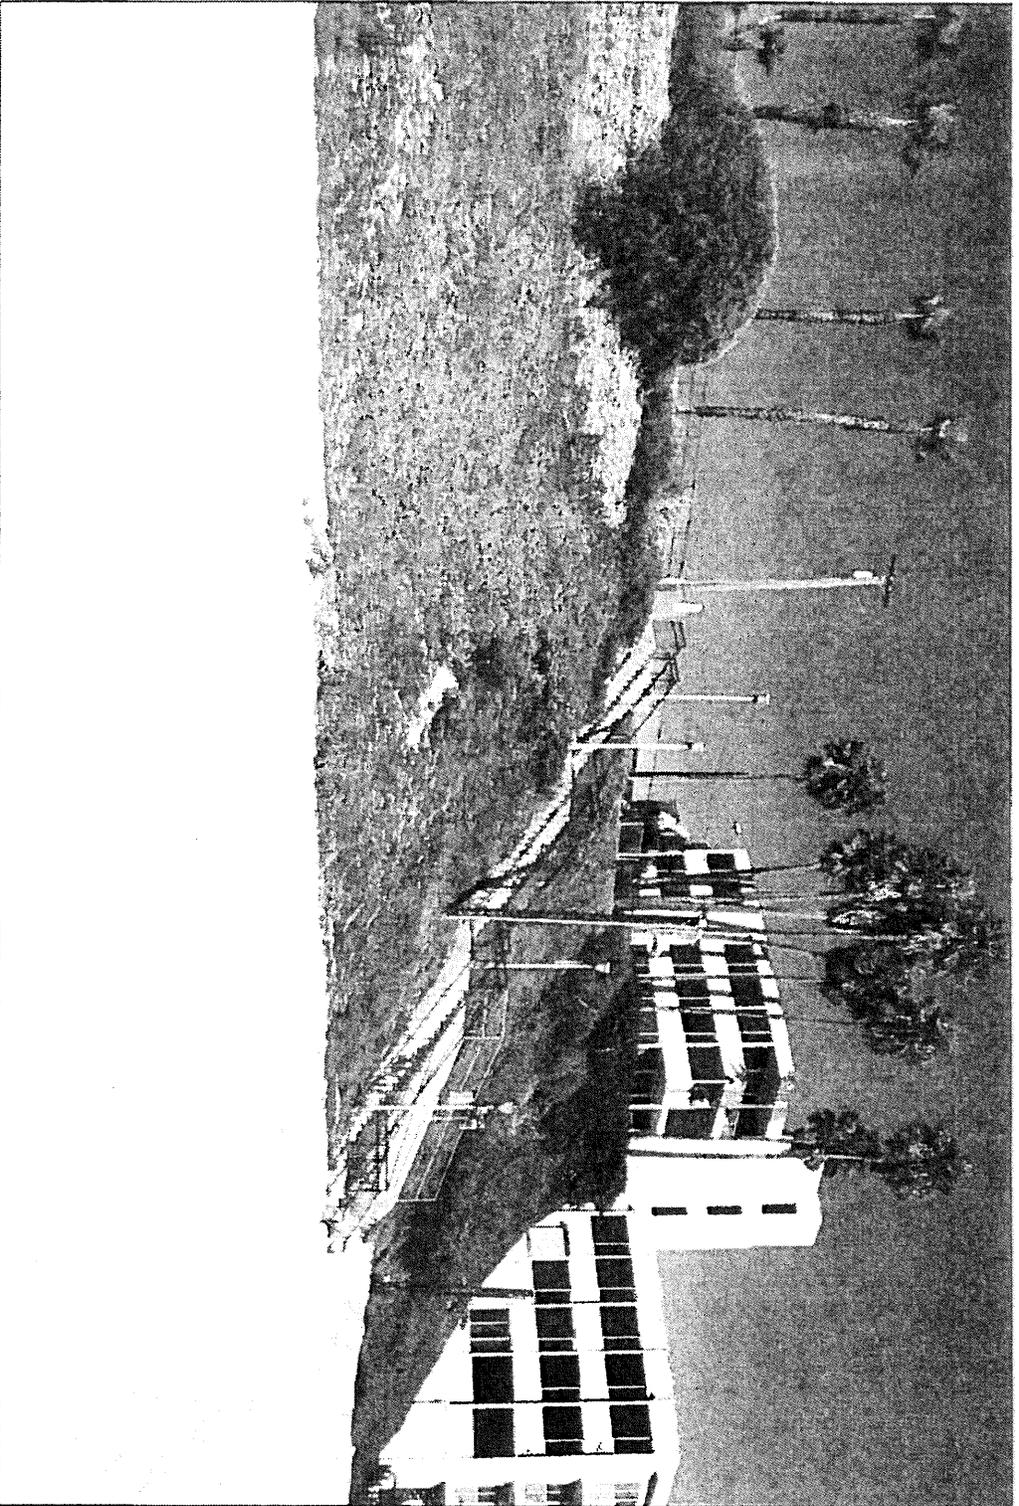
SLOPE EXTENDED BEYOND THE TOE WALL TO CONSTRUCT THE STAIRWAY.
