NAPLES SEAWALL STABILITY INVESTIGATION AND REPAIR RECOMMENDATIONS

LONG BEACH, CALIFORNIA

City of L. B. Project No. PW8110-14

FINAL REPORT Submitted: February 25, 2009
Approved by City: April, 2009

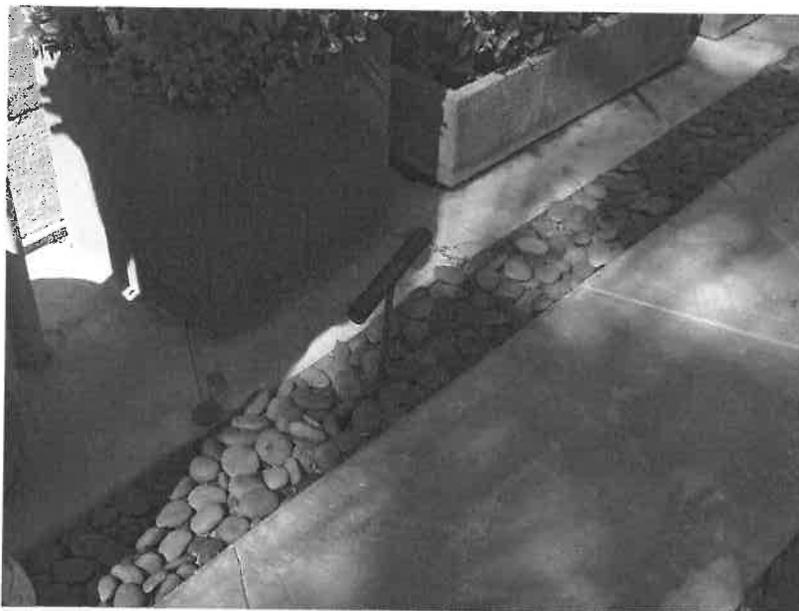
**Photo 2 – 2, Naples, Top Deck Survey: Rivo Alto Canal, #82
Loose soil occurring in rock bed. Probe shows extent of soft soil.**

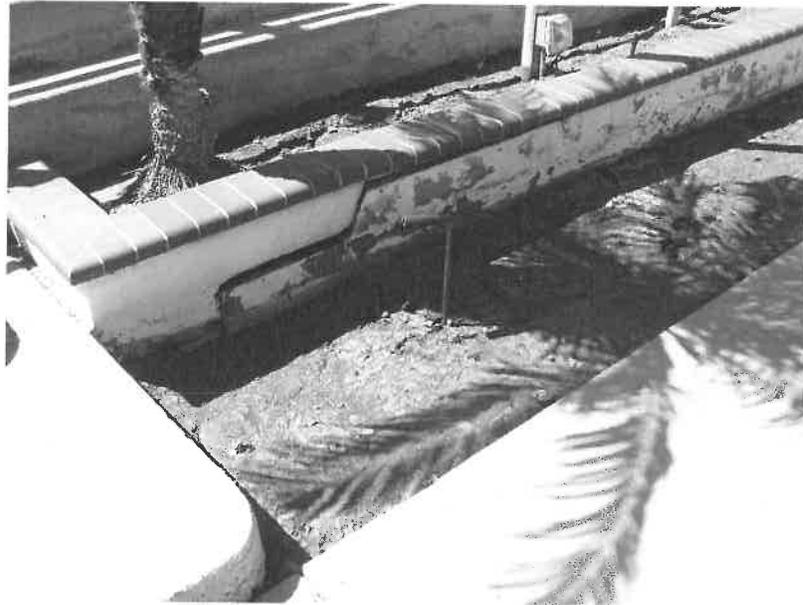
Photo 2 - 3, Naples, Top Deck Survey: Rivo Alto Canal, #24
Typical dirt planter with loose soil. Probe shows extent of soft soil.

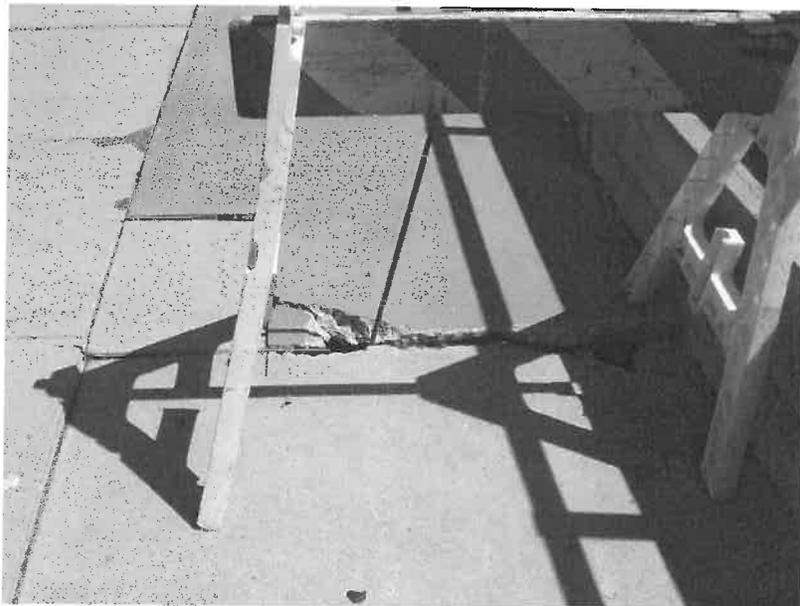
Photo 2 - 4, Naples, Top Deck Survey: Rivo Alto Canal, #133
Sinkhole under concrete sidewalk. Probe is in sinkhole.

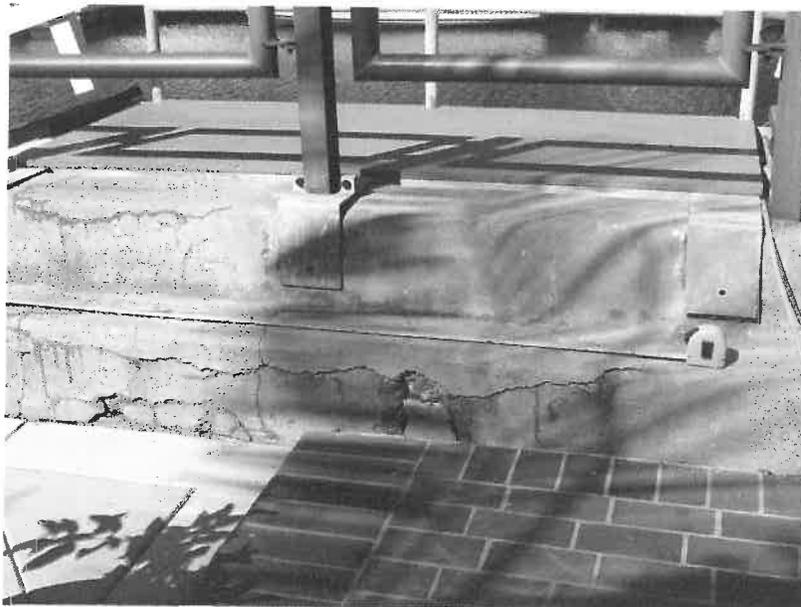
Photo 2 – 5, Naples, Top Deck Survey: Vista Del Golfo, #15
Tie rod protruding above ground.

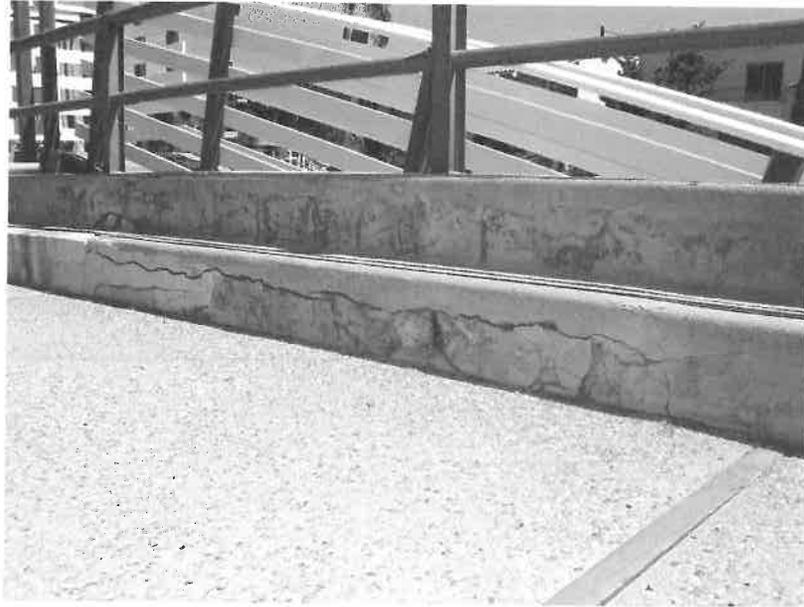
Photo 2 – 6, Naples, Top Deck Survey: Rivo Alto Canal, #118
Cap cracking on the inboard side of the lower cap.

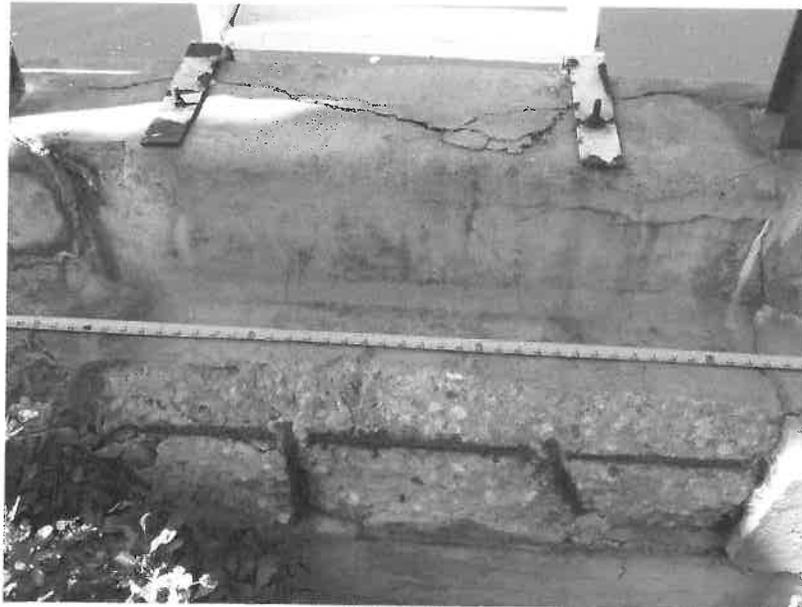
Photo 2 – 7, Naples, Top Deck Survey: Rivo Alto Canal, #47
Cap cracking on the inboard side of the lower cap.

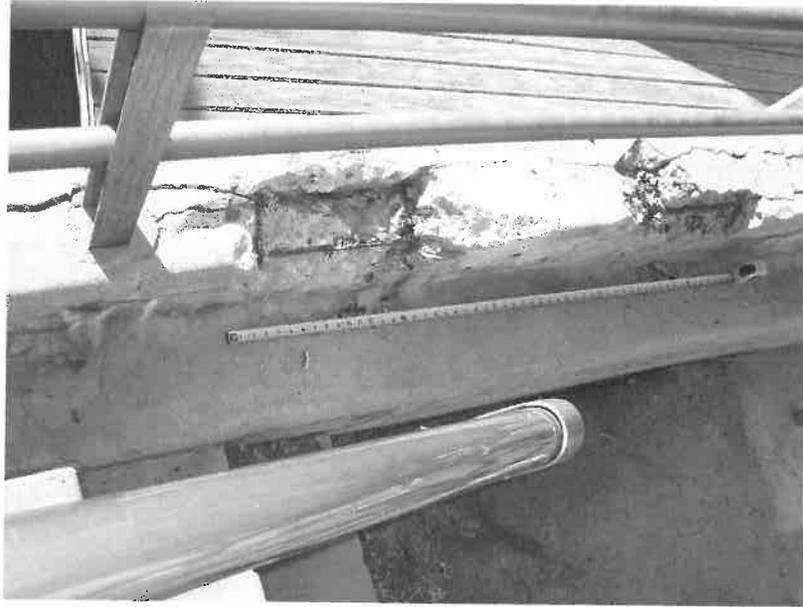
Photo 2 – 8, Naples, Top Deck Survey: Rivo Alto Canal, #185
Cap cracking on the inboard side of the lower cap. Rebar is exposed.

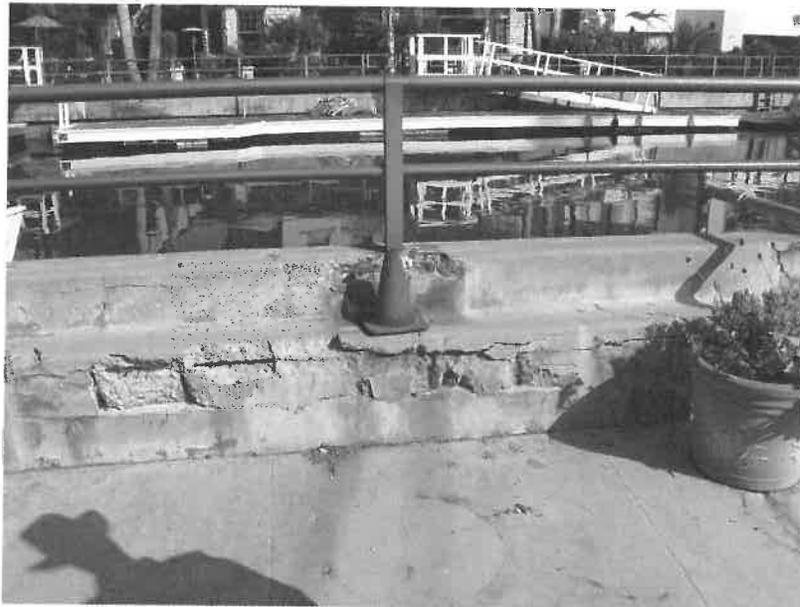
Photo 2 – 9, Naples, Top Deck Survey: Rivo Alto Canal, #20
Spalling on the inboard side of the new top cap. Rebar is rusted and exposed.

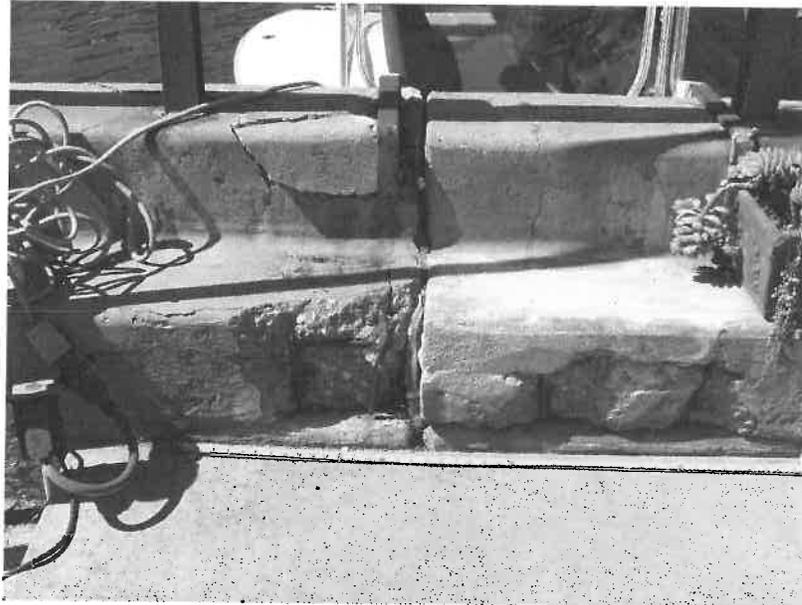
Photo 2 – 10, Naples, Top Deck Survey: Rivo Alto Canal, #179
Spalling on the inboard side of the new top cap & bottom cap. Rebar is rusted and exposed.

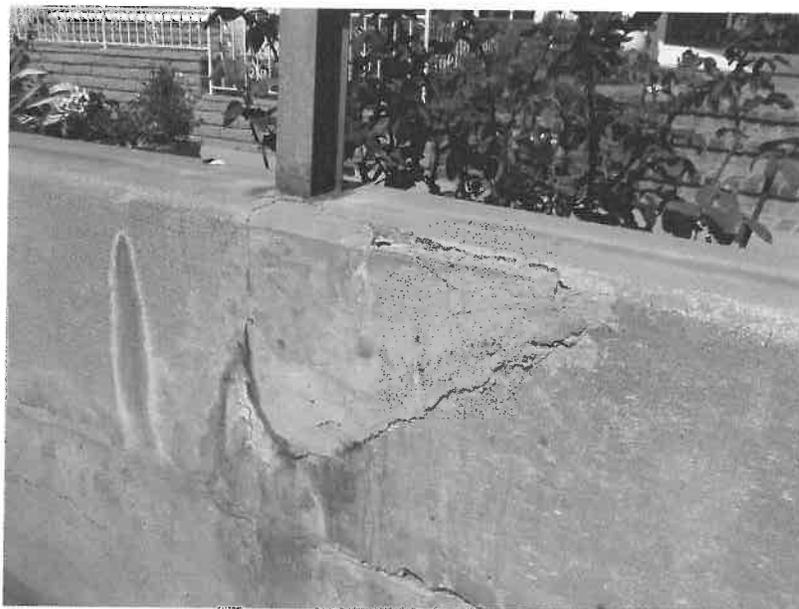
Photo 2 – 11, Naples, Top Deck Survey: Rivo Alto Canal, #183
Spalling on the inboard side of the new top cap & bottom cap at seawall joint. Rebar is rusted and exposed.

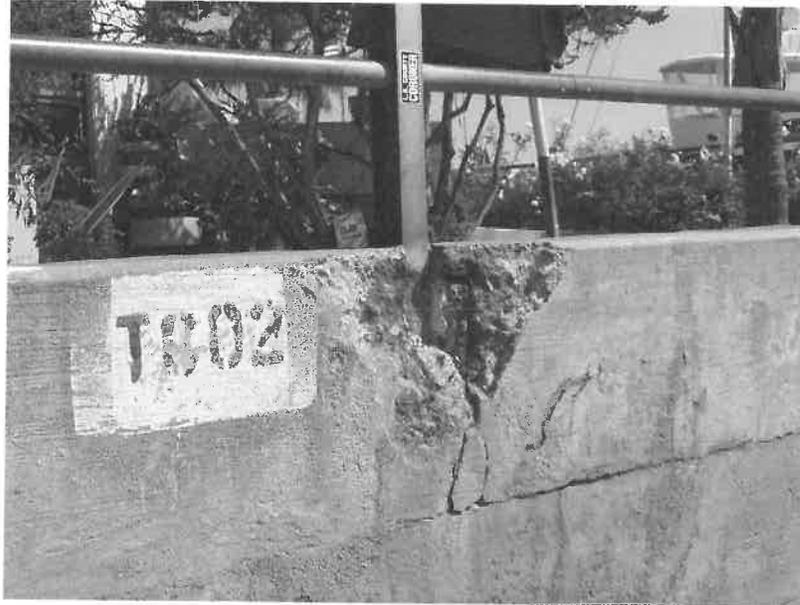
Photo 2 – 12, Naples, Top Deck Survey: Corso Di Napoli, #5733
Patch of a spall occurring in top cap.

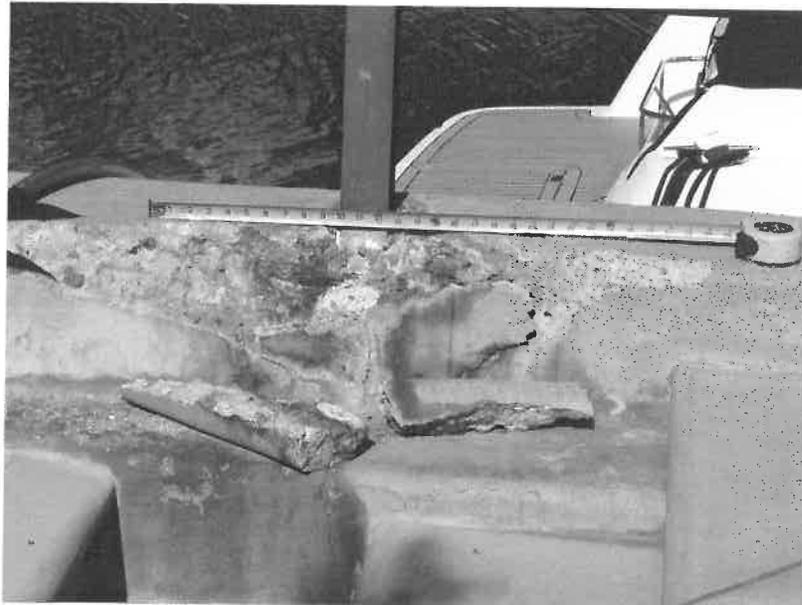
Photo 2 – 13, Naples, Top Deck Survey: Rivo Alto Canal, #221
Rail spalling at outboard side of seawall. Spalling occurs on top cap.

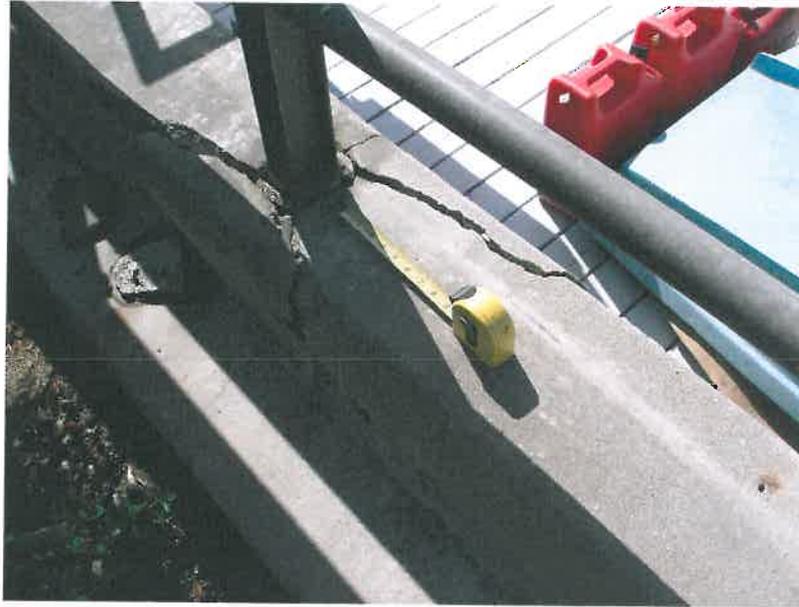
Photo 2 – 14, Naples, Top Deck Survey: Rivo Alto Canal, #144
Rail spalling at inboard side of seawall. Spalling occurs on top cap.

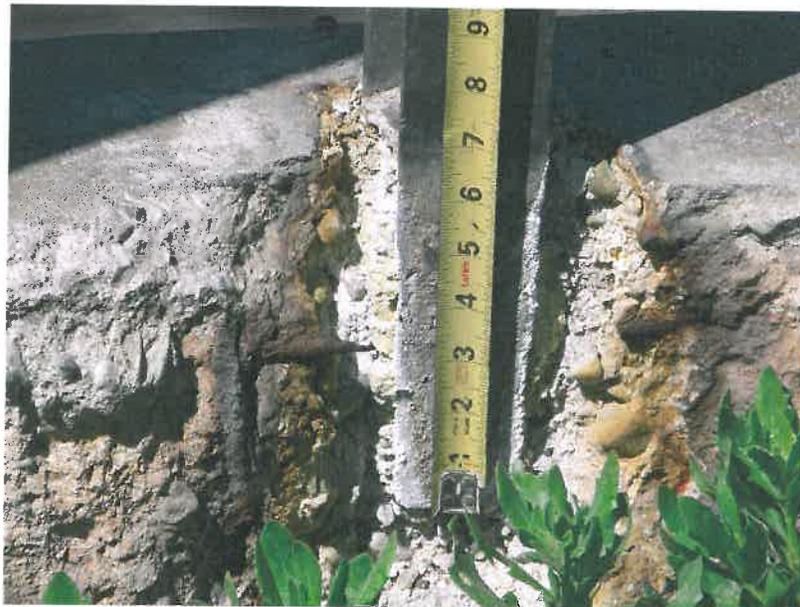
Photo 2 – 15, Naples, Top Deck Survey: Corso Di Napoli, #5639
Rail cracking on top side of seawall. Cracking occurs on top cap.

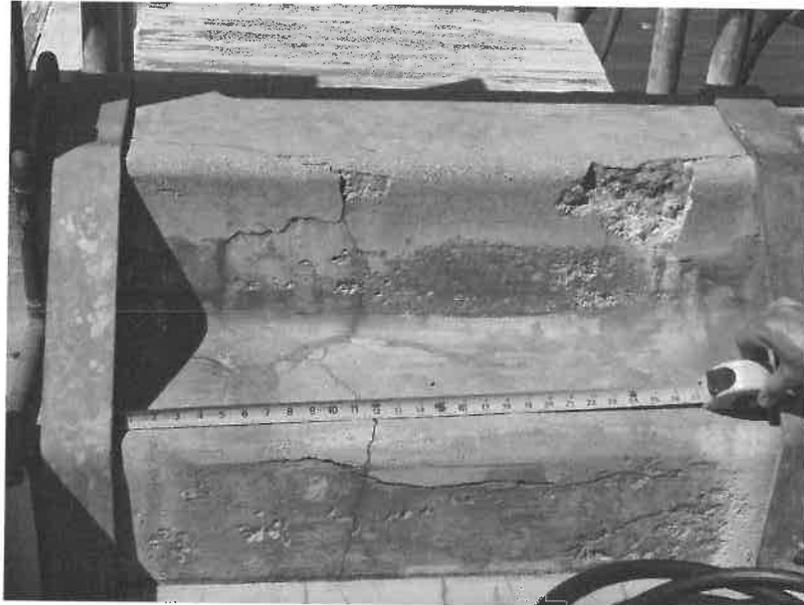
Photo 2 – 16, Naples, Top Deck Survey: Rivo Alto Canal, #213
Grout reaction – exposed concrete and rebar.

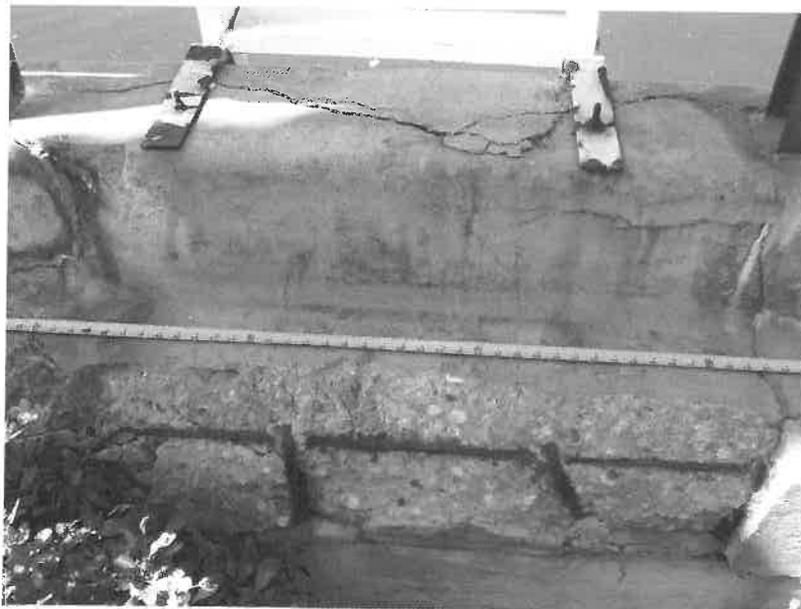
Photo 2 – 17, Naples, Top Deck Survey: Rivo Alto Canal, #213
Typical cracking of seawall cap at gangway gate.

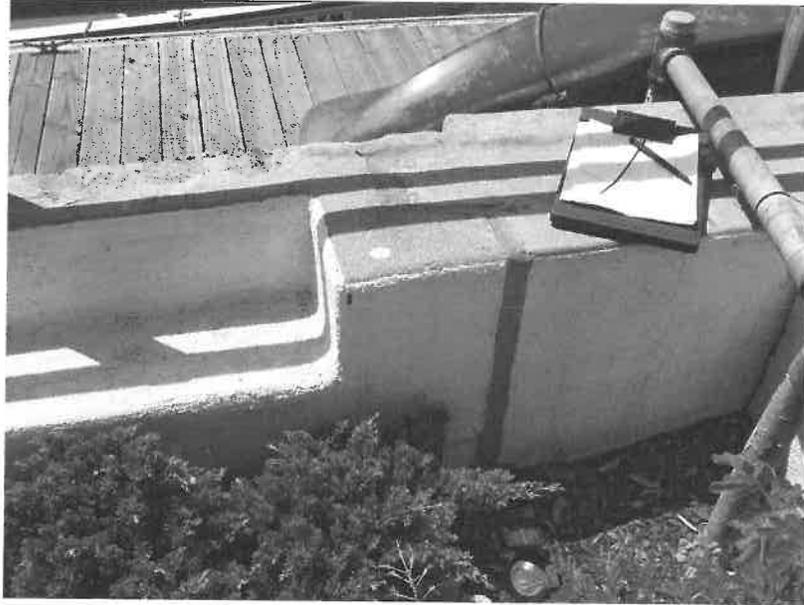
Photo 2 – 18, Naples, Top Deck Survey: Rivo Alto Canal, #185
Typical spalling of seawall cap at gangway gate. Rebar exposed.

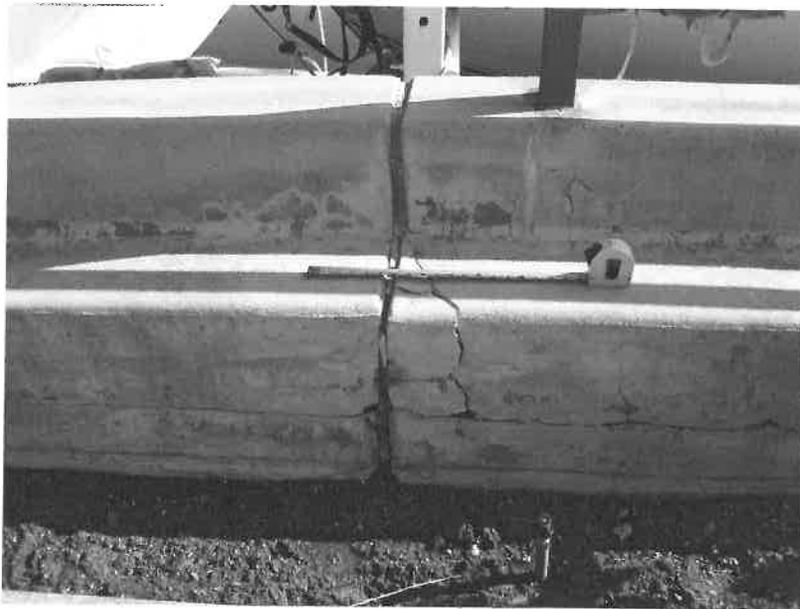
Photo 2 – 19, Naples, Top Deck Survey: Rivo Alto Canal, #95
Typical seawall joint in good condition.

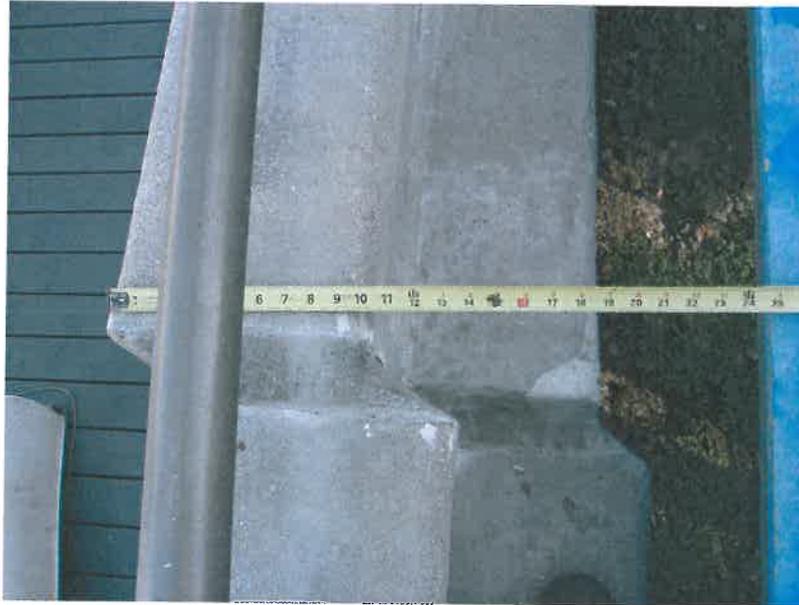
Photo 2 – 20, Naples, Top Deck Survey: Naples Canal, #5598
Typical seawall joint in fair condition.

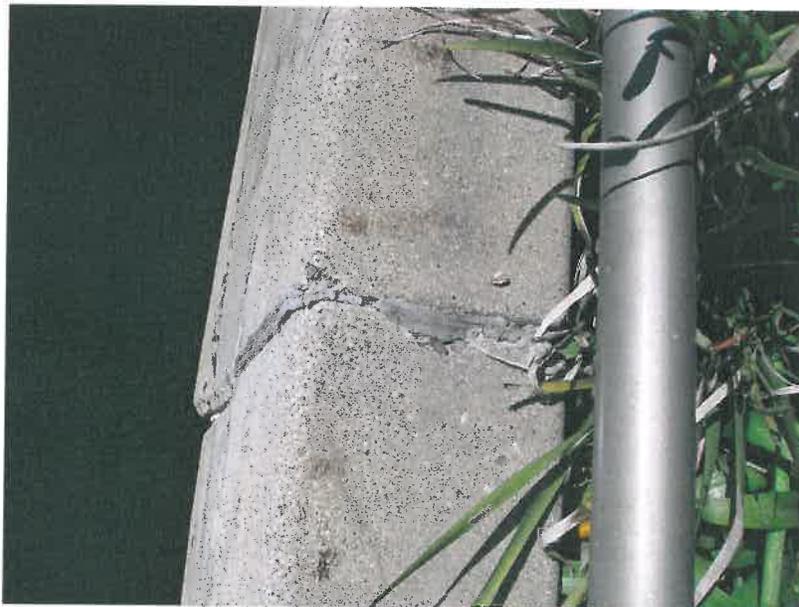
Photo 2 – 21, Naples, Top Deck Survey: Rivo Alto Canal, #172
Horizontal joint offset at failed seawall section.

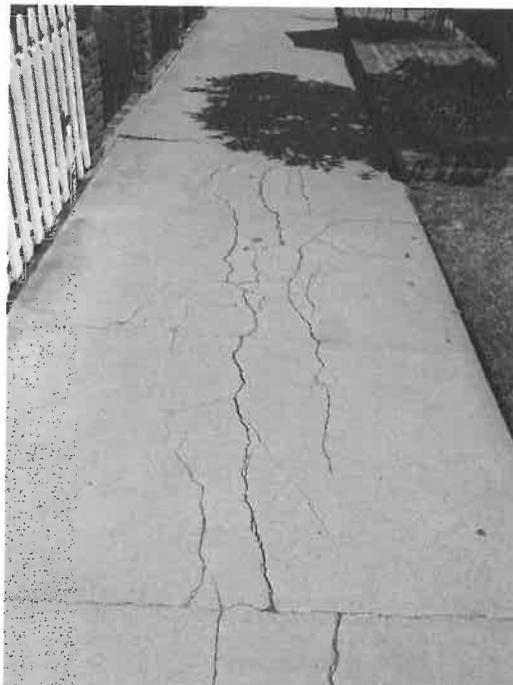
Photo 21 – 26, Naples, Top Deck Survey: Rivo Alto Canal, #81
Sidewalk cracking.

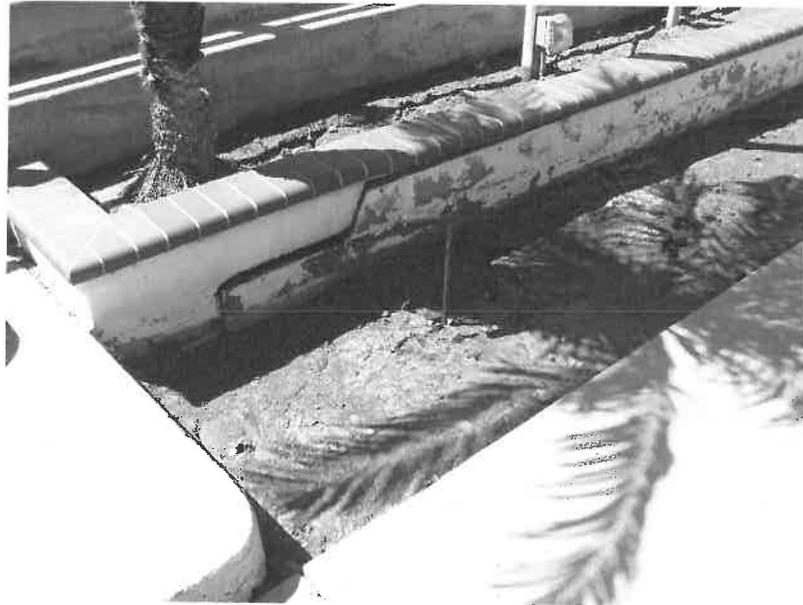
Photo 2 – 29, Naples, Top Deck Survey: Rivo Alto Canal, #24
Example of raised planter that has cracked due to subsidence. Note how deep the probe is sunk into the loose soil.

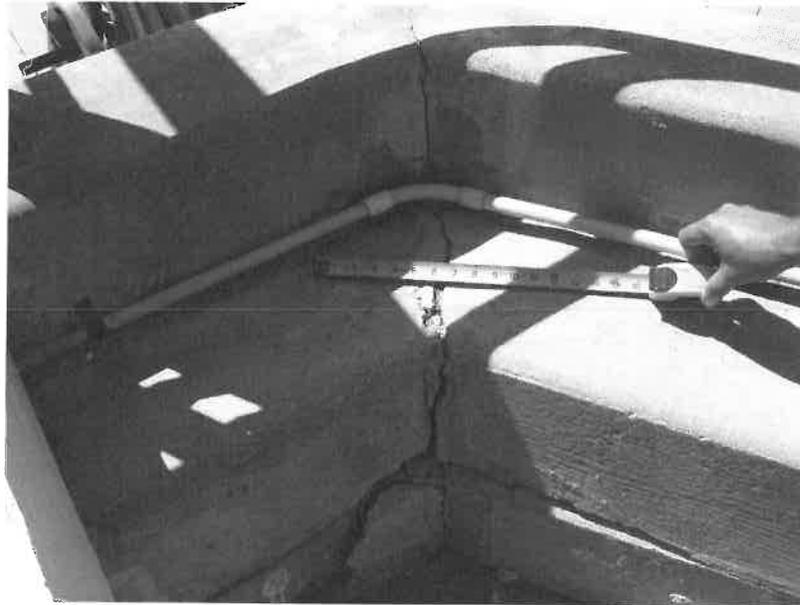
Photo 2 – 33, Naples, Top Deck Survey: Corso Di Napoli, #5705
Example of corner crack in the seawall cap.

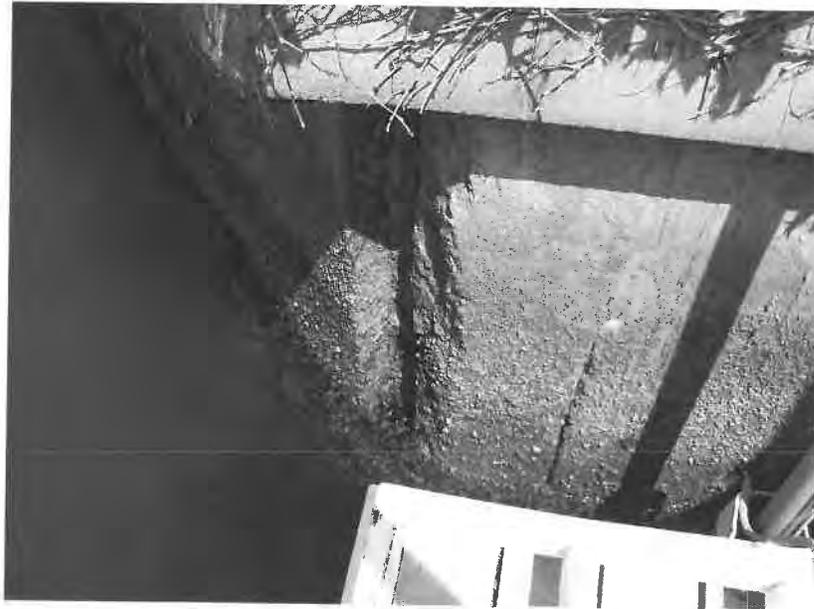
Photo 4 – 25, Naples, Waterside Survey: Rivo Alto Canal #5607
Broken/raveled sheet pile joint at corner near canal entrance.

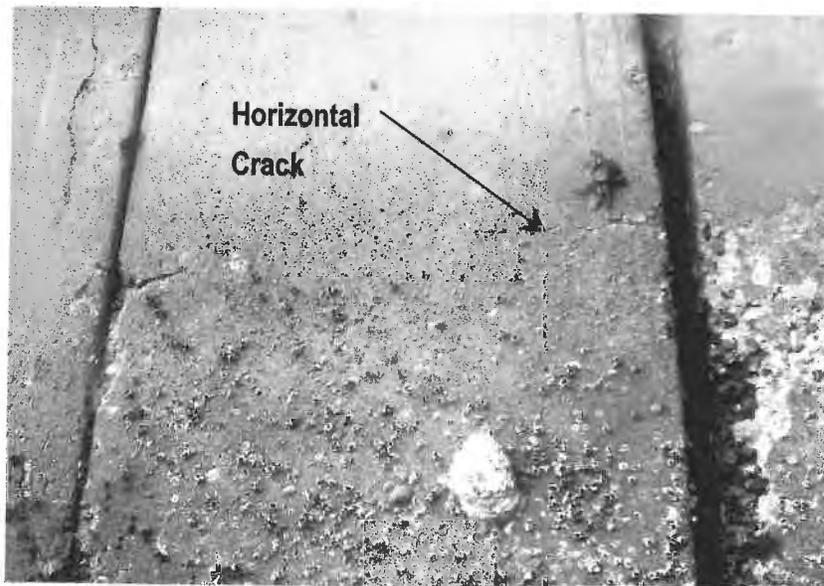
Photo 4 – 26, Naples, Waterside Survey: Rivo Alto Canal #173
Typical sheet pile horizontal crack near mean high tide elevation.

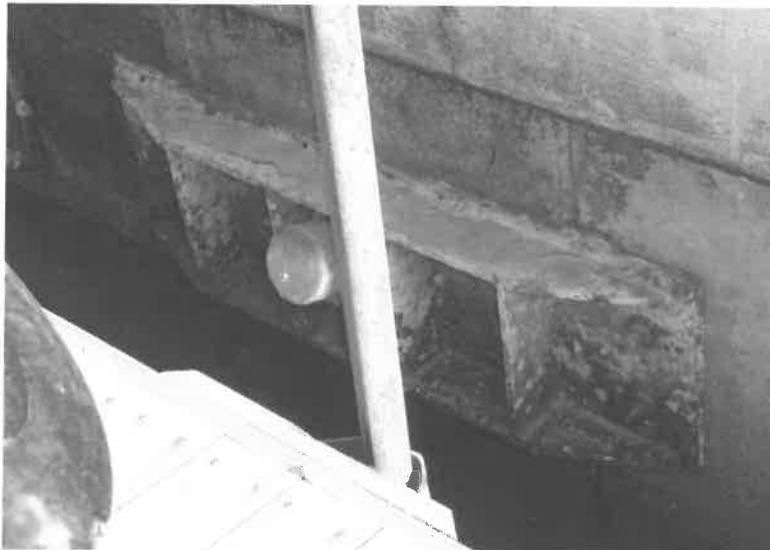
Photo 8.1 – Naples. Rivo Alto Canal #58, Replacement tie-backs have rapid corrosion due to their elevation and will require maintenance in the next five years.
