**HAZARDOUS BUILDING MATERIAL  
SURVEY AND CORROSION STUDY  
BELMONT PLAZA POOL FACILITY  
REBUILD/REVITALIZATION PROJECT  
4000 EAST OLYMPIC PLAZA  
LONG BEACH, CALIFORNIA 90803**

July 10, 2014  
Project No. 209120001

Subject: Hazardous Building Material Survey and Corrosion Study  
Belmont Plaza Pool Facility Rebuild/Revitalization Project  
4000 East Olympic Plaza  
Long Beach, California 90803

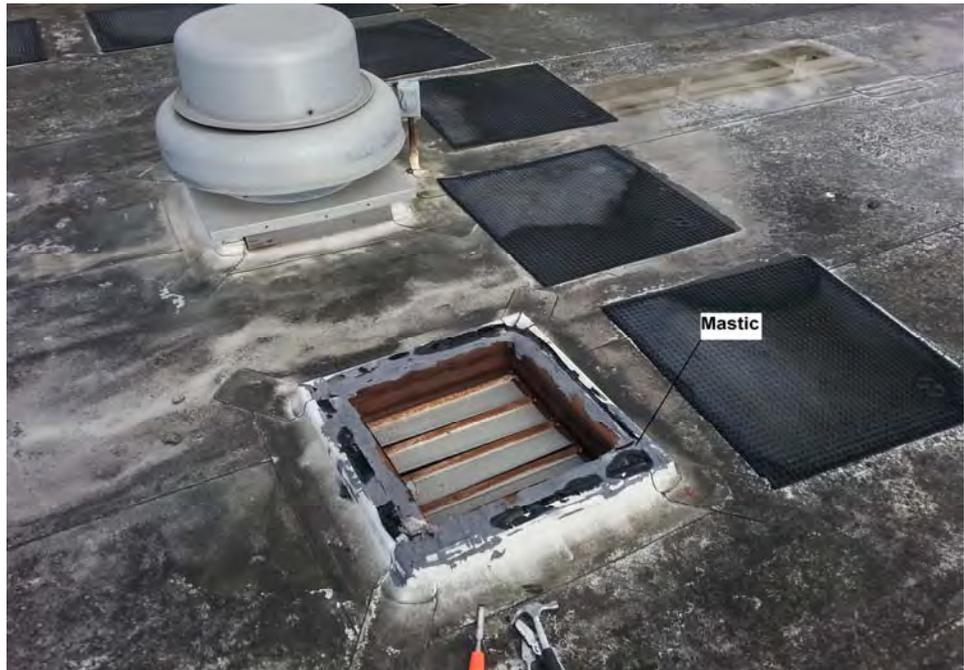
**Photograph 1:** View of locker rooms and office building roofing with asbestos containing vent penetration mastic.

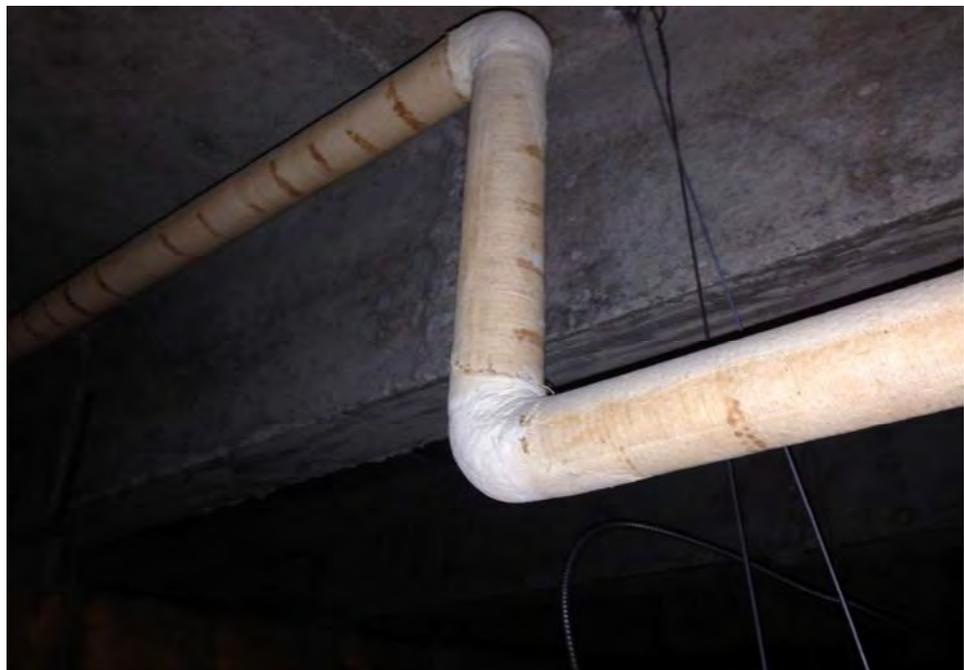
**Photograph 2:** View of representative asbestos containing cloth-wrapped elbow insulation in the ceiling plenum above the women's locker room in the locker rooms and office building.

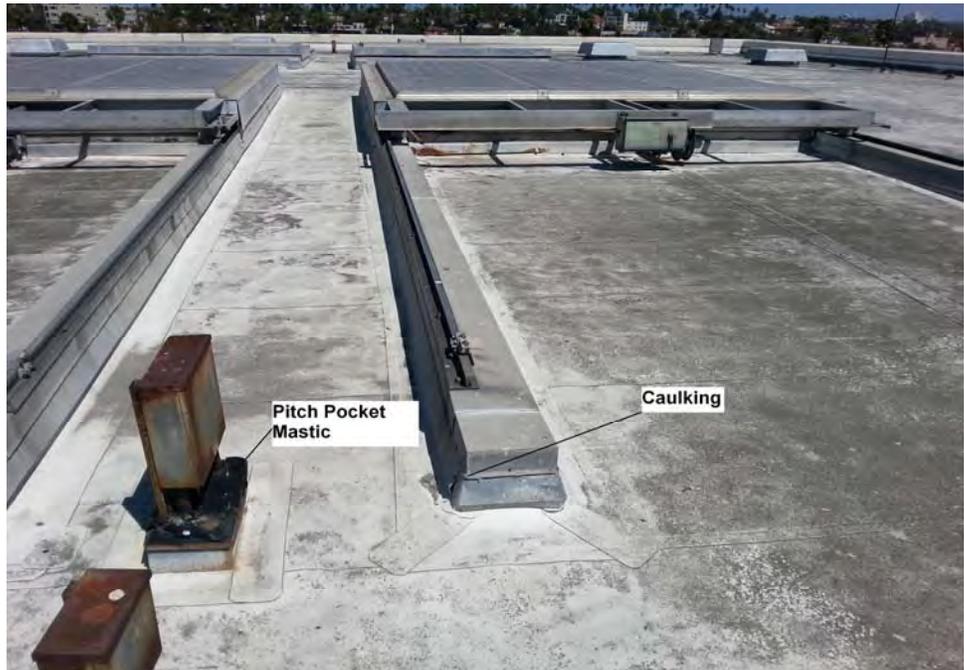
**Photograph 3:** View of main pool building roofing with asbestos containing materials including penetration mastic and skylight beige caulking.

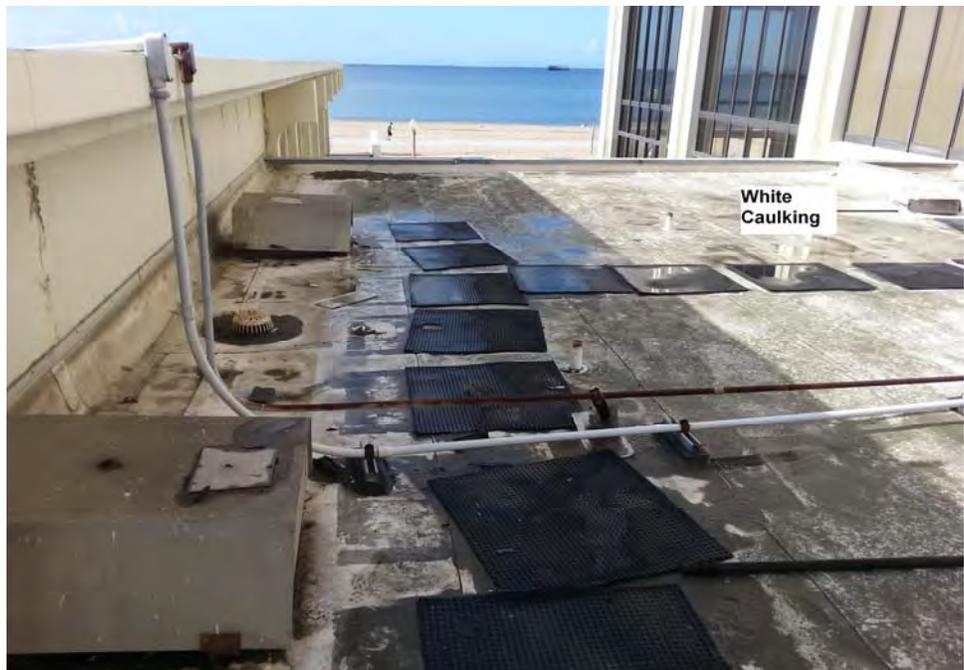
**Photograph 4:** View of walkway roofing between locker rooms and office building and main pool building with asbestos containing white caulking.

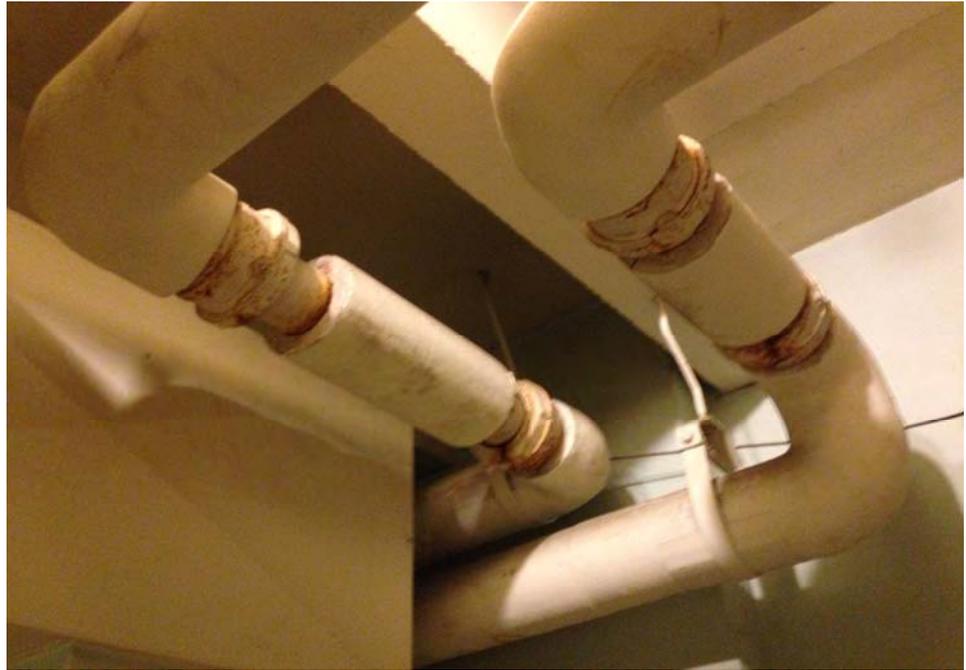
Approximately 18 cloth wrapped thermal system insulation elbows from 6-inch piping in the basement storage room and filter tank rooms are ACM. Approximately 150 SF of roofing penetration mastic at the hatches and skylight are ACM. Approximately 70 SF of the beige and gray caulking at the roof skylights are ACM. The ACMs were noted to be in a good condition. Approximately 100 assumed gaskets are present in the filter tank room and basement locations.

**Photograph 5:** View of representative asbestos containing cloth-wrapped elbow insulation in the main pool building basement.

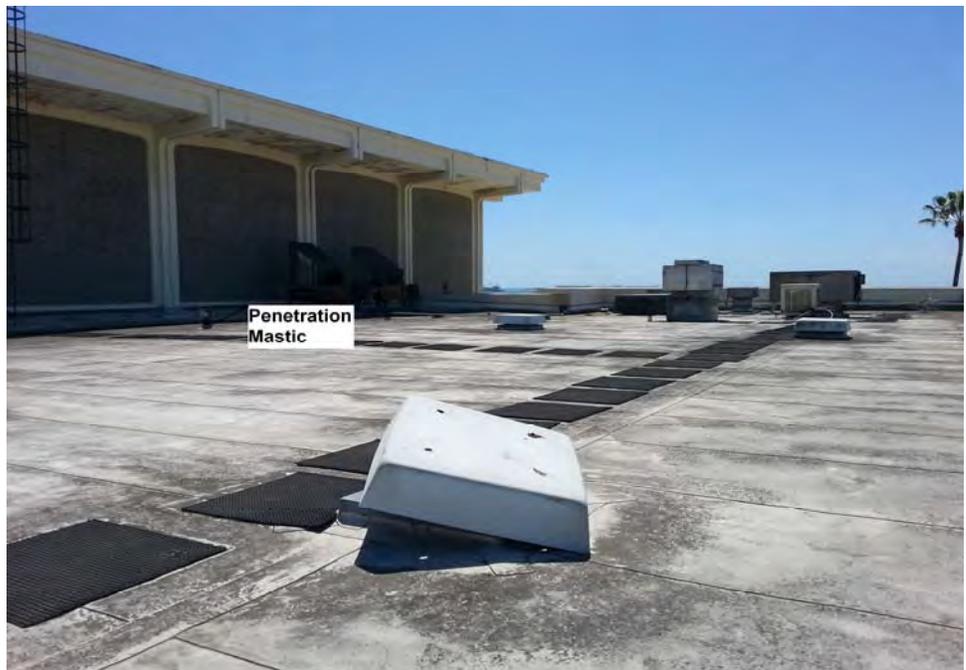
**Photograph 6:** View of restaurant roofing with asbestos containing penetration mastic.

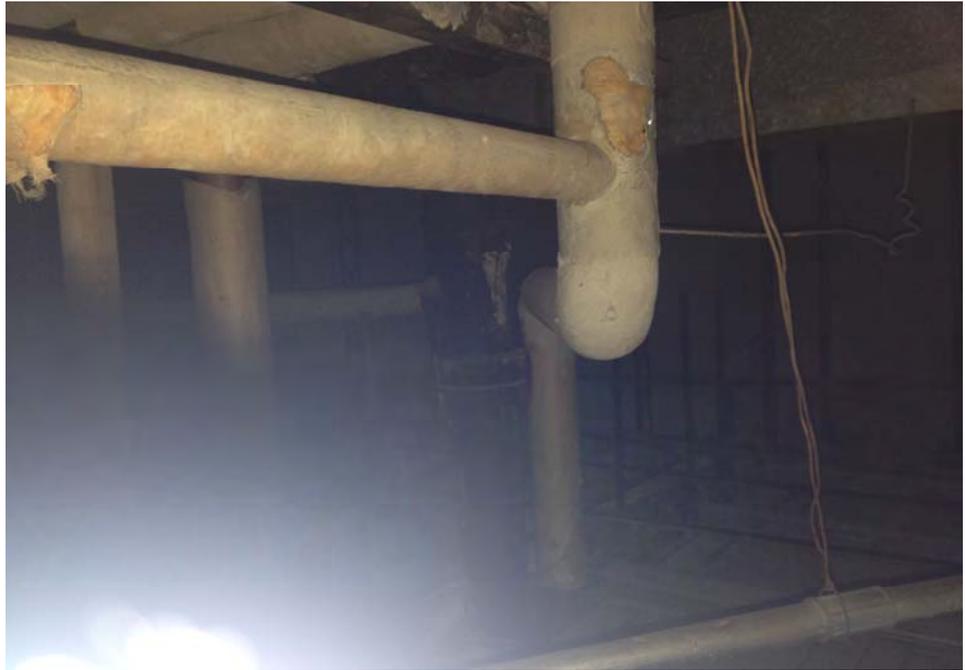
**Photograph 7:** View of representative asbestos containing cloth-wrapped elbow insulation in the ceiling plenum above the first floor women's restroom within the restaurant building.

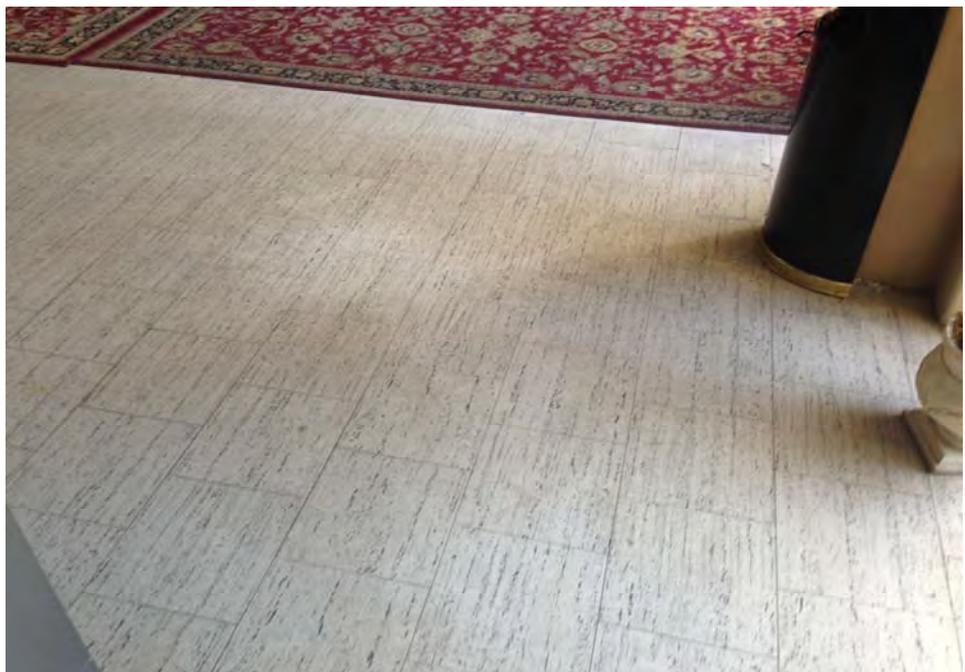
**Photograph 8:** View of asbestos containing vinyl floor tile and mastic on the second floor of the restaurant building.

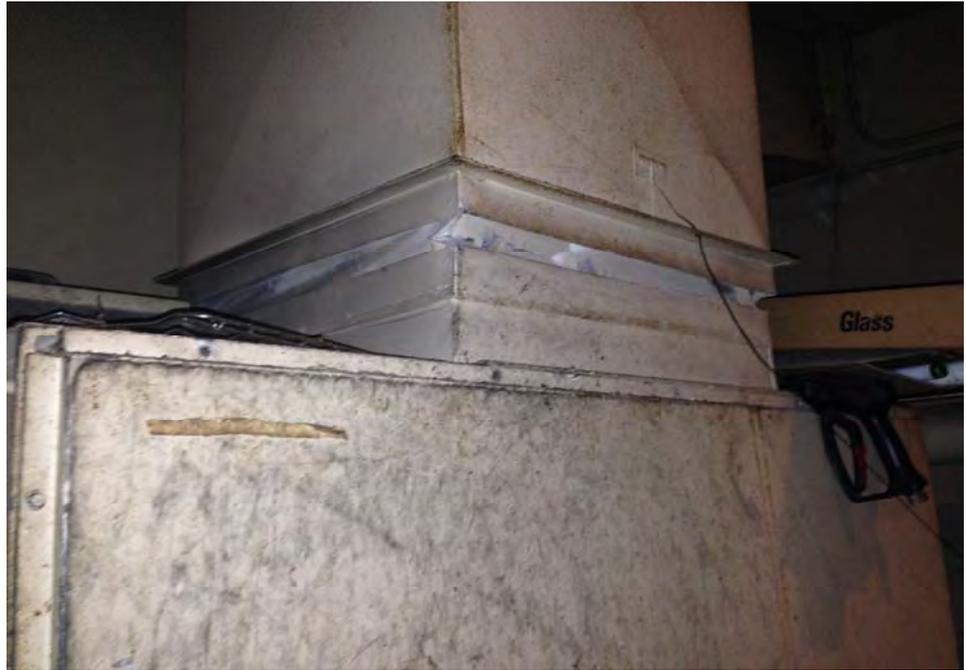
**Photograph 9:** View of assumed asbestos containing vibration damper in the mechanical room of the restaurant building.

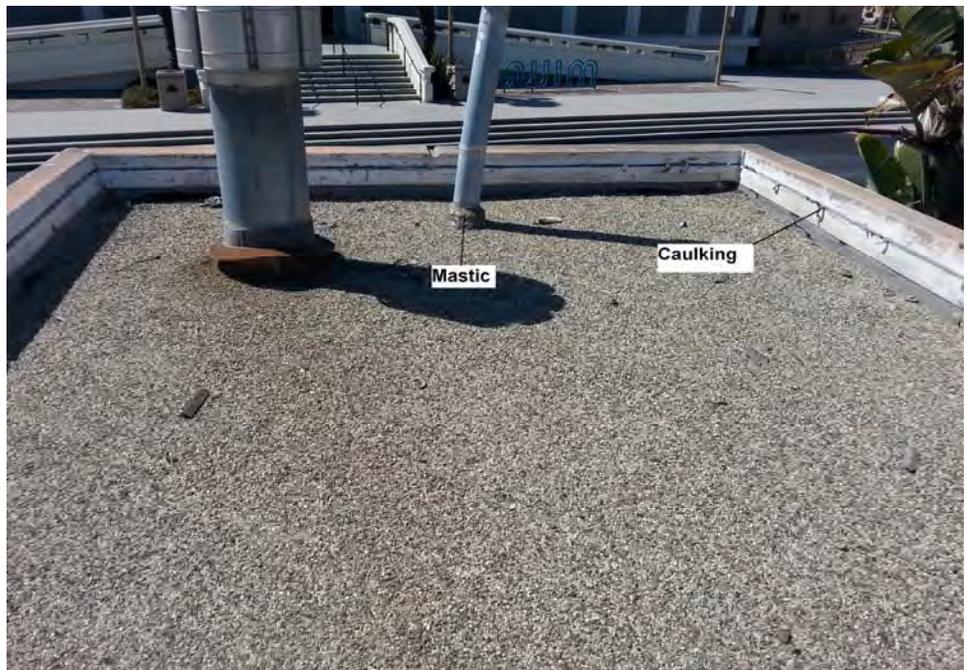
**Photograph 10:** View of old pool mechanical/chemical building roofing with asbestos containing materials including vent black mastic and gray caulking.

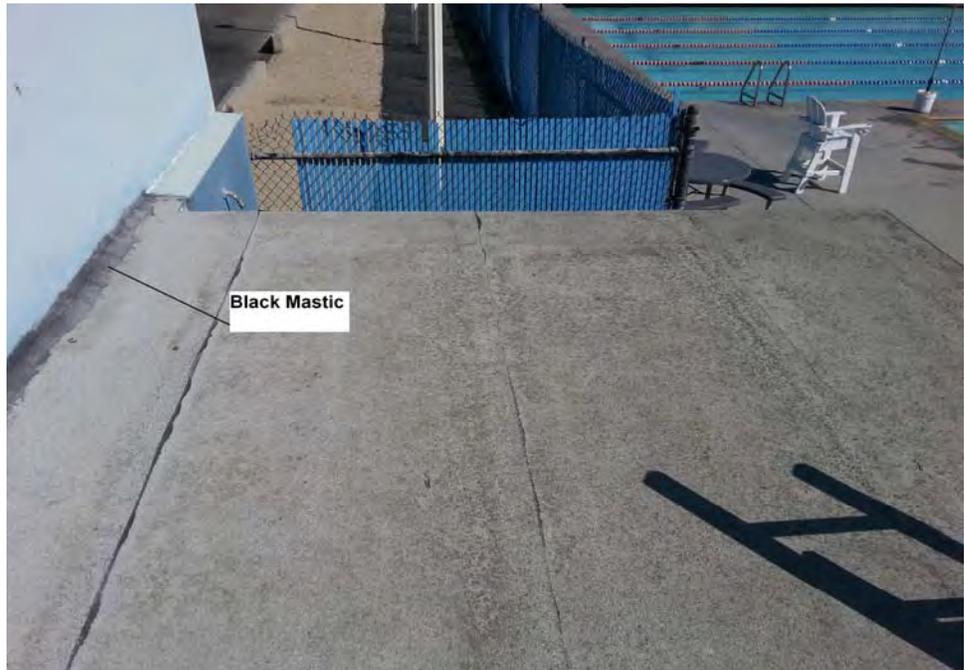
**Photograph 11:** View of old pool storage building roofing with asbestos containing black mastic.

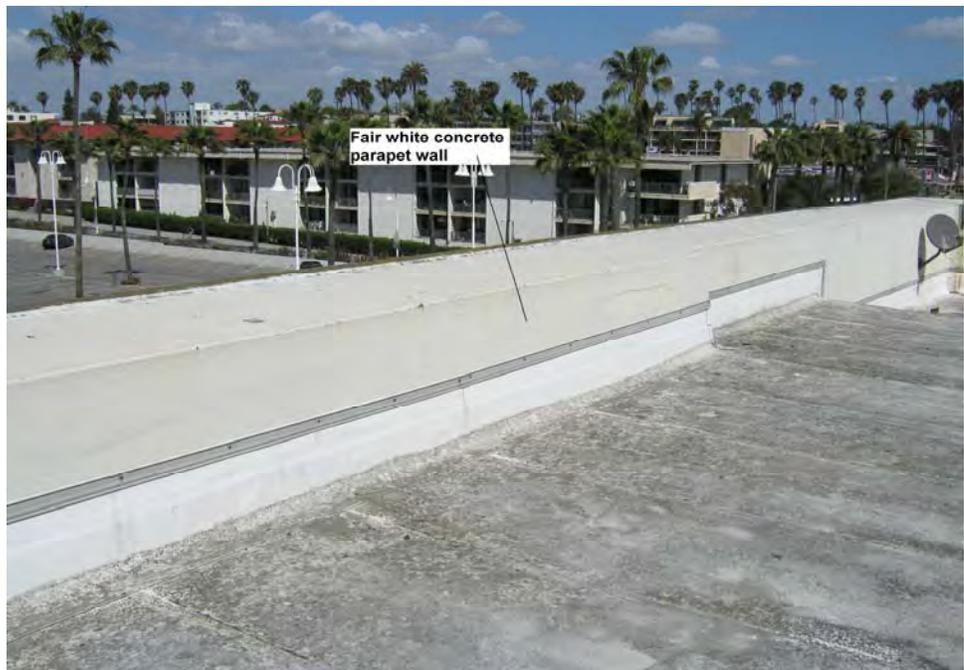
Approximately 25 SF of paint in fair condition was found at the roofing area parapet walls. Approximately 260 SF of beige ceramic wall tiles in the second floor men's restroom is LCS. Approximately 115 SF of white ceramic wall tiles in the second floor kitchen is LCS. Approximately 260 SF of white ceramic wall tiles in the second floor women's restroom is LCS.

**Photograph 12:** View of fair lead-containing white paint on parapet concrete wall on the roof of the restaurant building.

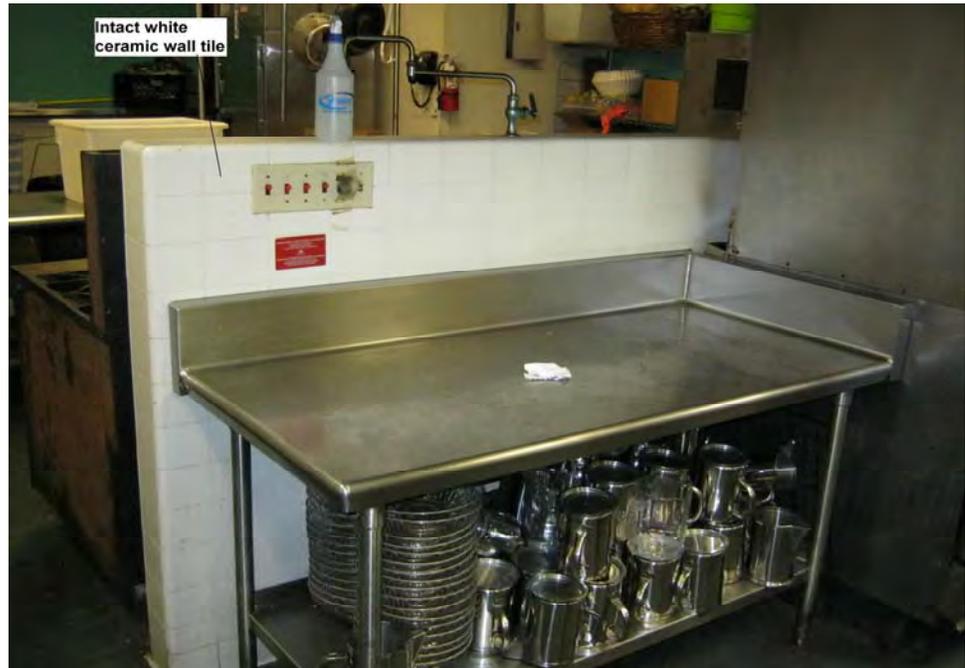
**Photograph 13:** View of intact lead-containing white ceramic wall tile in the 2<sup>nd</sup> floor kitchen of the restaurant building.

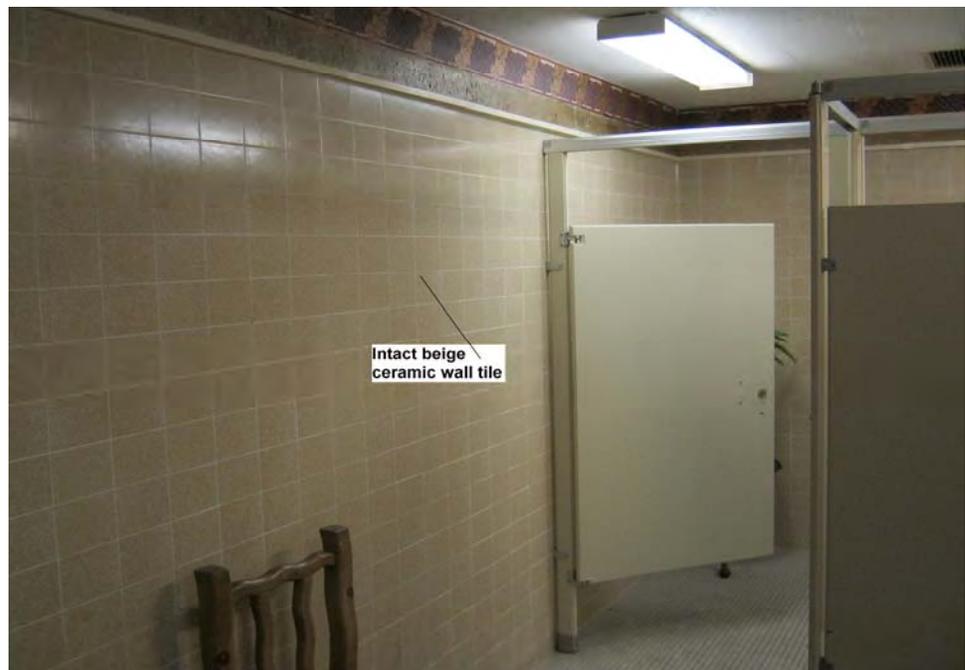
**Photograph 14:** View of intact lead-containing beige ceramic wall tile in the 2<sup>nd</sup> floor men's restroom of the restaurant building.

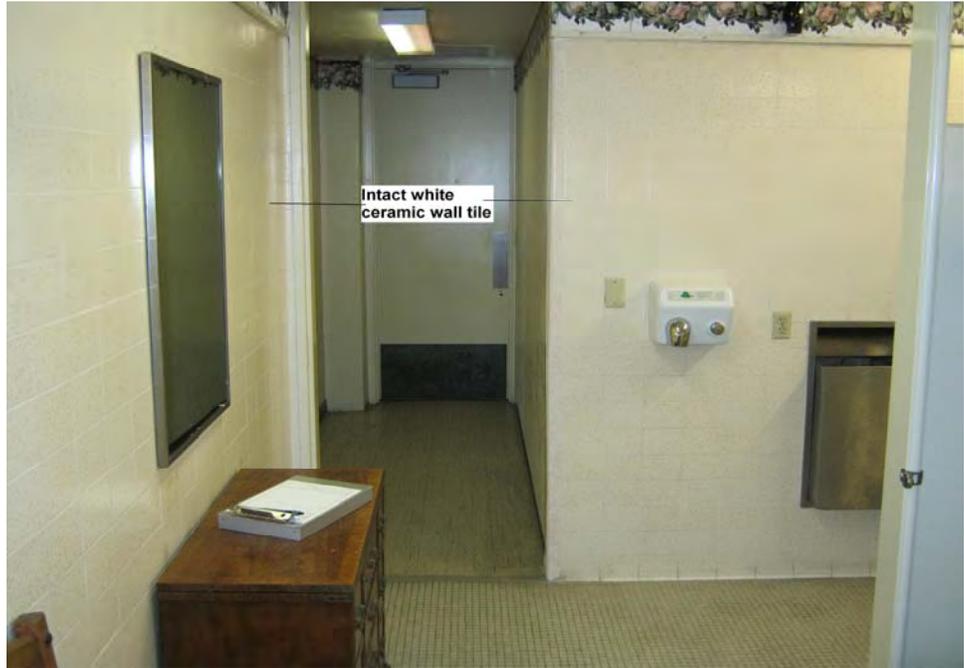
**Photograph 15:** View of intact lead-containing white ceramic wall tile in the 2<sup>nd</sup> floor women's restroom of the restaurant building.

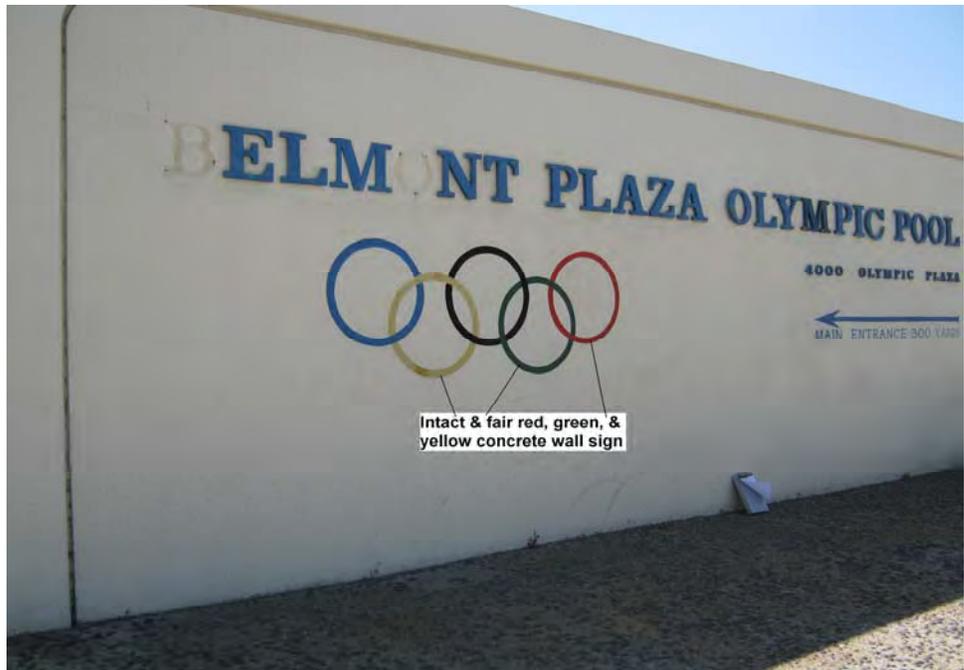
**Photograph 16:** View of intact and fair lead-containing red, green, and yellow paint on concrete wall sign on the exterior wall of the ramp.

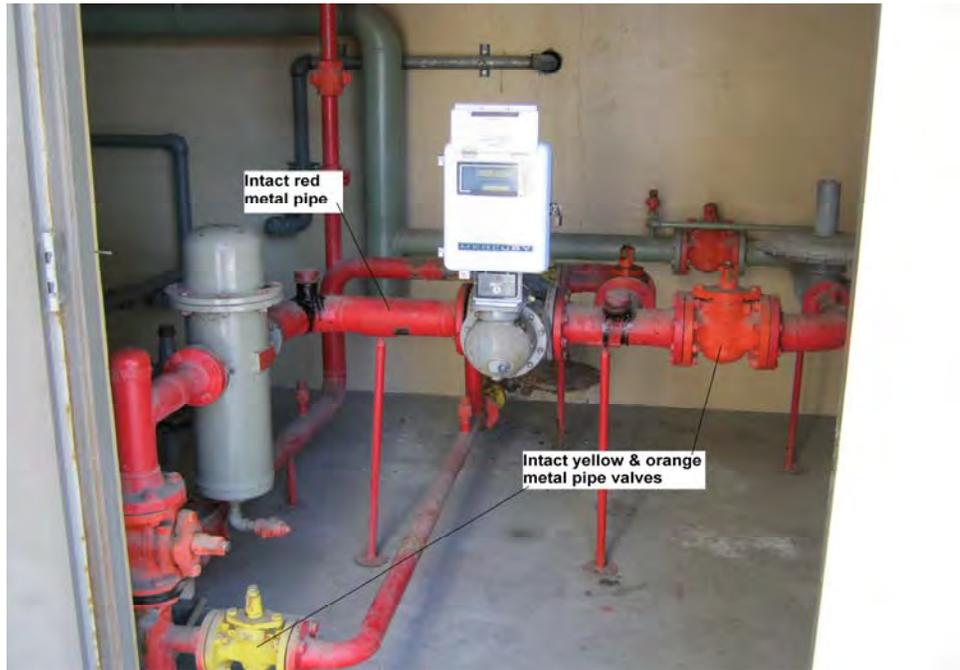
**Photograph 17:** View of intact lead-containing red paint on metal pipes and yellow and orange paint on metal pipe valves in Room 2 under the ramp.

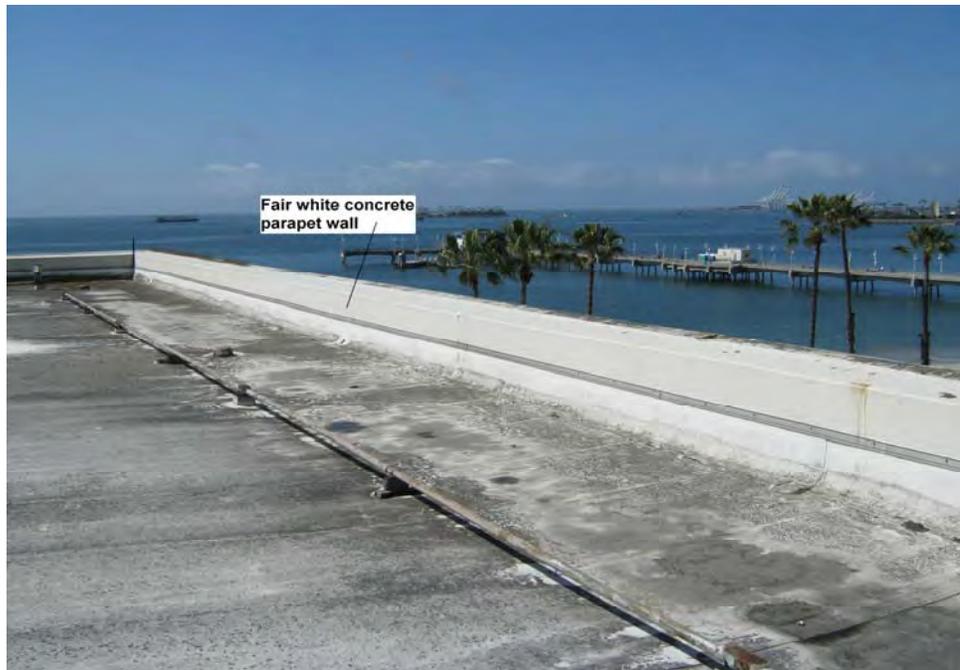
**Photograph 18:** View of fair lead-containing white paint on concrete parapet wall on the roof of the main pool building.

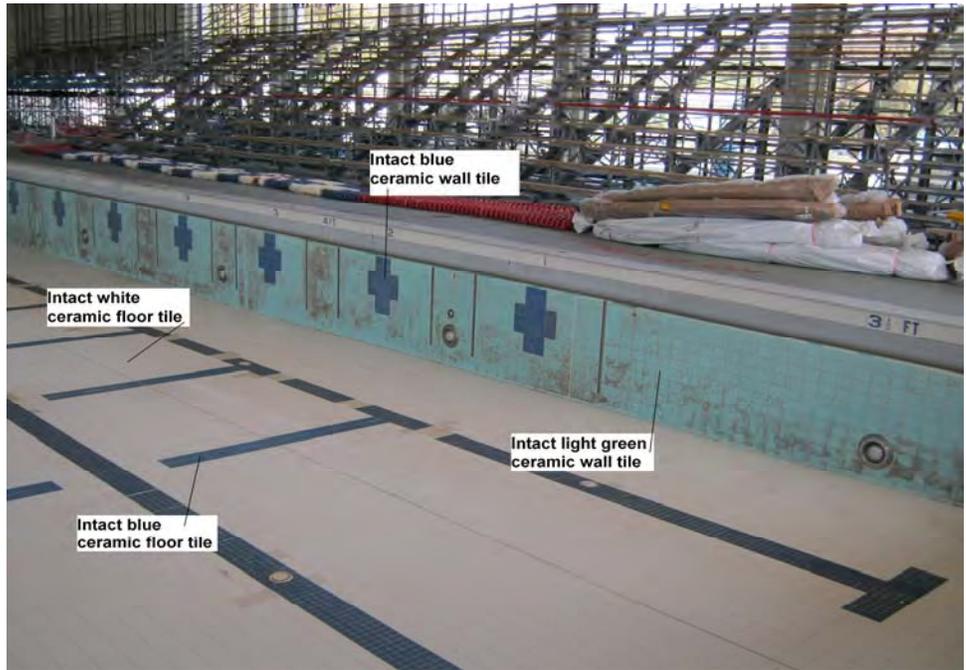
Approximately 18,725 SF of intact LCS was found on the various white, blue, and light green ceramic tiles within the flooring and wall areas of the swimming pool. Approximately 50 SF of paint in fair condition was found at the roofing area parapet walls. Approximately 1,000 linear feet of metal overhead plumbing pipes in the basement pool equipment storage, basement hallway, and basement filter tank rooms contain LCS in a poor to intact condition.

**Photograph 19:** View of representative intact lead-containing white, blue, and light green ceramic wall and floor tiles in the swimming pool and diving pool of the main pool building.

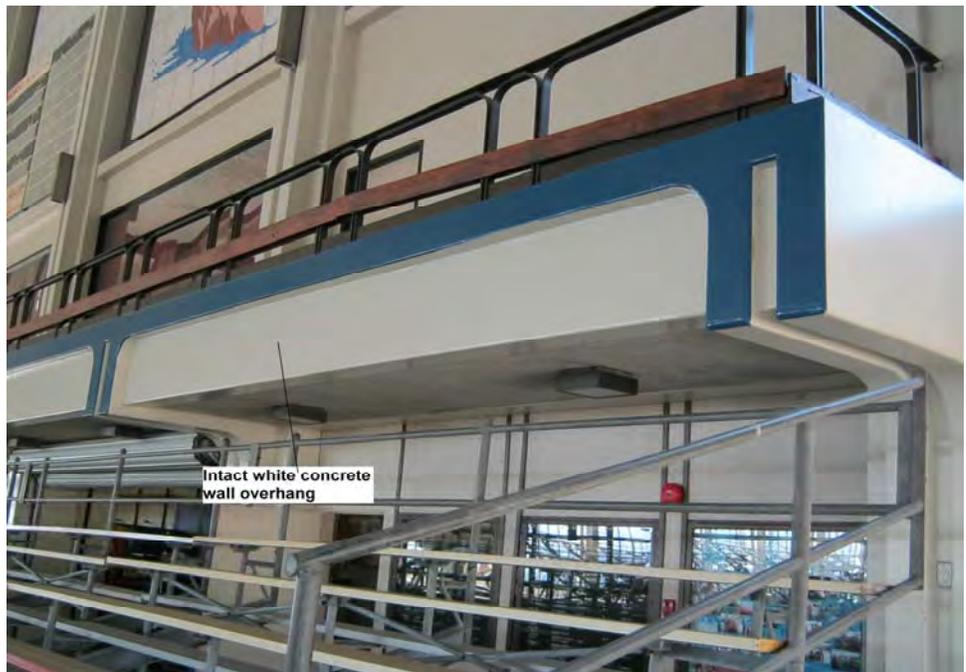
**Photograph 20:** View of representative intact lead-containing white paint on concrete wall overhang in the main pool building.

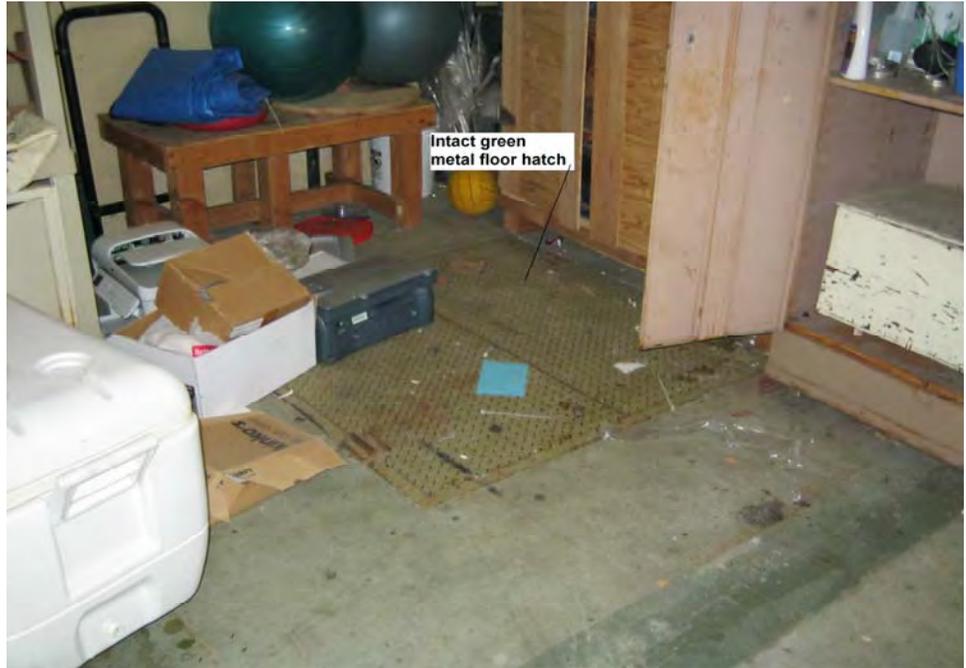
**Photograph 21:** View of intact lead-containing green paint on metal floor hatch in the storage area of the main pool building.

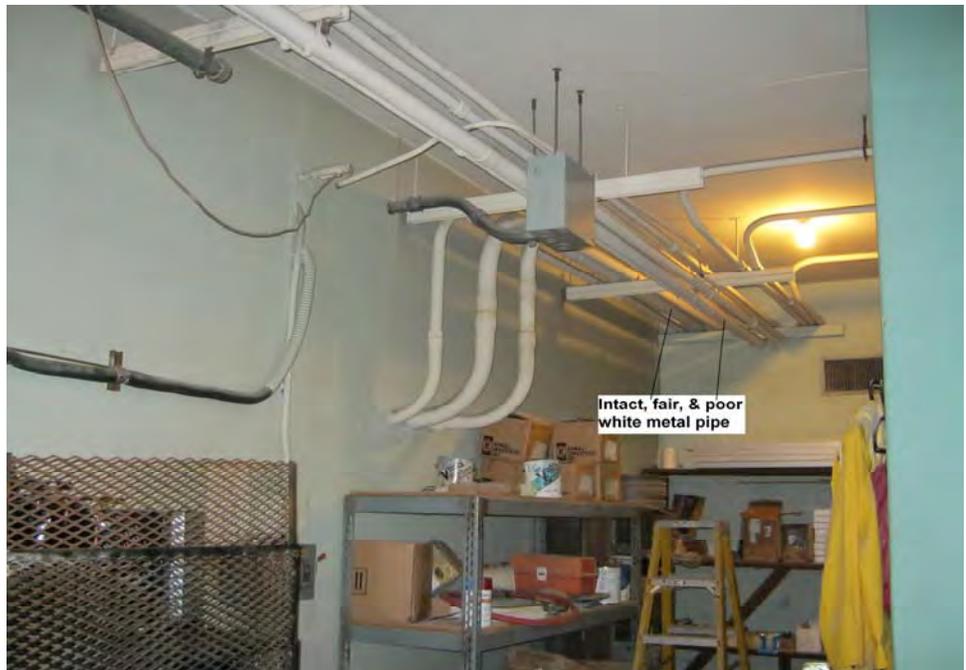
**Photograph 22:** View of representative intact, fair, and poor lead-containing white paint on metal ceiling pipes in the pool equipment storage room in the basement of the main pool building.

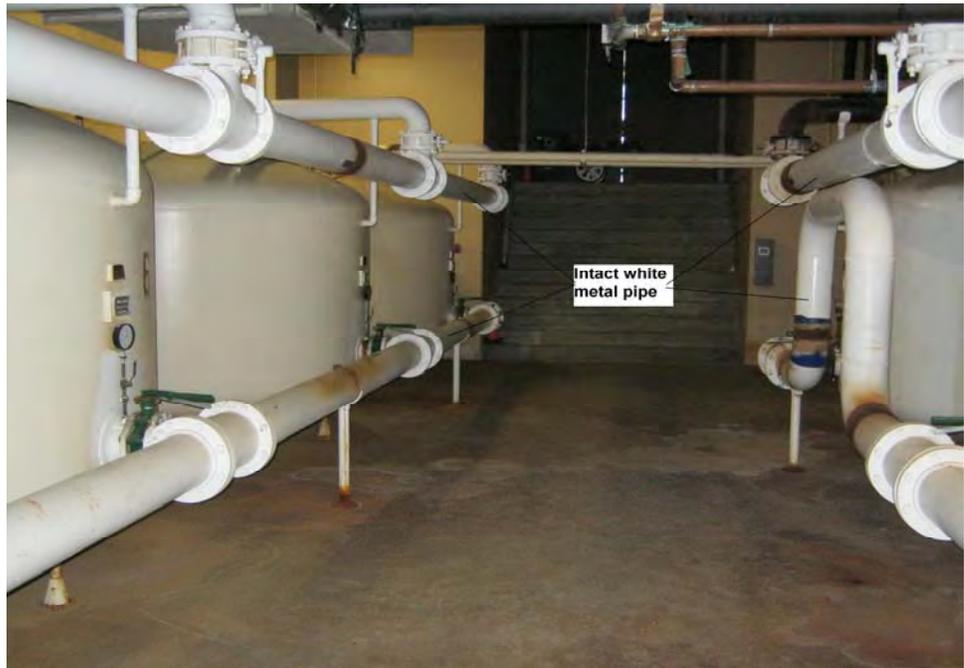
**Photograph 23:** View of representative intact lead-containing white paint on metal pipes in the filter tank room in the basement of the main pool building.

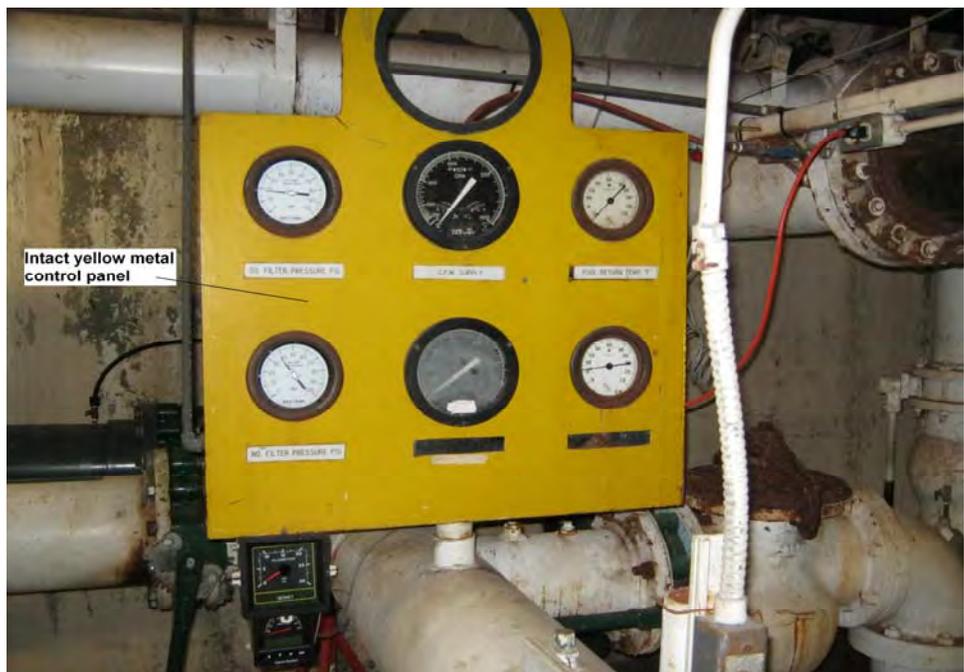
**Photograph 24:** View of intact lead-containing yellow paint on metal control panel in the filter tank room in the basement of the main pool building.

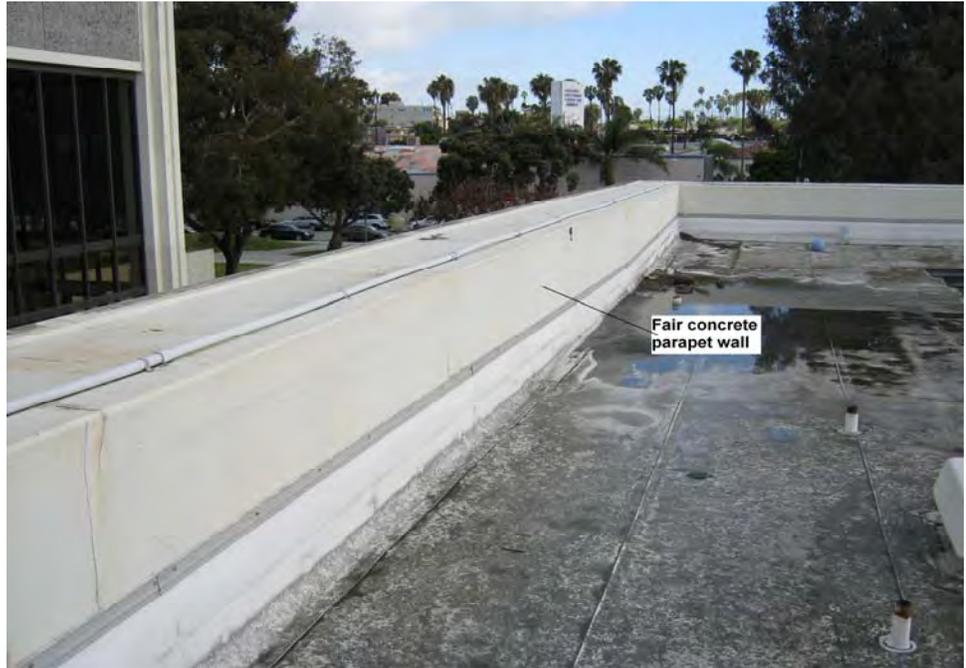
**Photograph 25:** View of fair lead-containing white paint on concrete parapet wall on the roof of the locker rooms and office building.

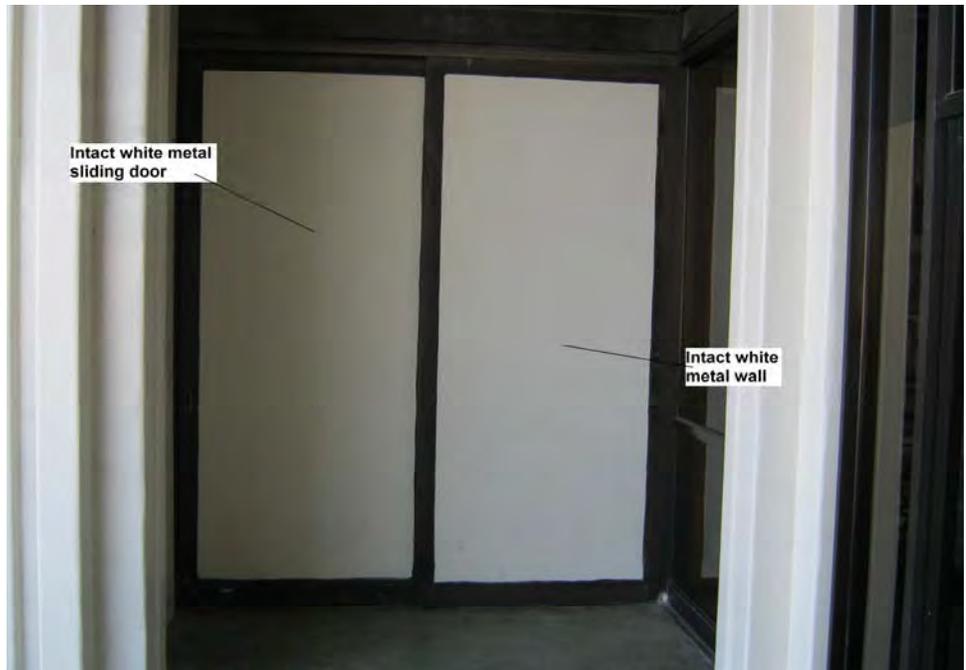
**Photograph 26:** View of representative intact lead-containing white paint on metal wall and sliding door on the exterior of the locker rooms and office building.

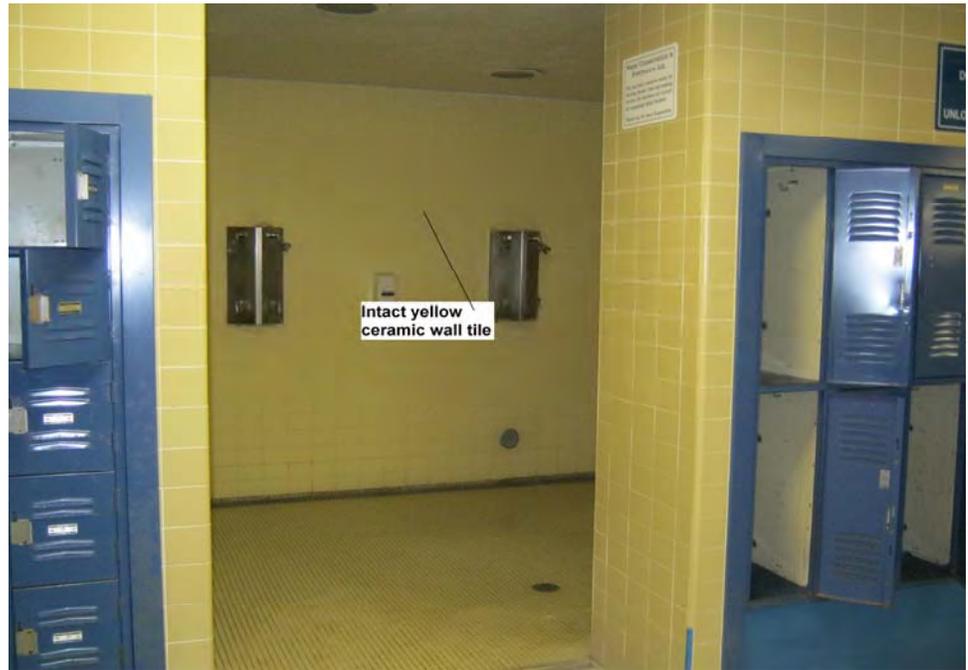
**Photograph 27:** View of representative intact lead-containing yellow ceramic wall tile in the women's, women's executive, and men's executive locker rooms in the locker rooms and office building.

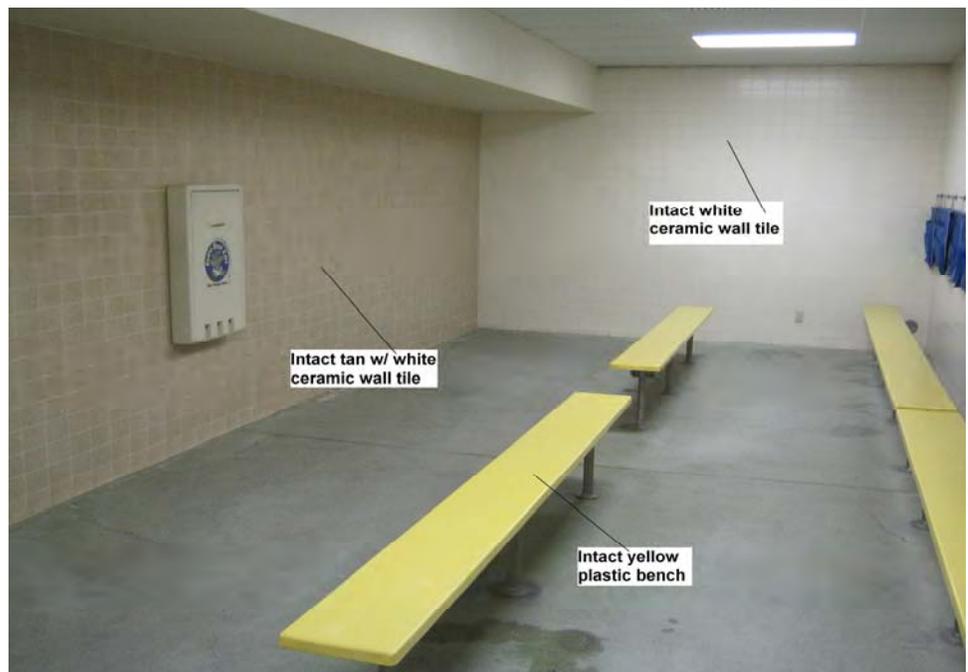
**Photograph 28:** View of representative intact lead-containing white and tan with white ceramic wall tile, and yellow paint on plastic benches in the women's, men's women's executive, men's executive, and women's employee locker rooms in the locker rooms and office building.

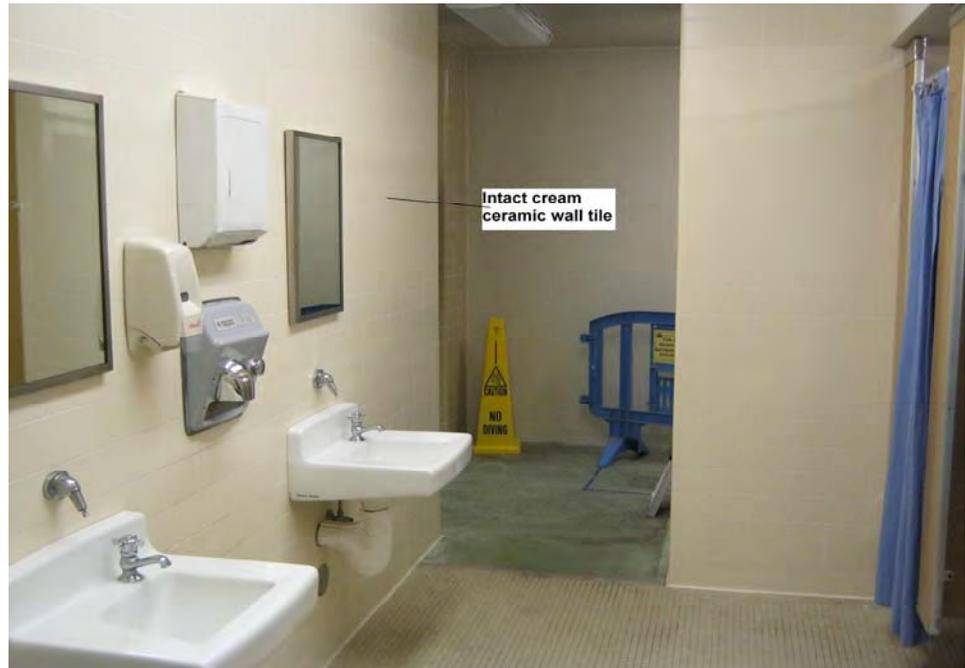
**Photograph 29:** View of intact lead-containing cream ceramic wall tile in the women's executive locker room in the locker rooms and office building.

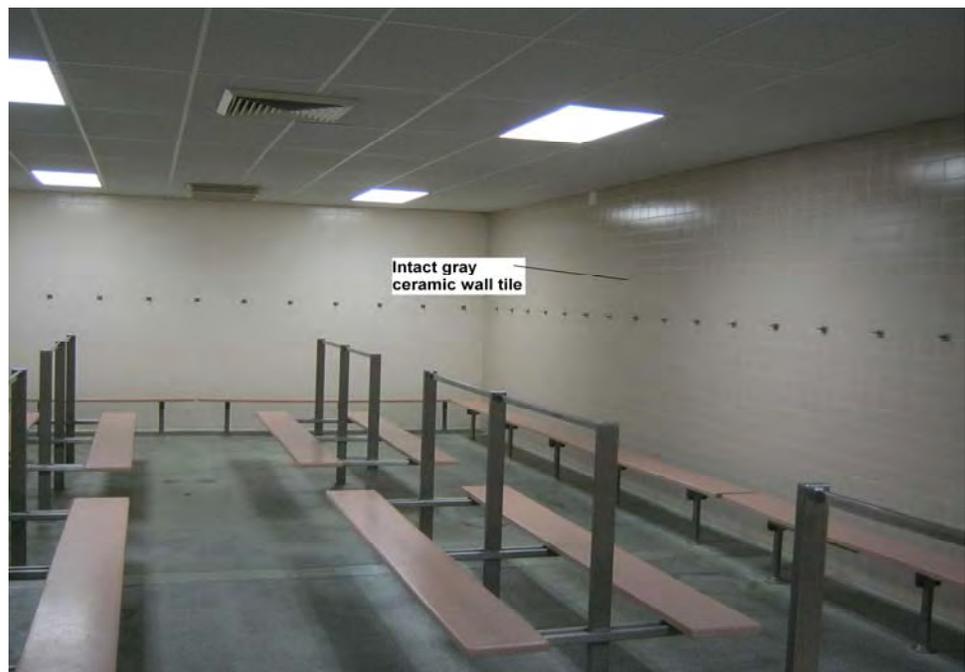
**Photograph 30:** View of intact lead-containing gray ceramic wall tile in the men's locker room in the locker rooms and office building.

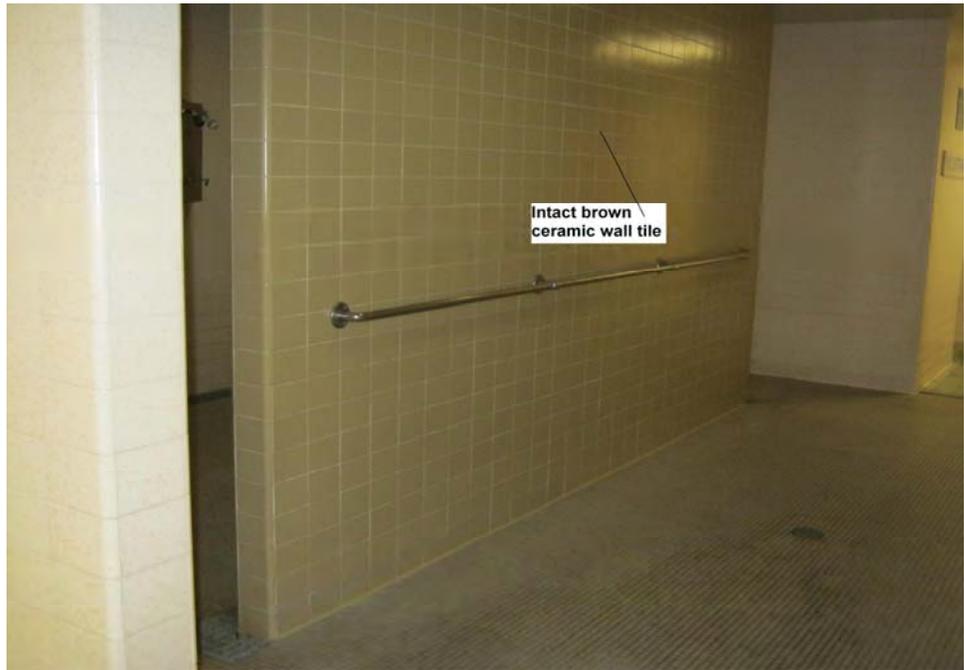
**Photograph 31:** View of representative intact lead-containing brown ceramic wall tile in the women's, women's executive, men's, men's executive, and men's employee locker rooms in the locker rooms and office building.

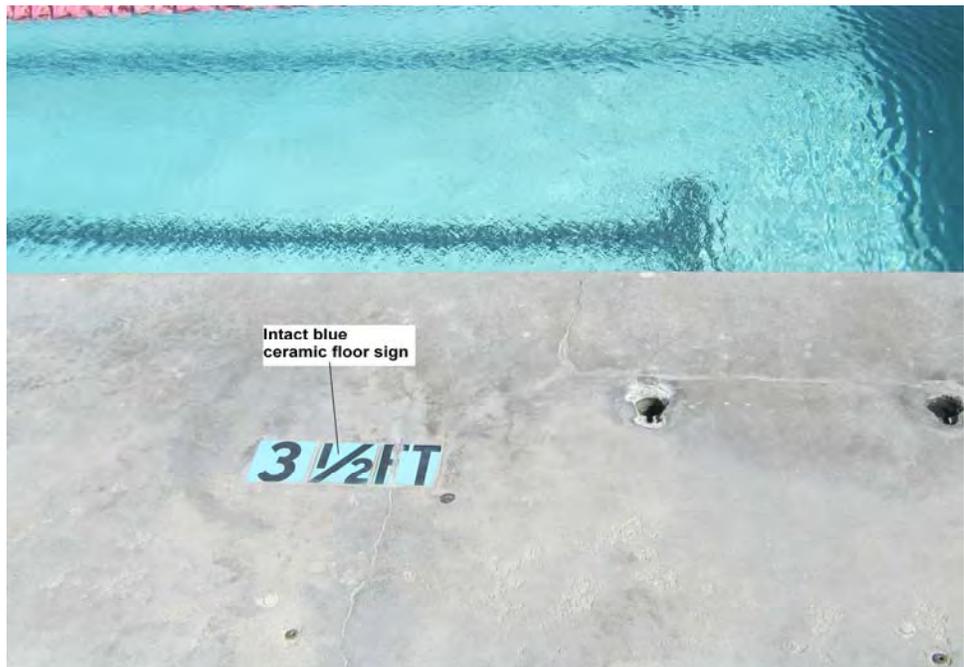
**Photograph 32:** View of intact lead-containing blue ceramic floor tile in the old pool area.

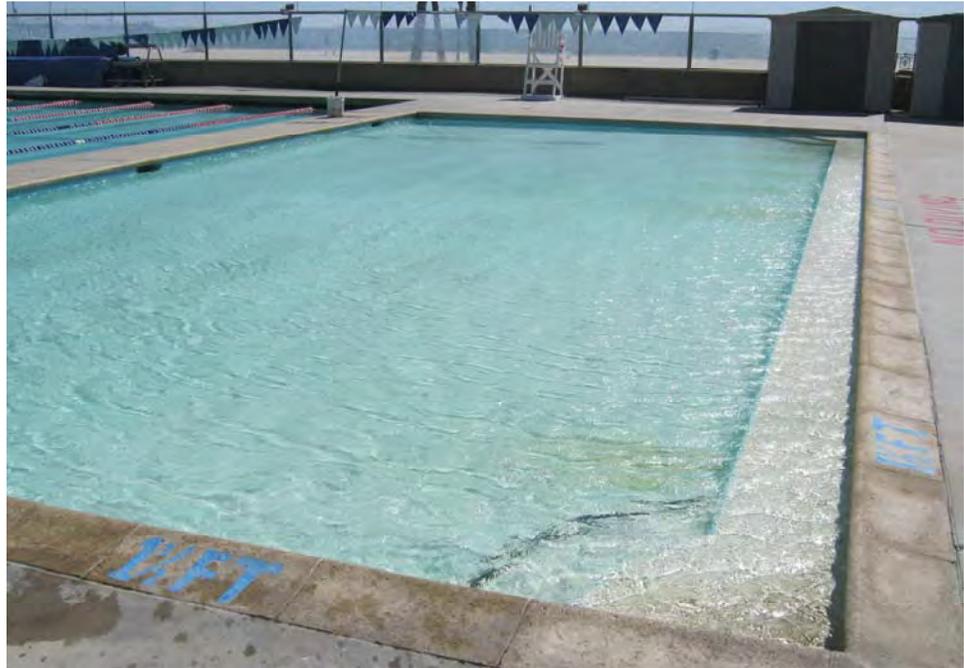
**Photograph 33:** View of assumed intact lead-containing blue ceramic wall tile and white paint on concrete walls and floor in the wading pool of the old pool area.
