**HAZARDOUS BUILDING MATERIAL  
SURVEY AND CORROSION STUDY  
BELMONT PLAZA POOL FACILITY  
REBUILD/REVITALIZATION PROJECT  
4000 EAST OLYMPIC PLAZA  
LONG BEACH, CALIFORNIA 90803**

July 10, 2014  
Project No. 209120001

Subject: Hazardous Building Material Survey and Corrosion Study  
Belmont Plaza Pool Facility Rebuild/Revitalization Project  
4000 East Olympic Plaza  
Long Beach, California 90803

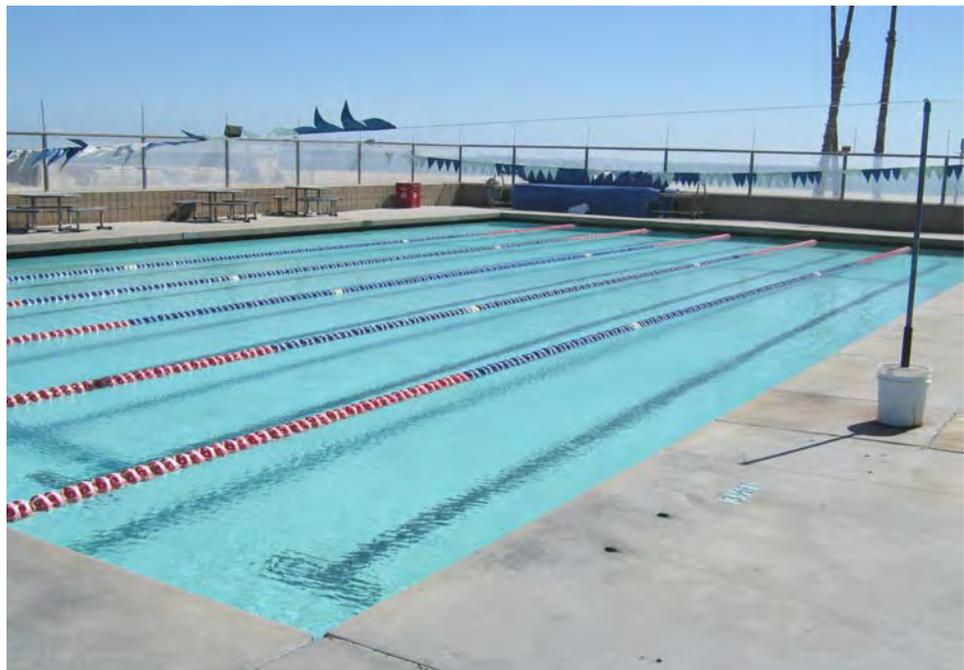
**Photograph 34:** View of assumed intact lead-containing blue ceramic wall and floor tile and white paint on concrete walls and floor in the swimming pool of the old pool area.

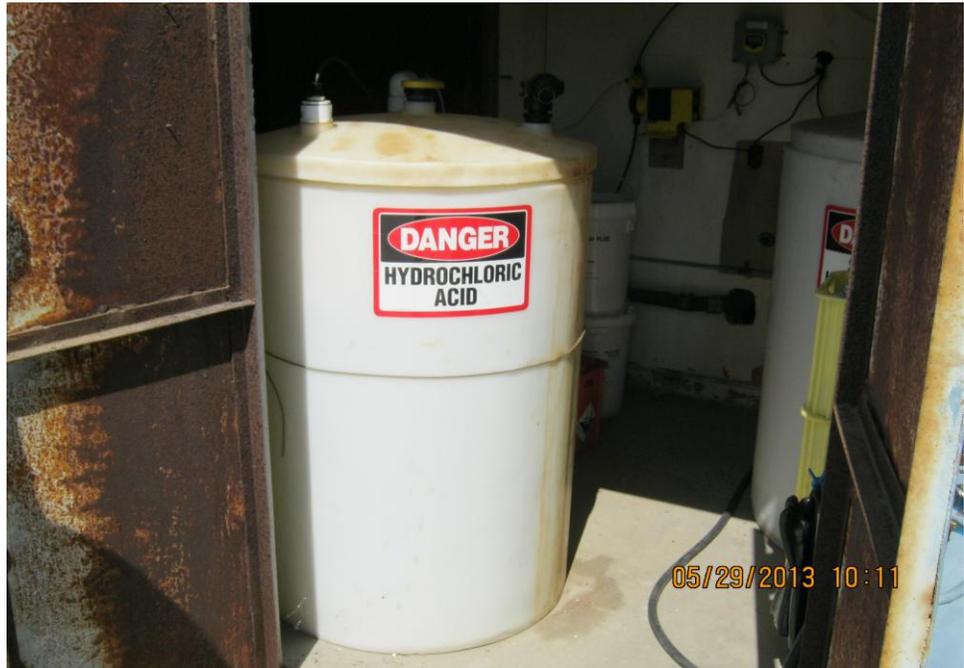
**Photograph 5:** Looking inside the storage shed at the 150-gallon aboveground storage tanks (ASTs) containing hydrochloric acid and sodium hypochlorite.

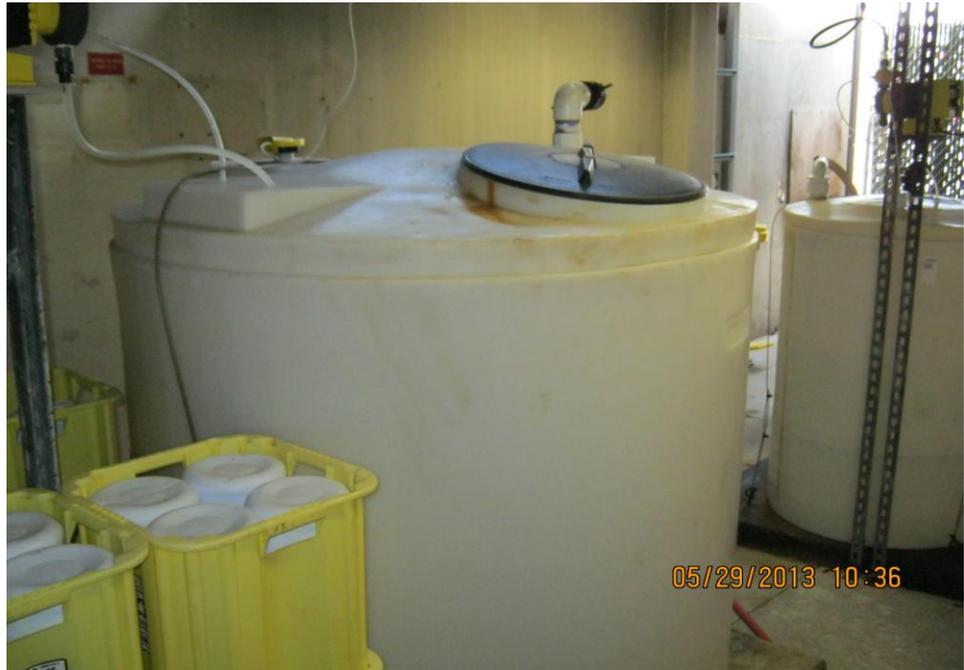
**Photograph 11:** Looking at the hydrochloric acid and sodium hypochlorite tanks located within the indoor olympic-size pool area.
