**APPENDIX E:**  
**Structural Seismic Risk Assessment/Feasibility Study**

**Re: Structural Seismic Risk Assessment / Feasibility Study  
East Division PD Sub-Station  
3800 East Willow St.  
Long Beach, CA 90815  
MHP JN: 130232**

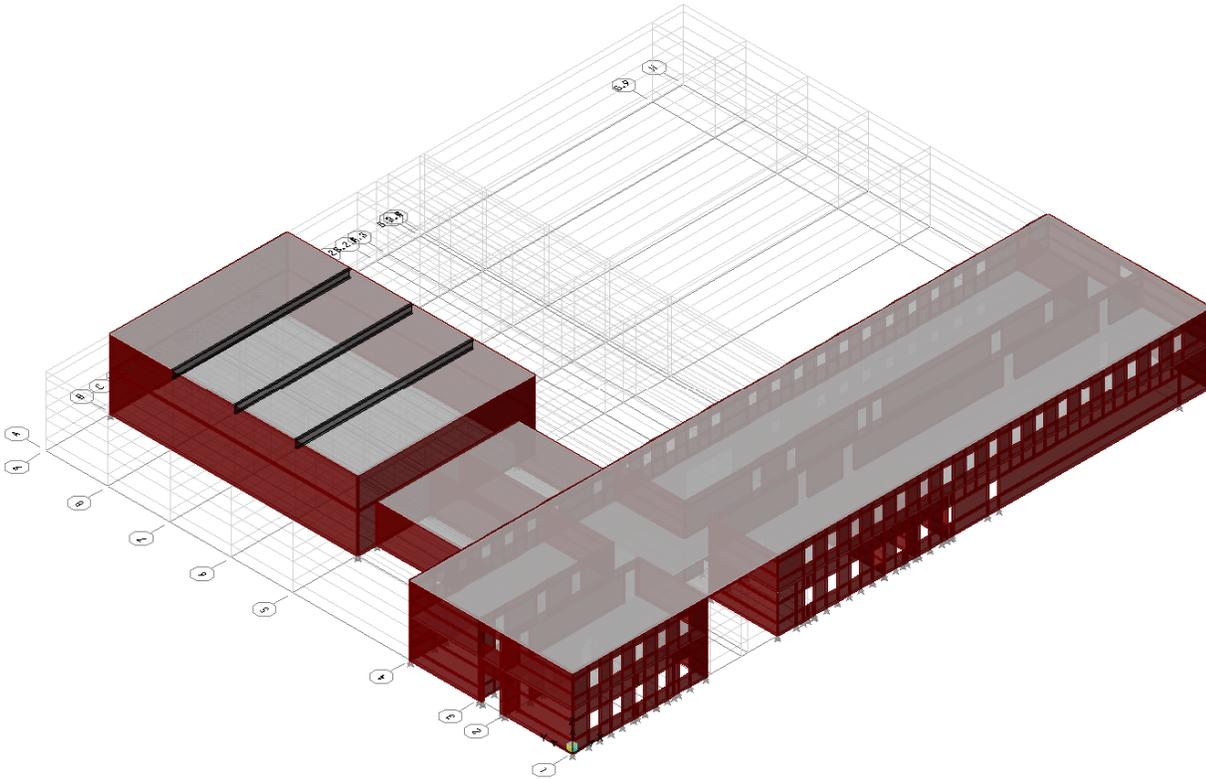
*ETABS Computer Analysis Model of Existing Structure*

The existing structure is in overall good condition and is expected to perform reasonably well when subjected to the design basis earthquake. However, the following concerns were noted as a result of our analysis of the building per ASCE/SEI 41-06 procedures for evaluating the structural performance per the criteria listed above:

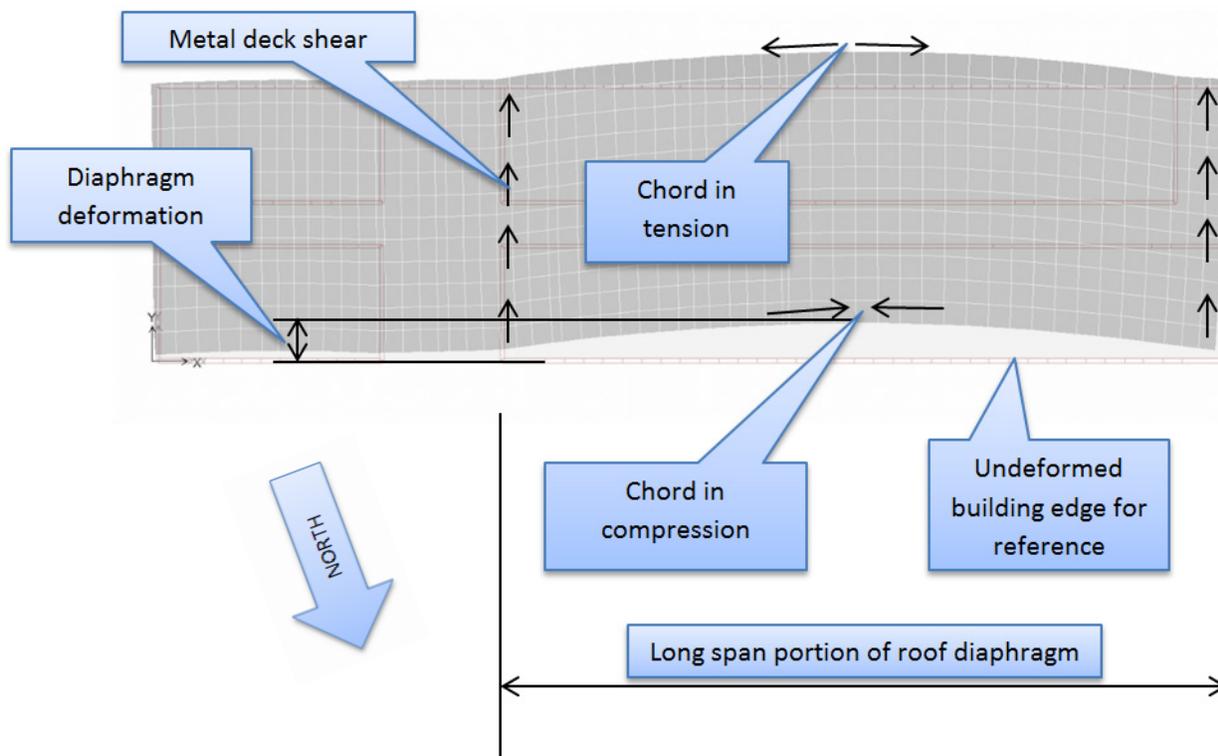
*Main Wing Partial Roof Plan Showing Diaphragm Behavior*

- The metal roof deck at each end of the long span portion of the main wing roof diaphragm exhibits insufficient in-plane metal deck shear strength to satisfy the selected performance criteria for north-south motion. The deck is approximately **208% overstressed** at the Collapse Prevention/BSE-2 level and approximately **83% overstressed** at the Life Safety/BSE-1 level.
- Wall reinforcing acting as diaphragm chords for north-south motion was determined to be inadequate to resist the prescribed loads. Roof diaphragm

chords are as much as **182% overstressed** at the Collapse Prevention/BSE-2 level and as much as **68% overstressed** at the Life Safety/BSE-1 level.

- **Main wing roof diaphragm:** to address the shear strength deficiency at the roof a new rod braced diaphragm system (very similar to what was added to the second floor level in 1960) will be required to provide needed strength to the existing metal deck diaphragm. A rod-bracing strengthening scheme is beneficial to this project in that the work may be performed from the underside of the roof, preserving the exterior condition. To address the diaphragm chord member deficiency new steel chord members in the form of steel channels will be provided. These new members will be anchored to the inside face of the existing masonry walls at the north and south walls using adhesive anchorage and will be continuous for the length of the long span portions of the diaphragm.

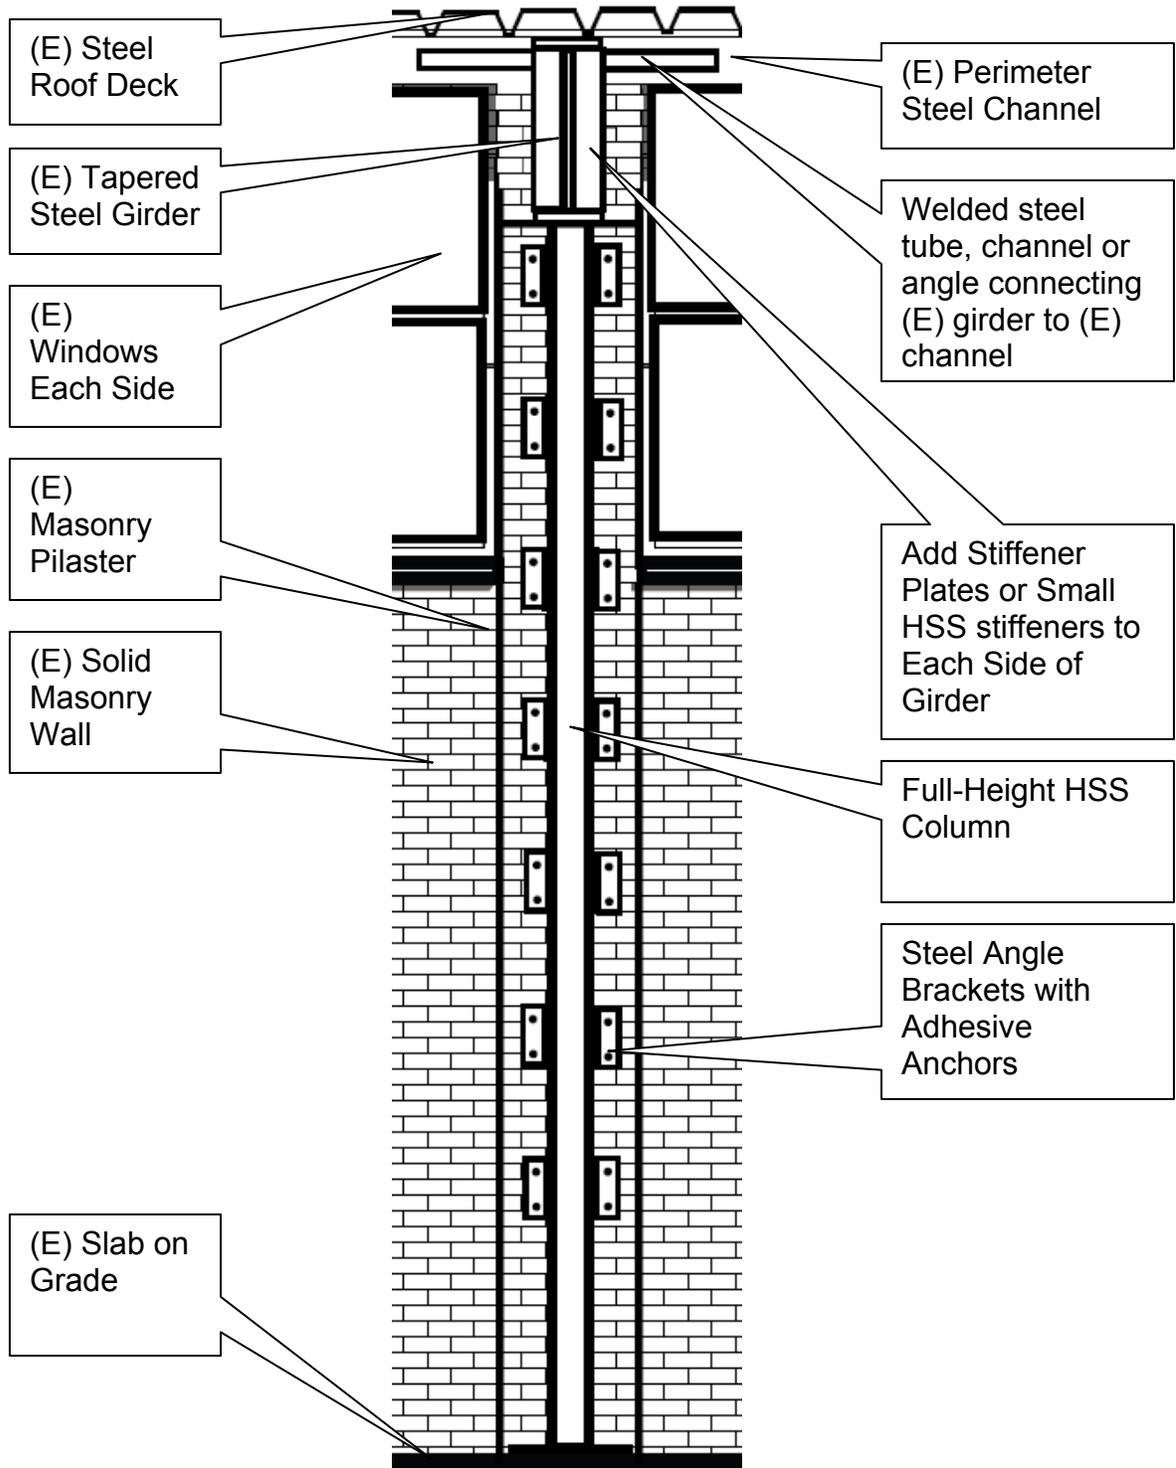
*Interior Elevation of Schematic Pilaster Strengthening at Assembly*

- There is no adequate load path between the existing cantilevered masonry pilasters and the metal deck diaphragm for resisting out-of-plane (perpendicular to the wall) seismic forces. Existing wall anchor rods are approximately **133% overstressed** (DCR of 2.33) at the Collapse Prevention/BSE-2 level and approximately **85% overstressed** (DCR of 1.85) at the Life Safety/BSE-1 level.

- The connection between the pilasters and the metal deck diaphragm for in-plane shear forces is as much as **321% overstressed** at the Collapse Prevention/BSE-2 level and as much as **149% overstressed** at the Life Safety/BSE-1 level.

- Due to deficiencies at the pilaster to roof diaphragm connection in the assembly portion of the building, it is considered possible that portions of the roof framing will separate from the supporting walls during a future 475-Year seismic event, resulting in heavy localized structural damage and possible localized collapse of roof framing and adjacent walls.
- **Main wing roof diaphragm:** horizontal diaphragms resist lateral wind and seismic loads primarily through shear and flexure (bending). Shear forces at the main wing are resisted by the steel roof deck, while flexural stresses are resisted by chord reinforcing bars in the supporting masonry walls.

- **Cantilever masonry pilasters at assembly:** tube steel (HSS) columns aligned at the face of each existing pilaster running from the slab on grade up to the underside of the existing tapered steel girders would address both out-of-plane wall anchorage and in-plane load path concerns. The columns would be attached to the existing pilasters via adhesive anchors. These columns would span vertically from the slab on grade below to the underside of the tapered steel girders. A schematic sketch of this condition is provided below.
