Rose Park

Tree Removals

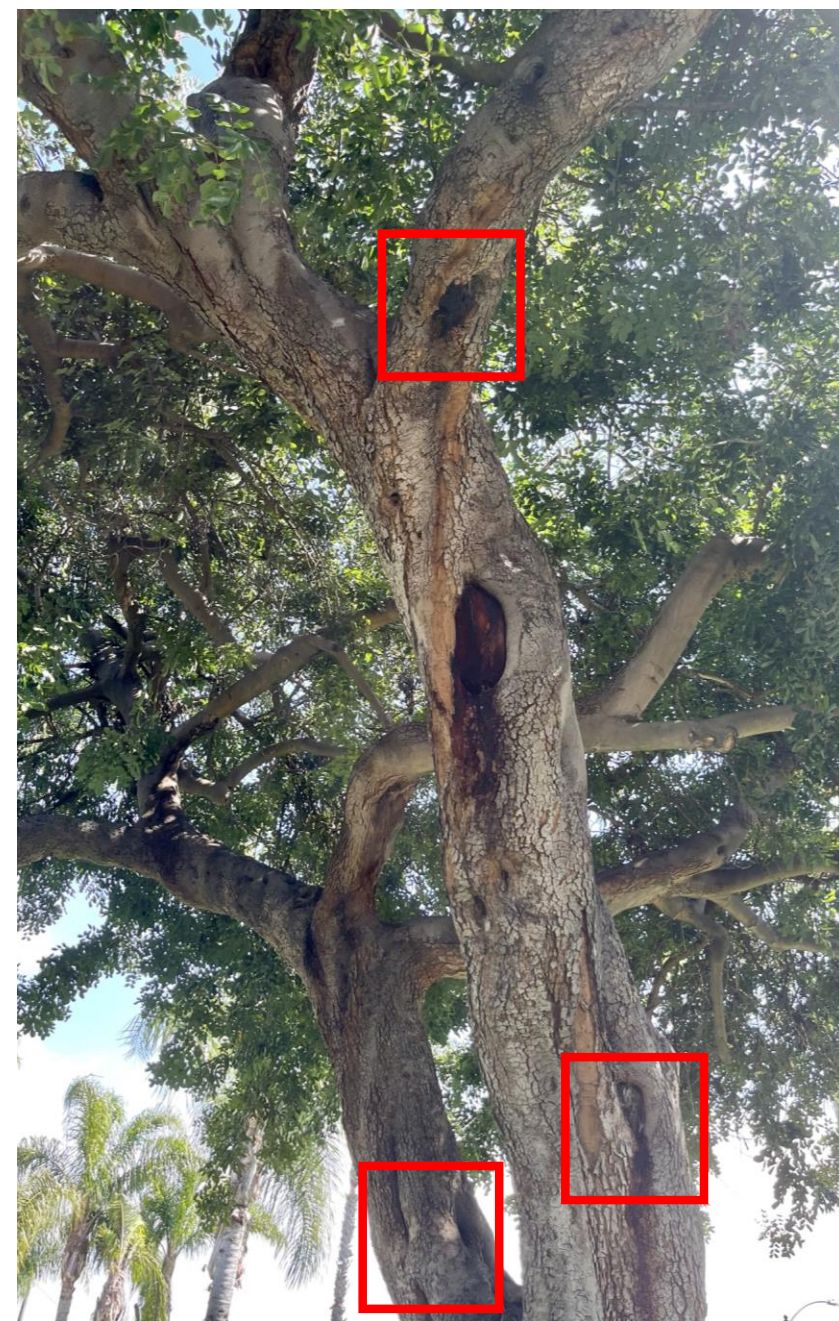
Cavity in the primary limb with other cavities developing

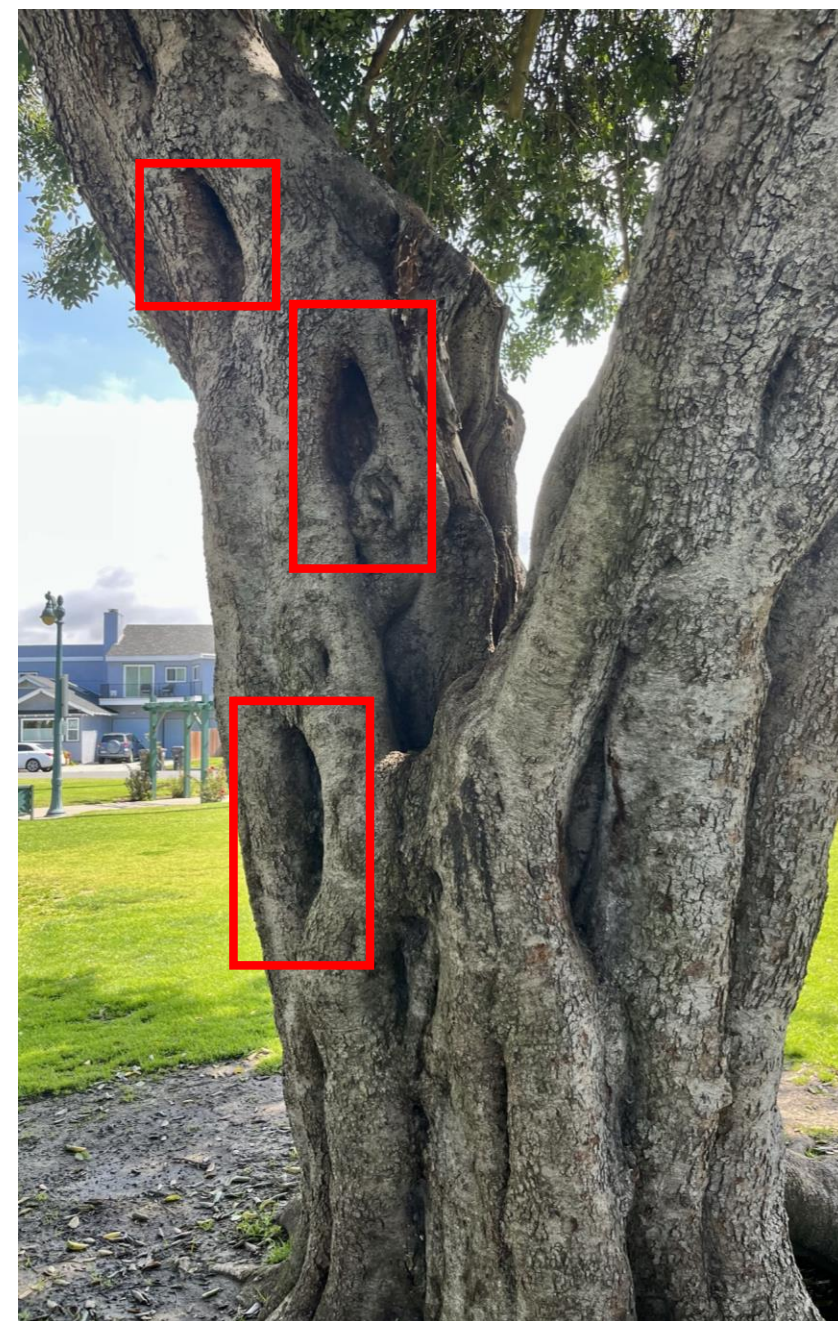
Multiple cavities in the trunk and primary limb.

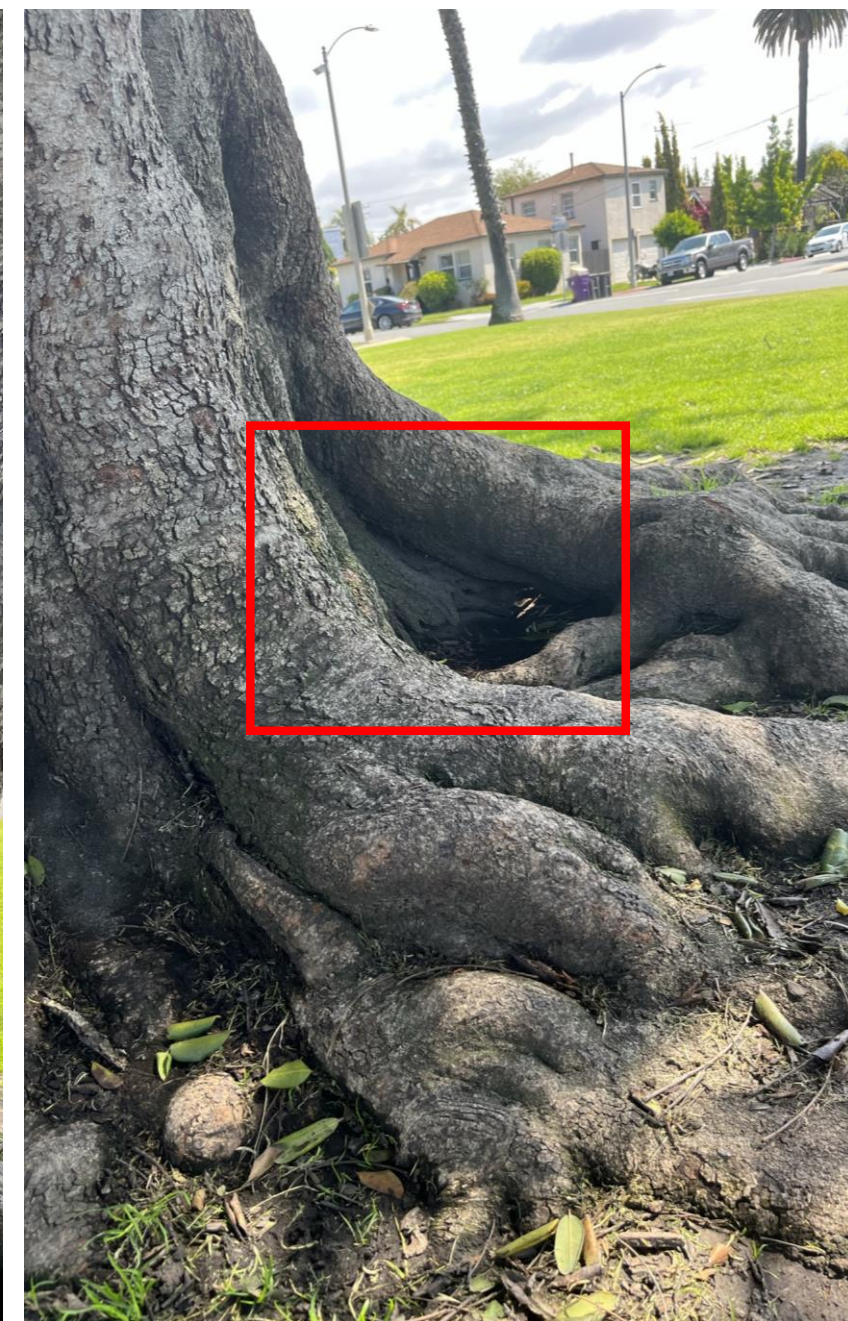
Cavity forming at the root crown of the tree.

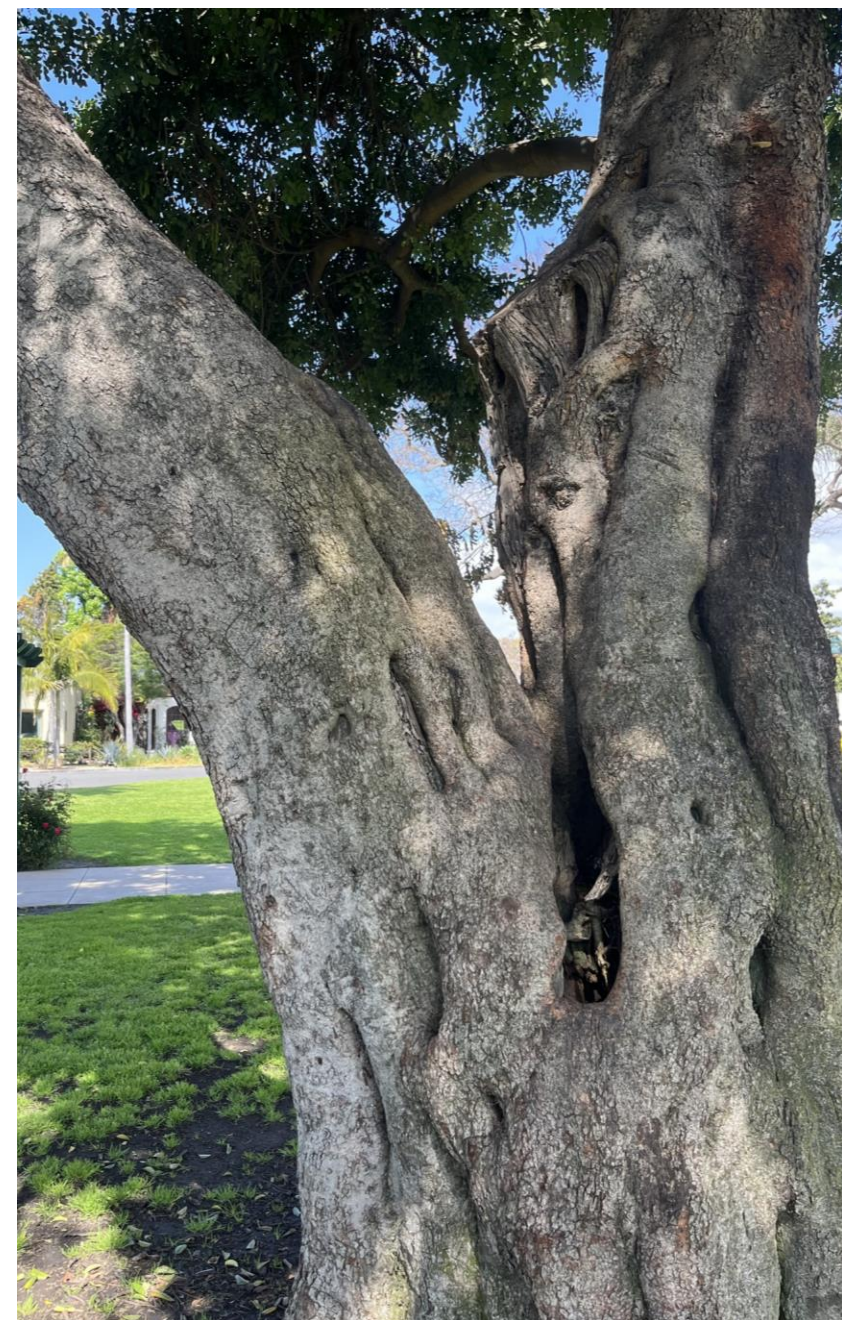
Cavity at the main joint of the tree.

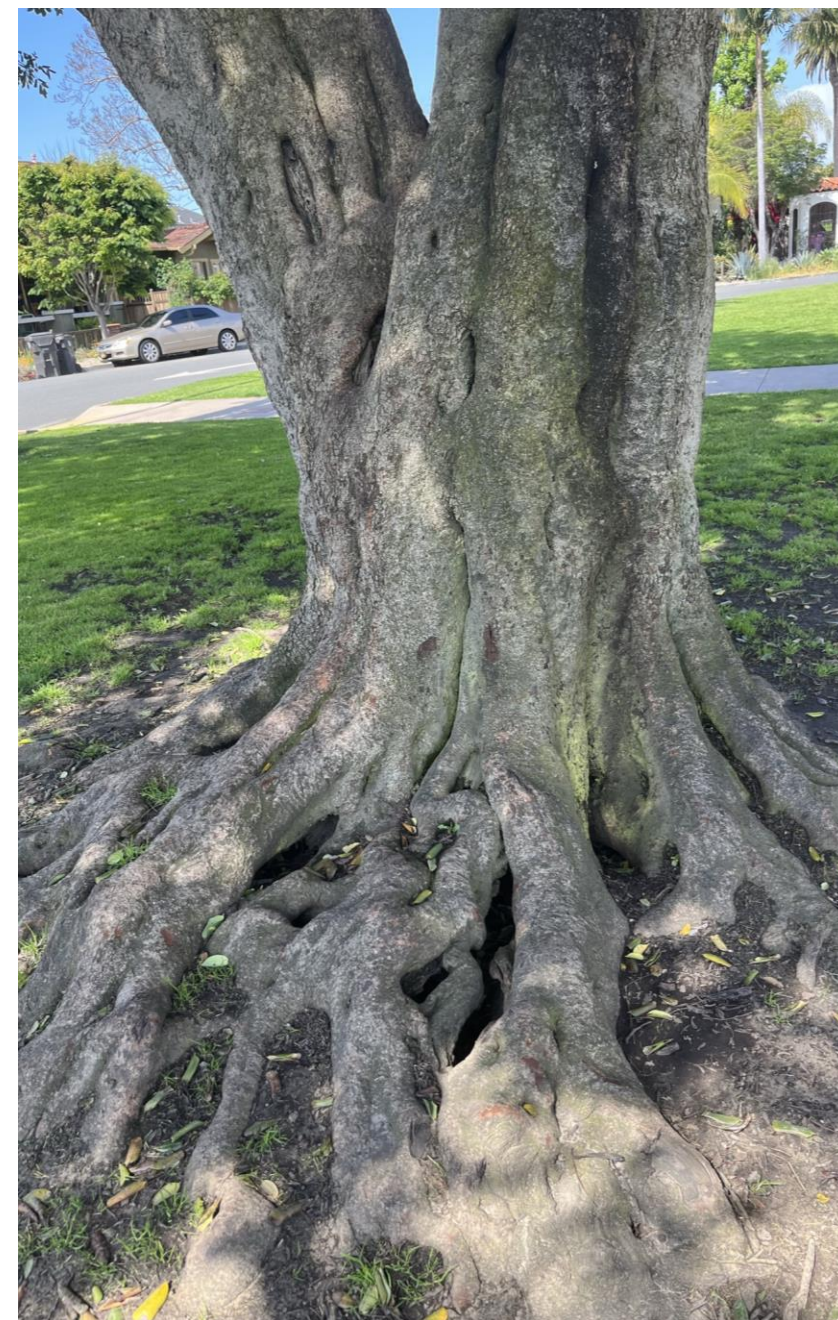
Roots beginning to lift.

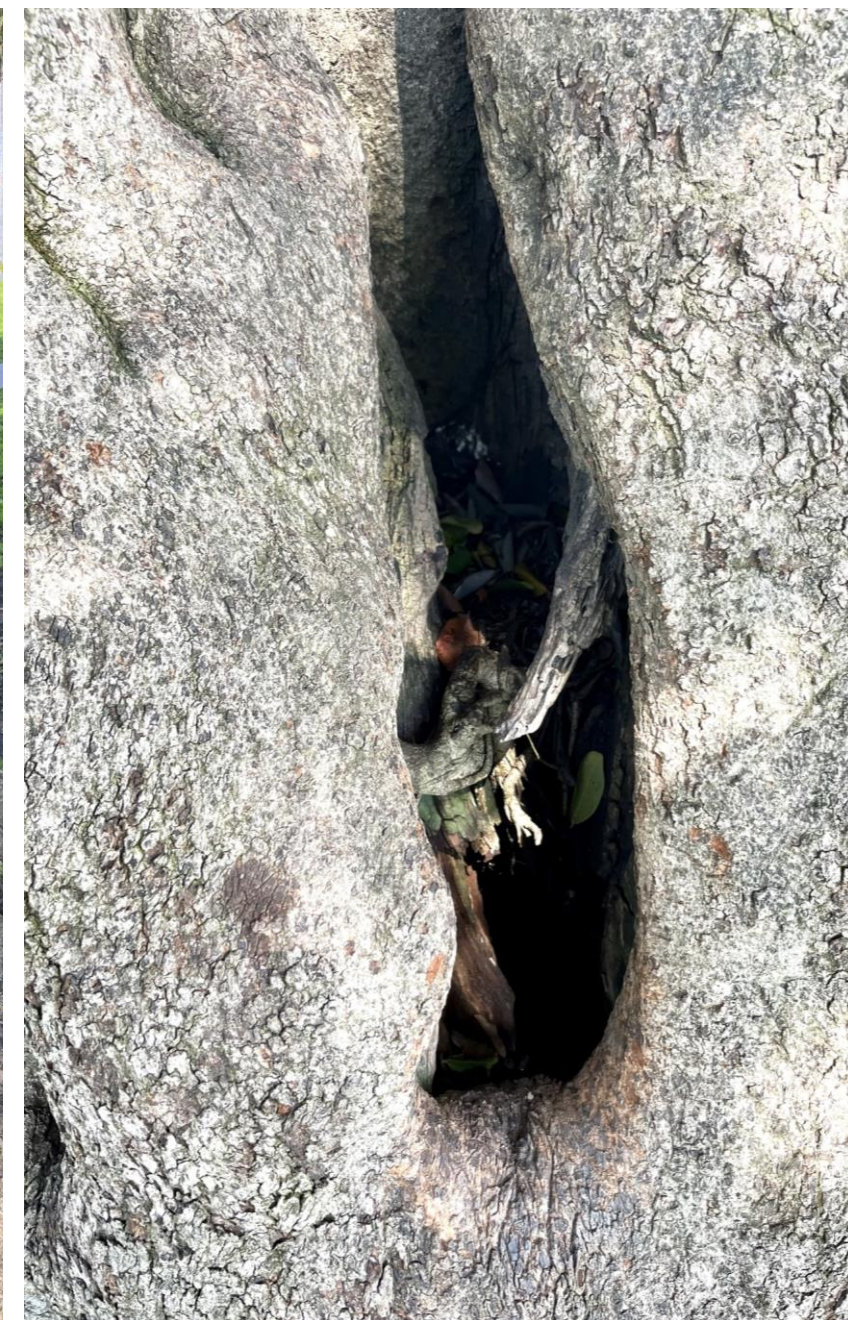
Cavity at the main joint of the tree.

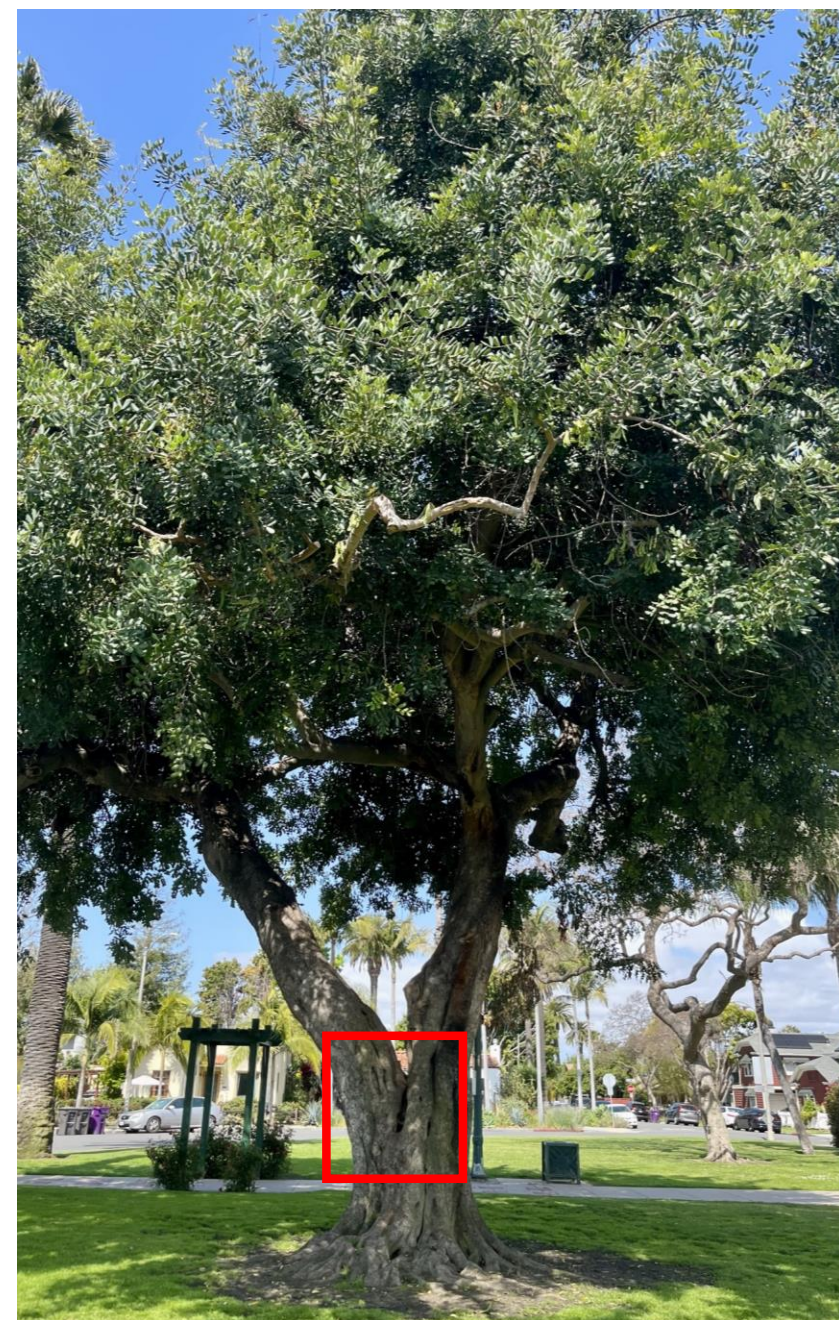
Overall photo of tree with a cavity in the main joint.

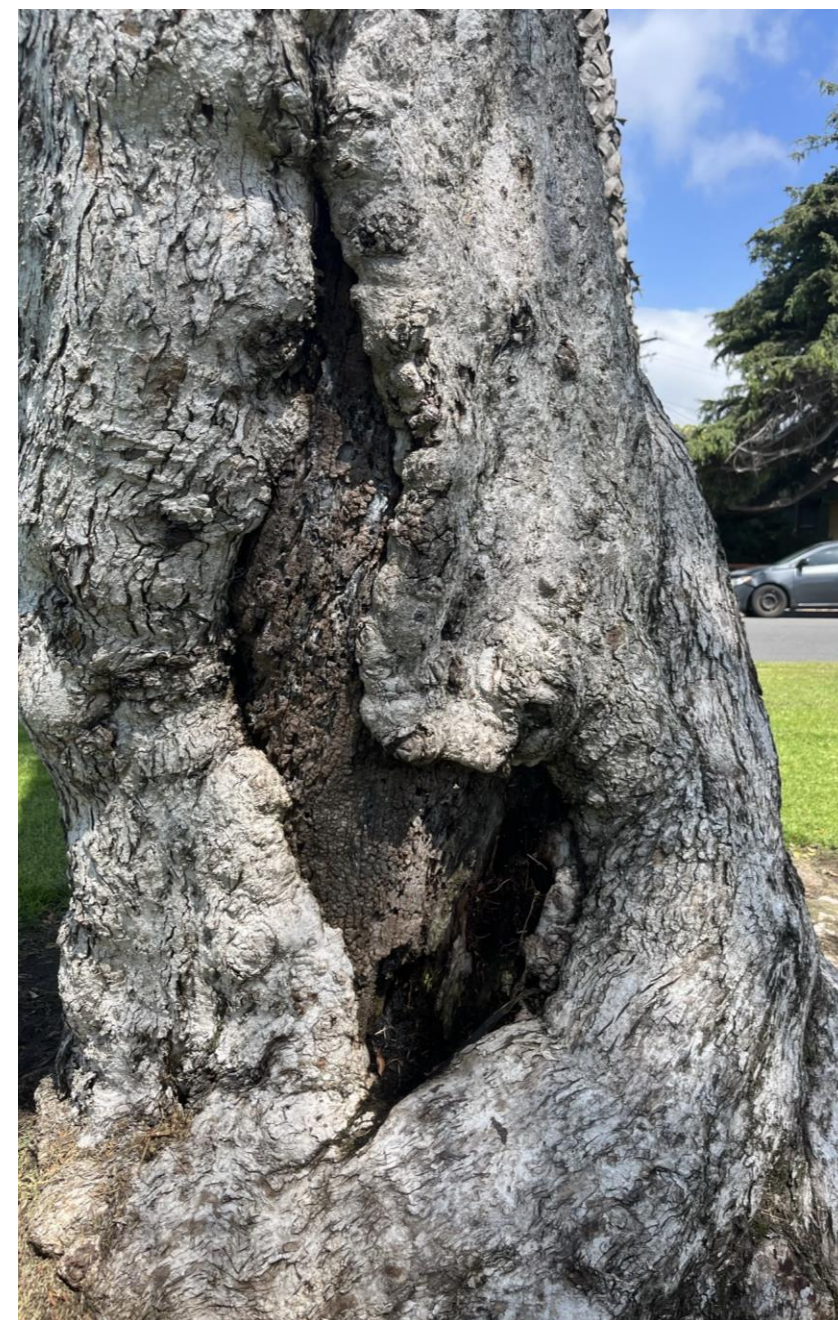
Cavity forming in the main trunk of the tree. Weak point of the tree.

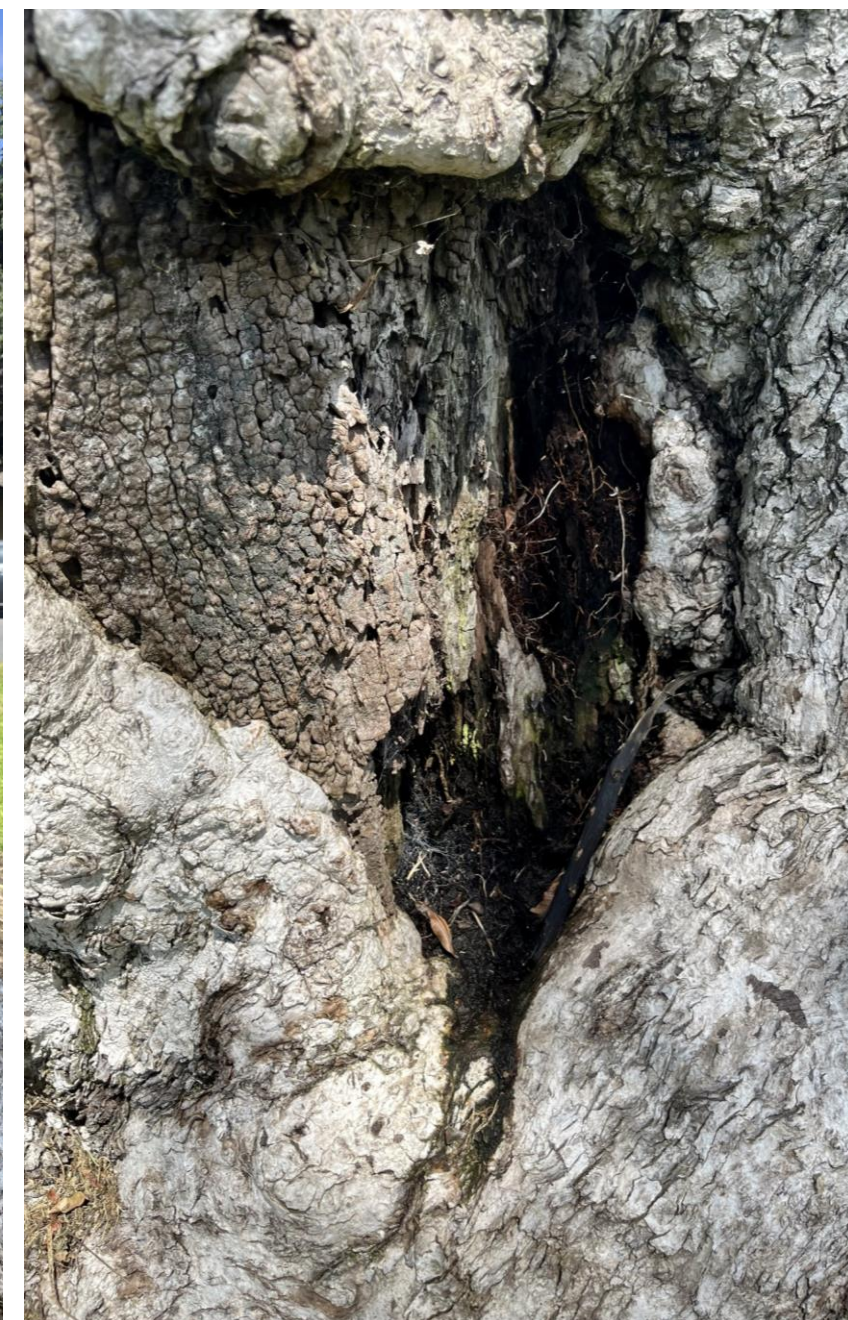
Cavity forming in the main trunk of the tree. Weak point of the tree.

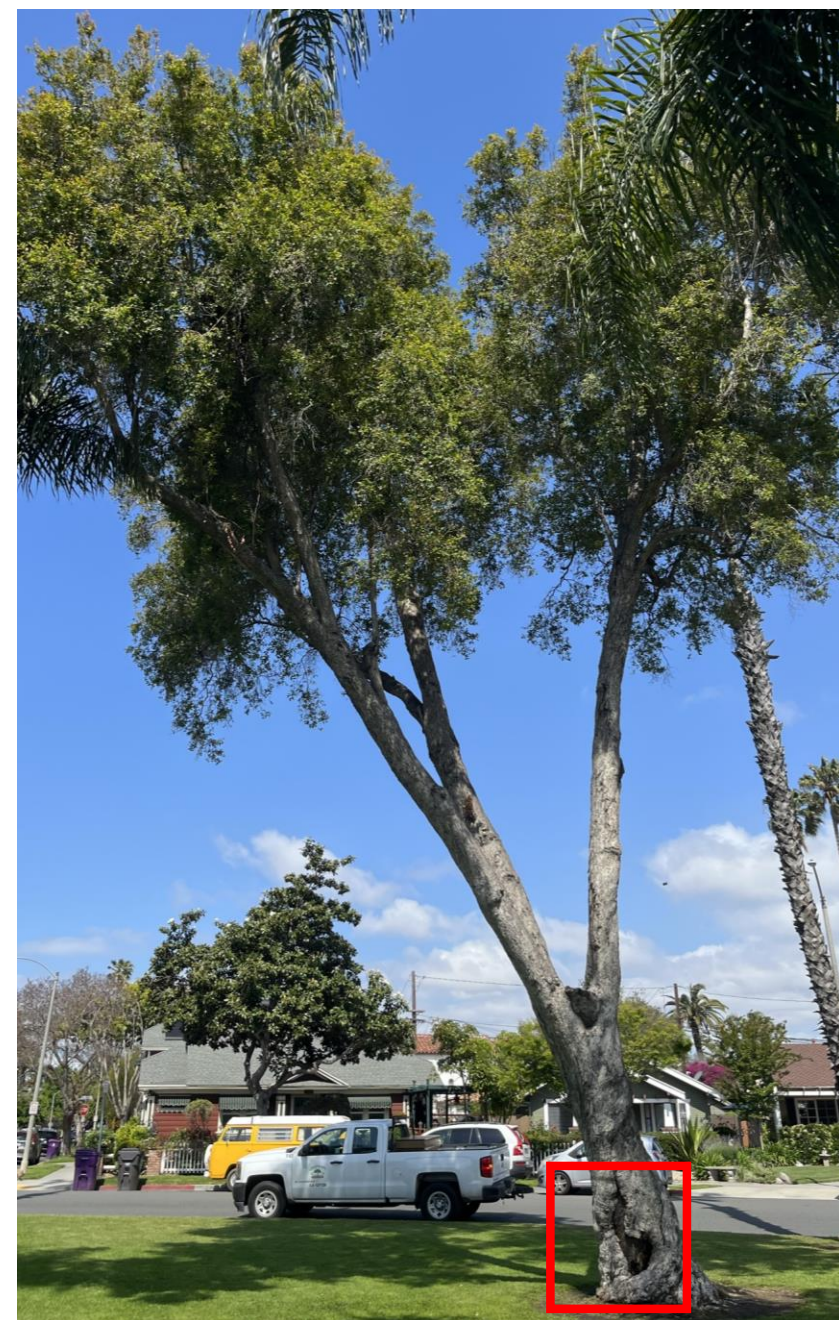
Overall photo of the tree with the cavity in the main trunk.

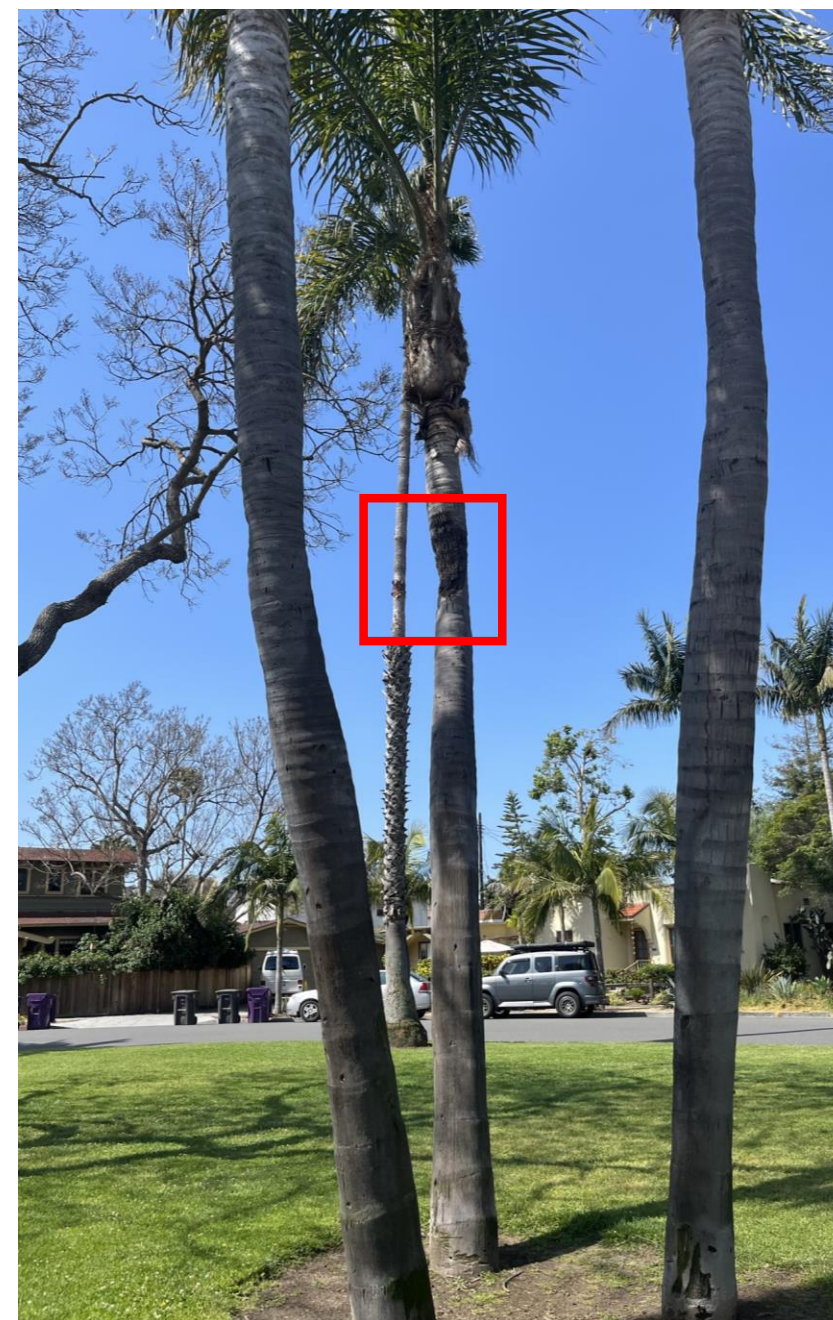
Trunk of palm tree is decaying.

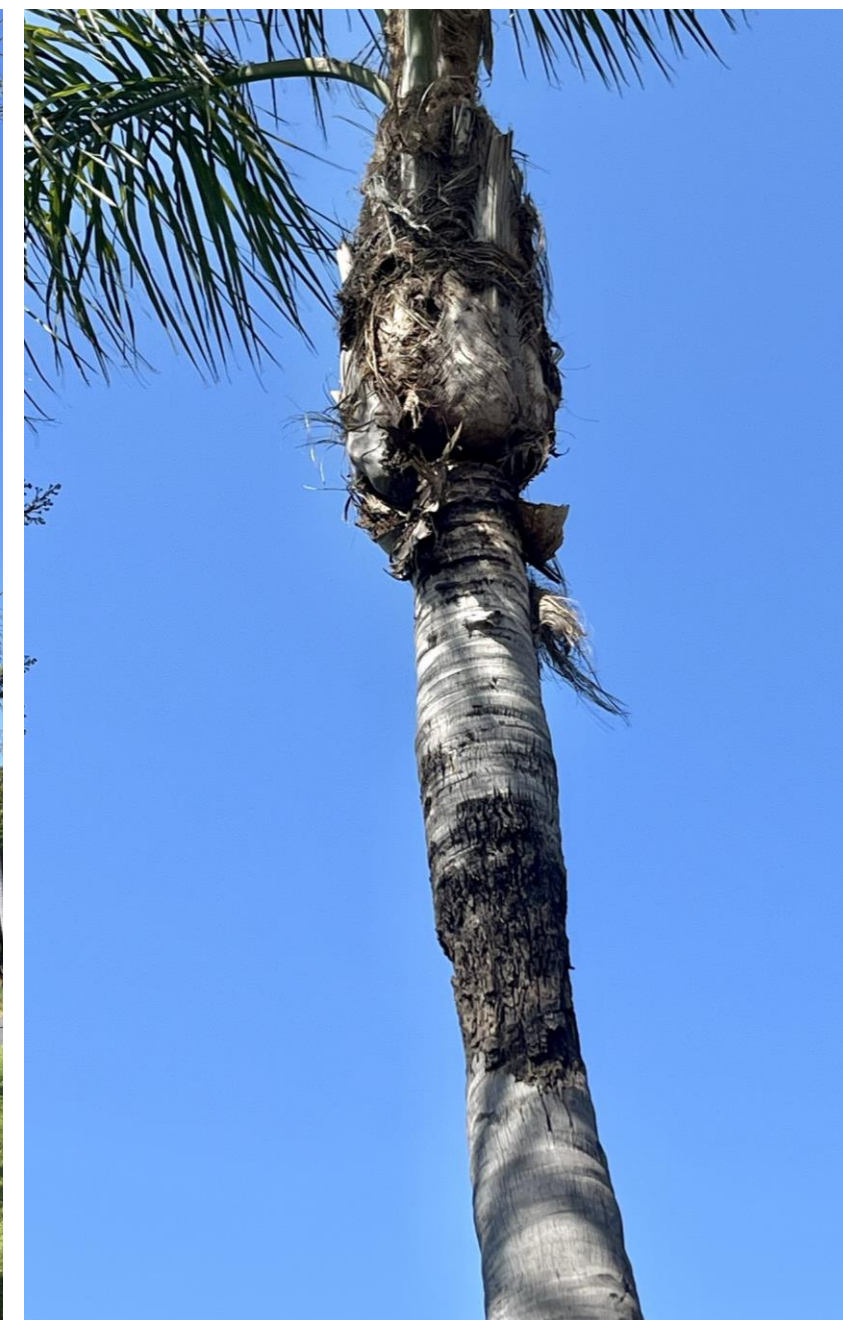
Trunk of palm tree is decaying.

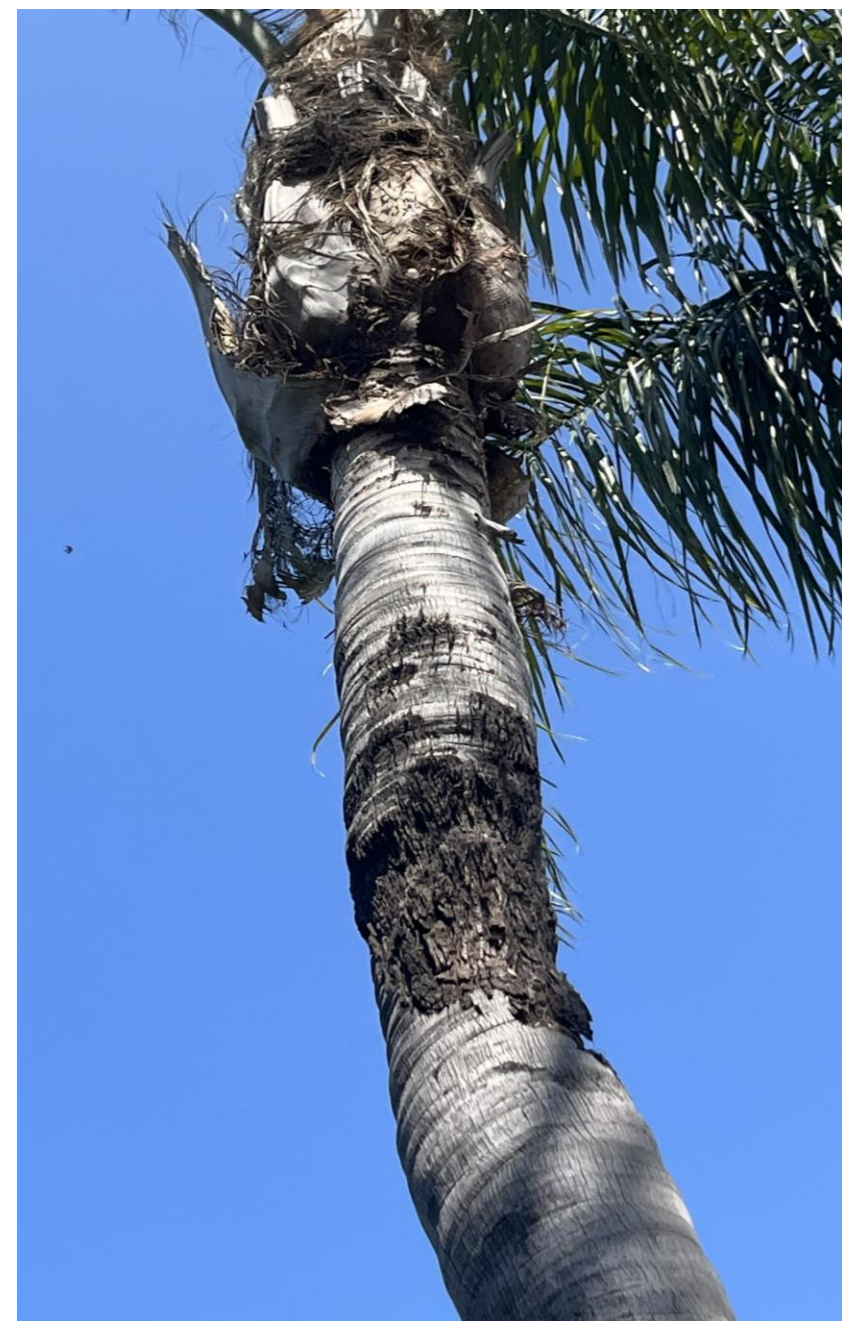
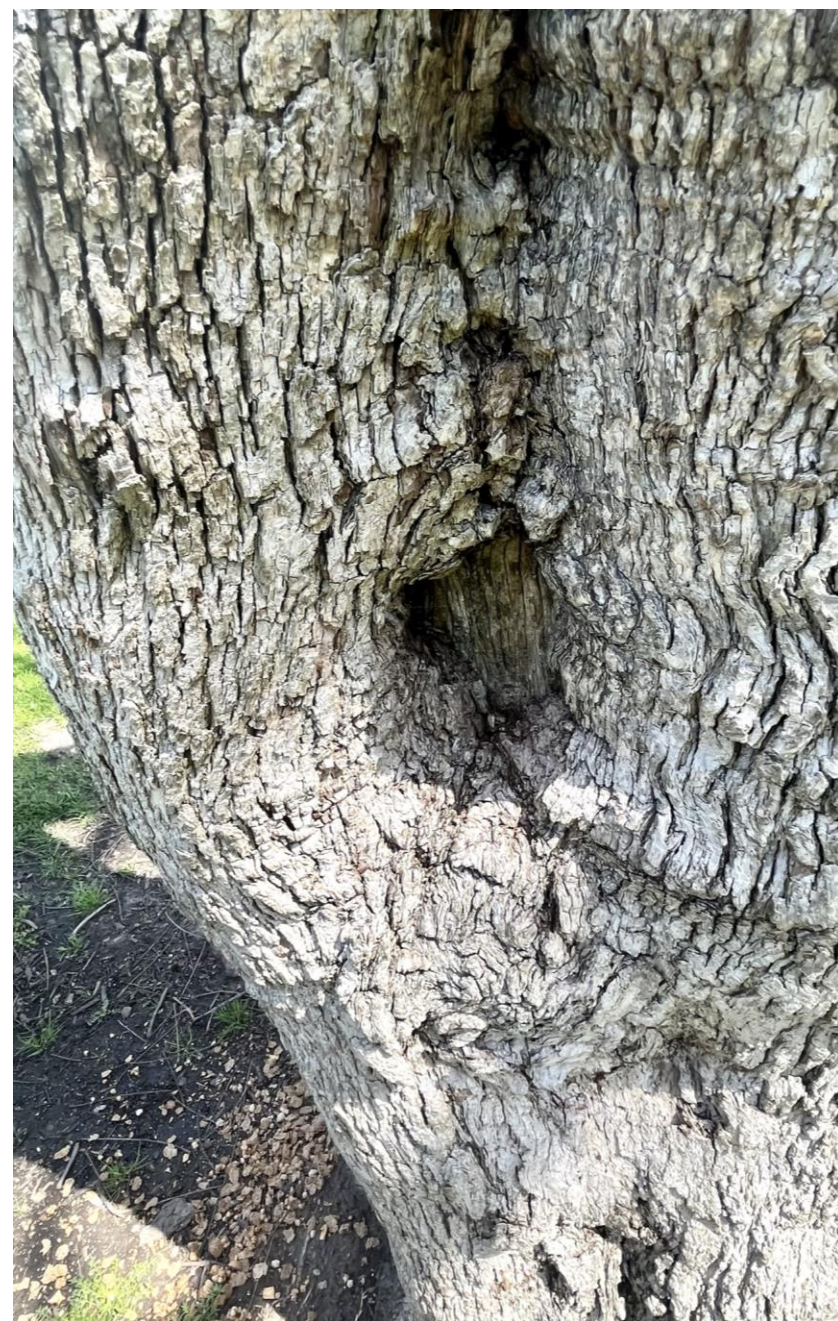
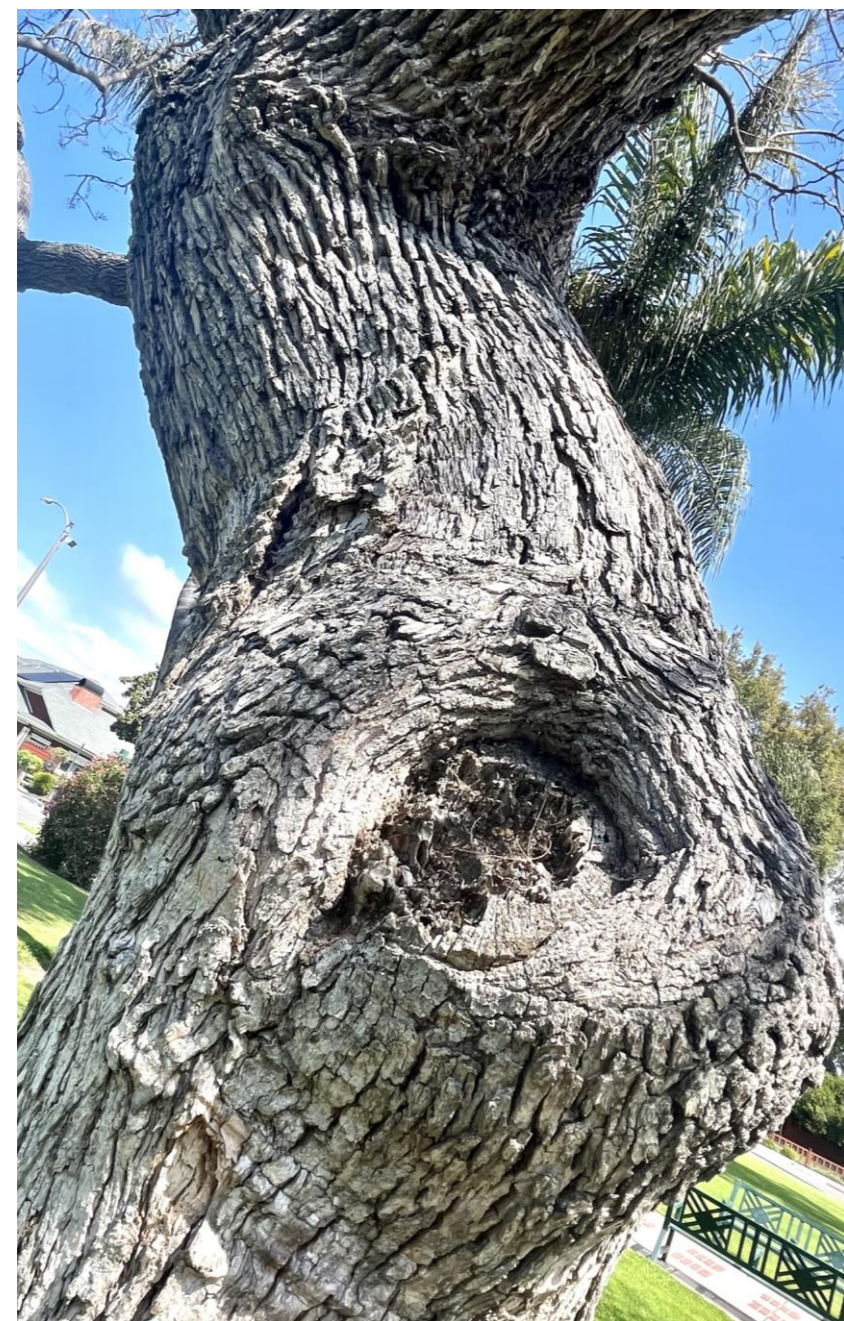
Trunk of palm tree is decaying.

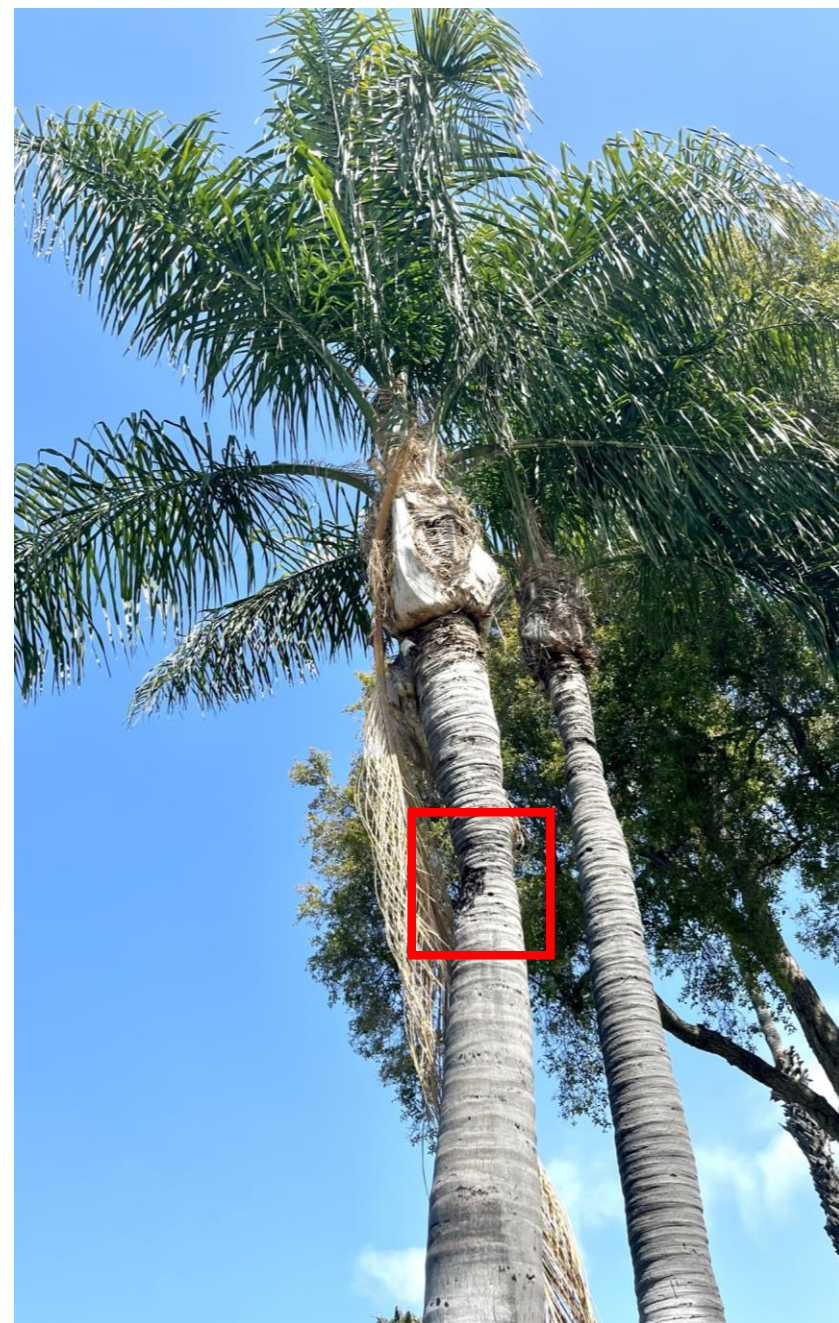
Trunk of palm tree is decaying.
