El Dorado Park

Area 2

Tree Removals

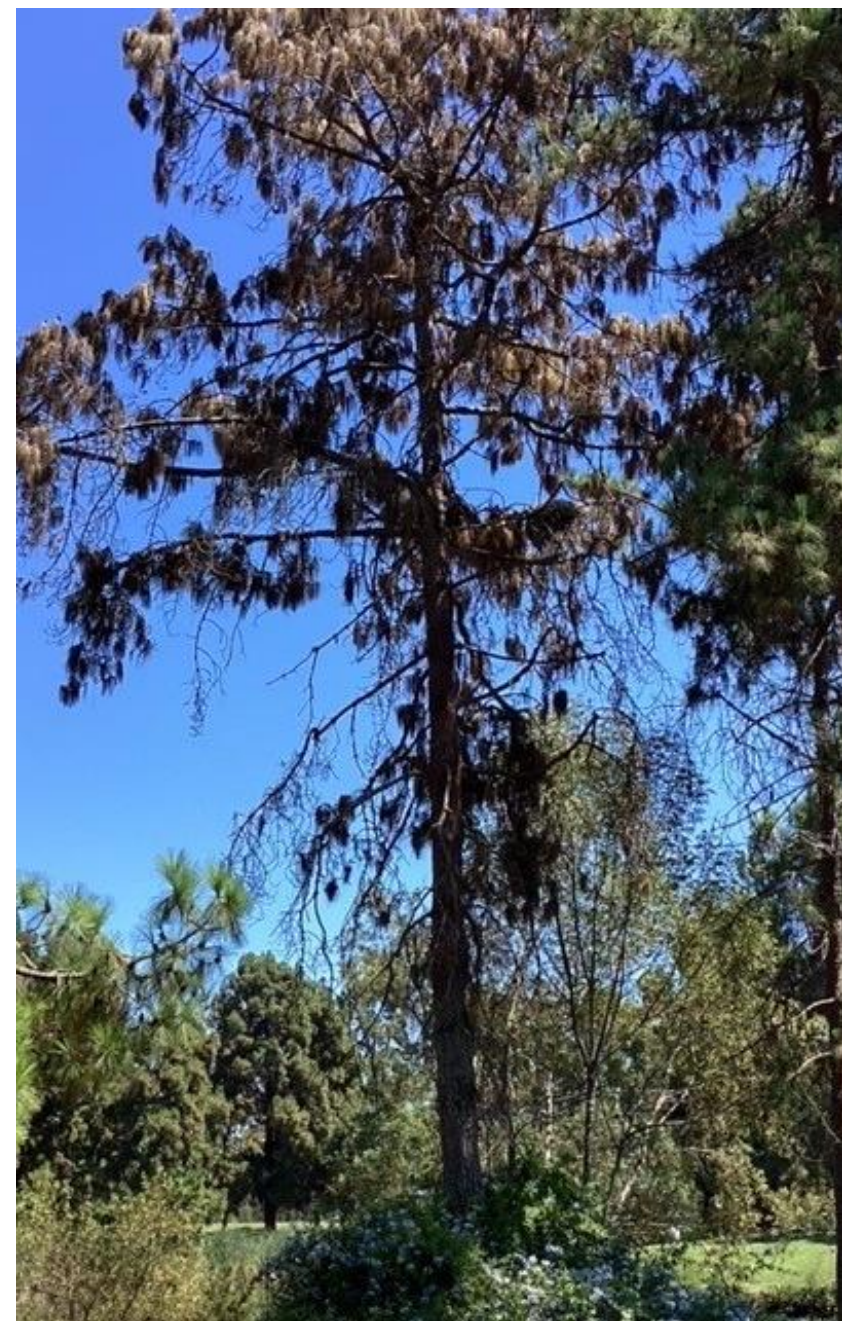
Dead Tree

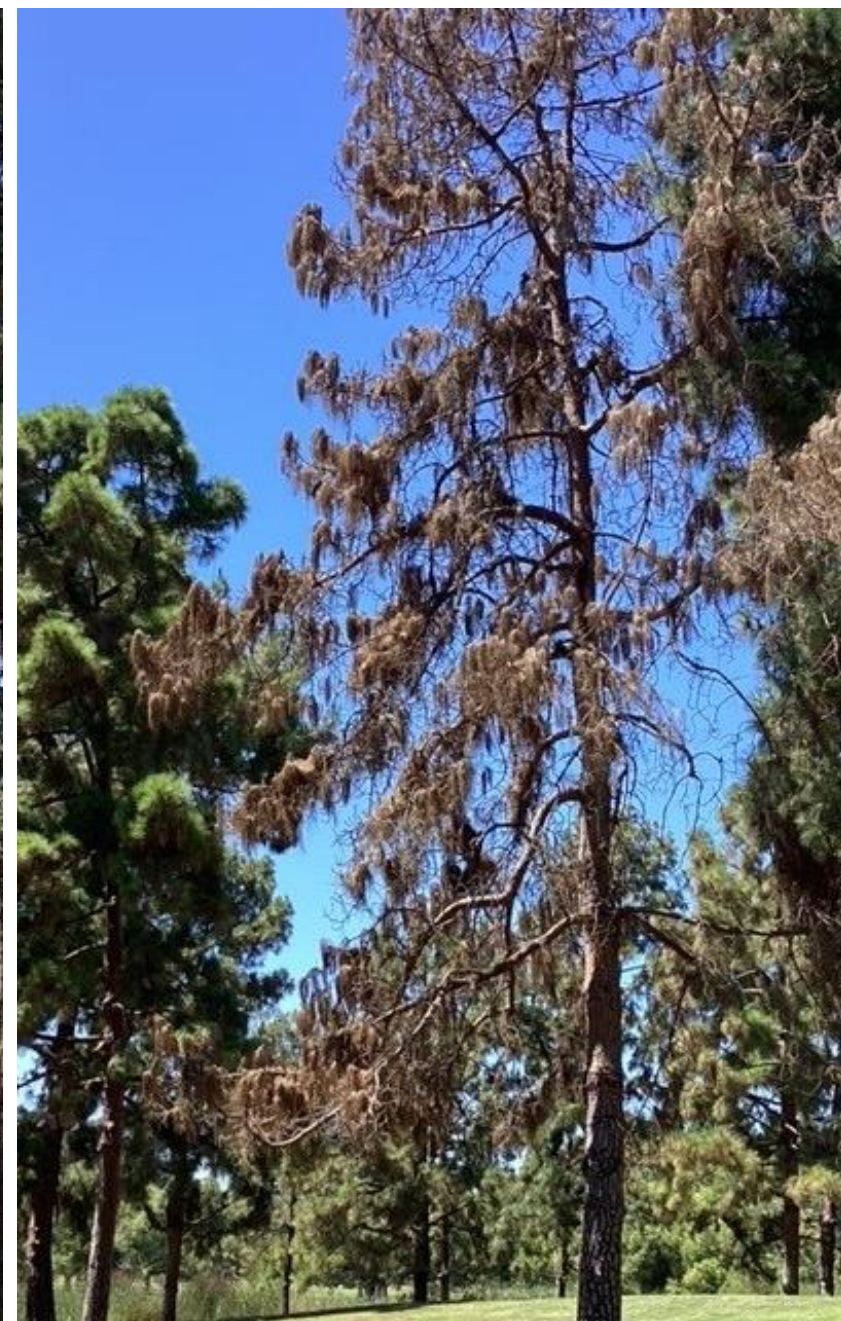
Dead Tree

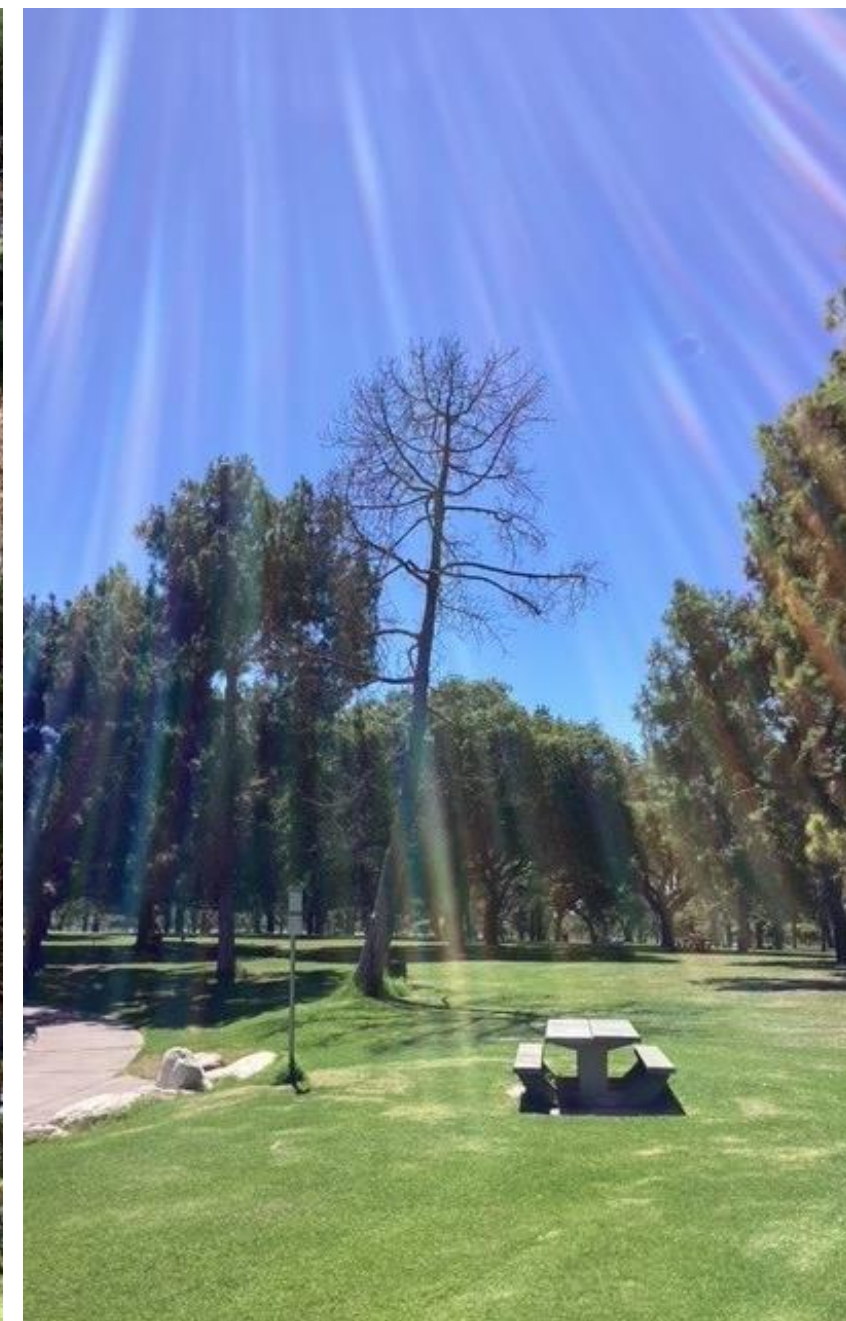
Dead Tree

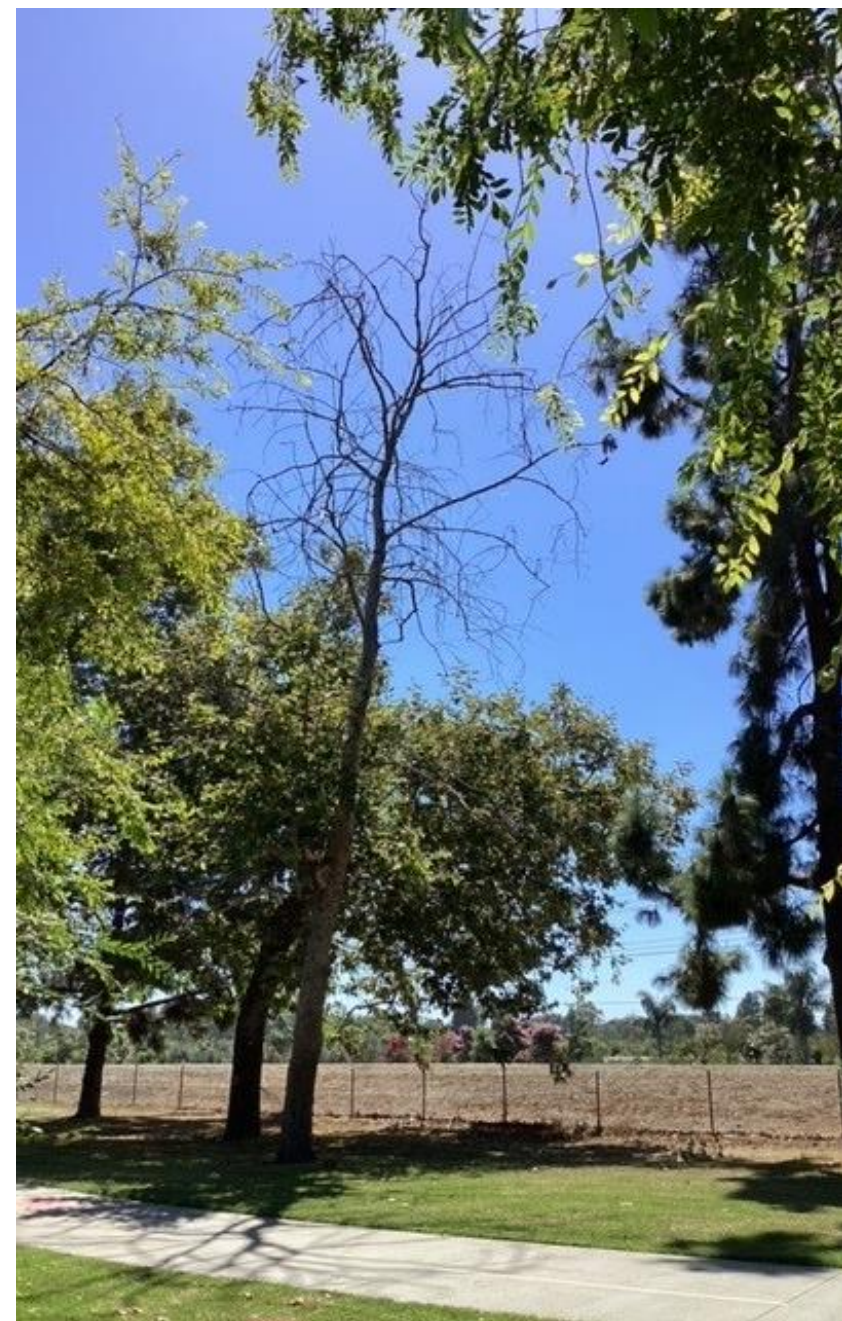
Dead Tree

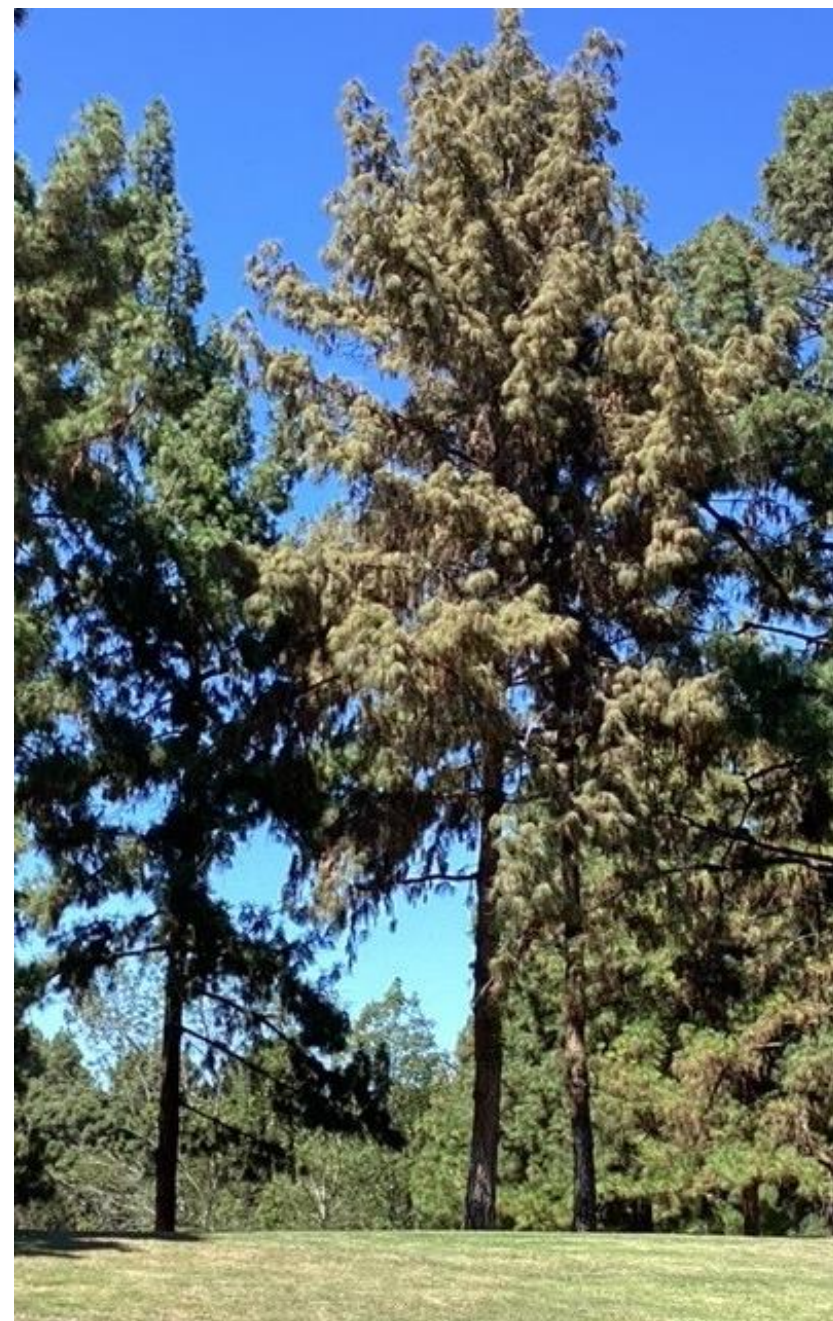
Dying Trees

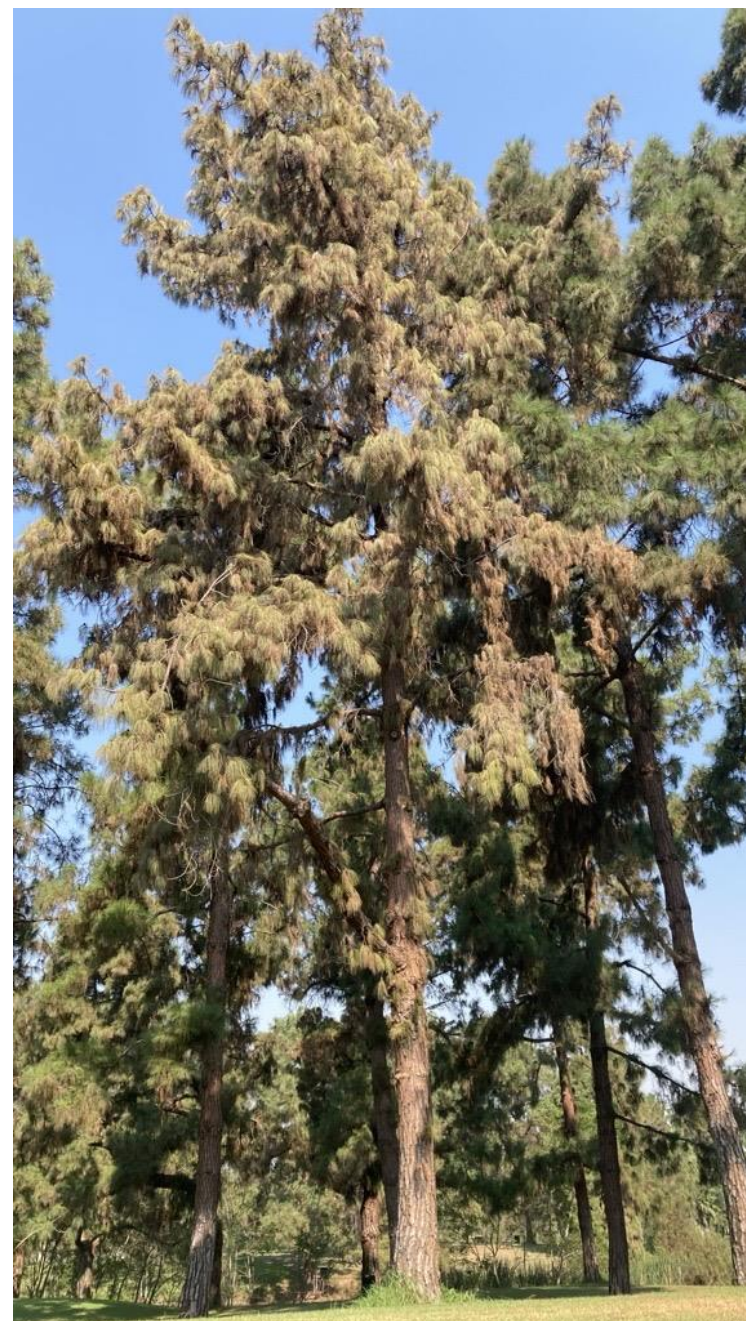
Dying tree

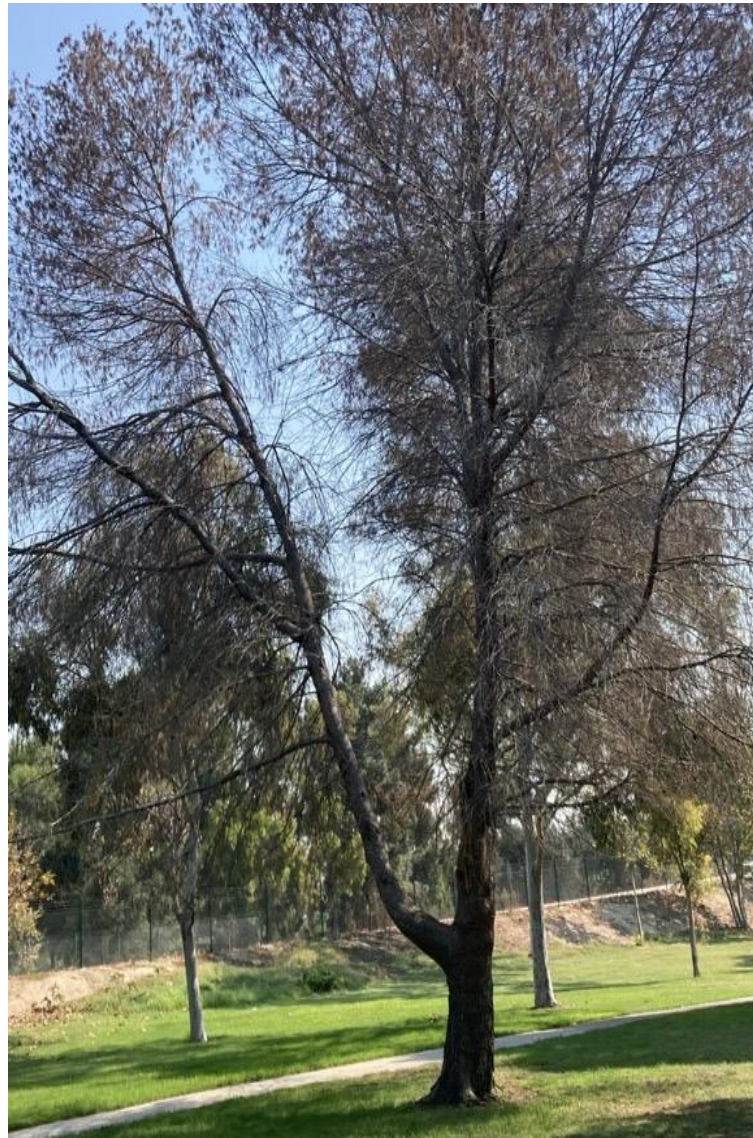
Dead Tree

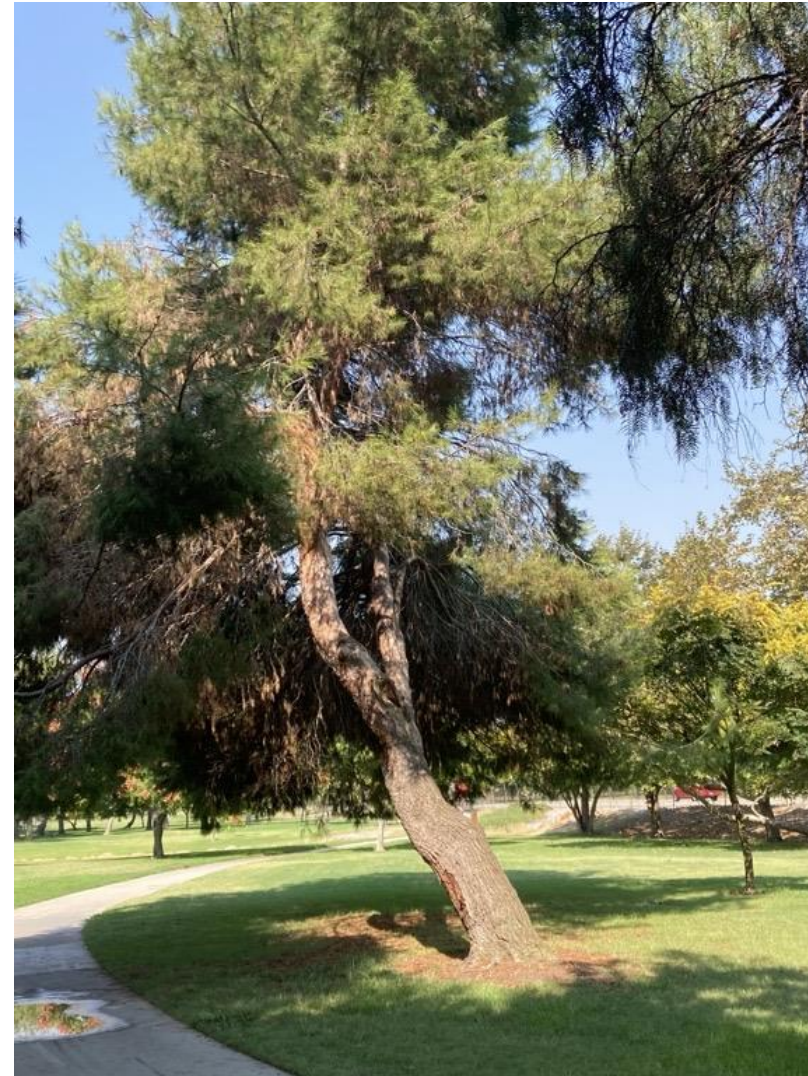
Severe lean on tree with poor structure

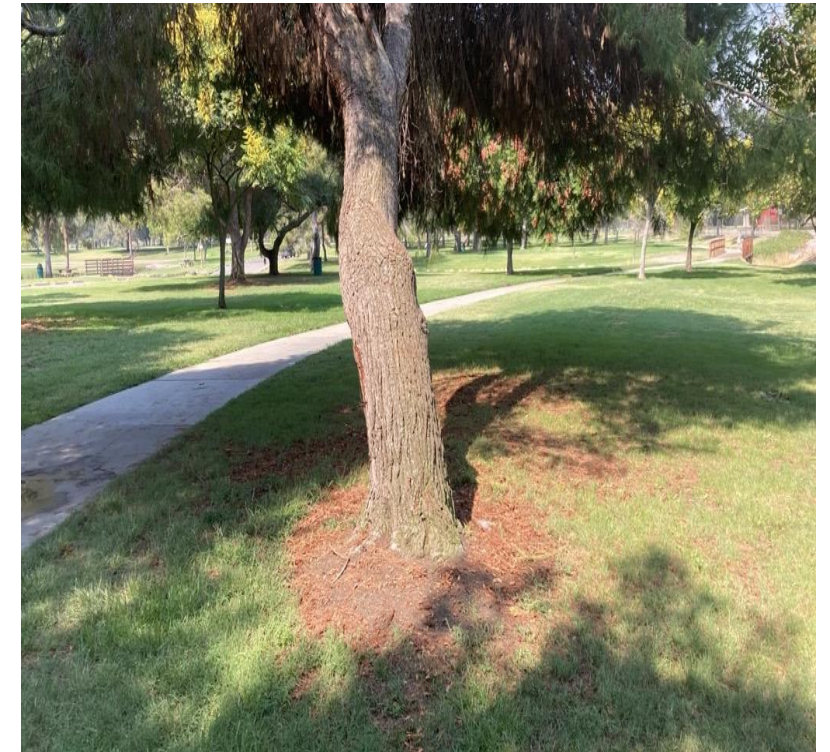
Tree leaning with roots beginning to lift

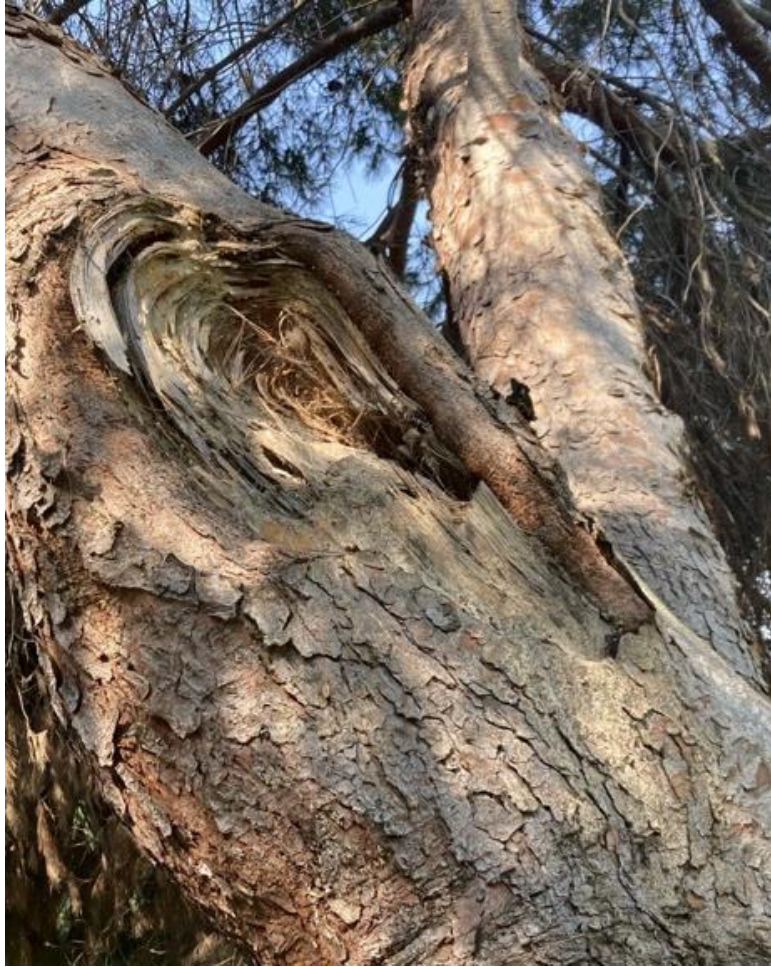
Cavity forming in the leaning tree at the main joint. Overall weak pint in the tree.

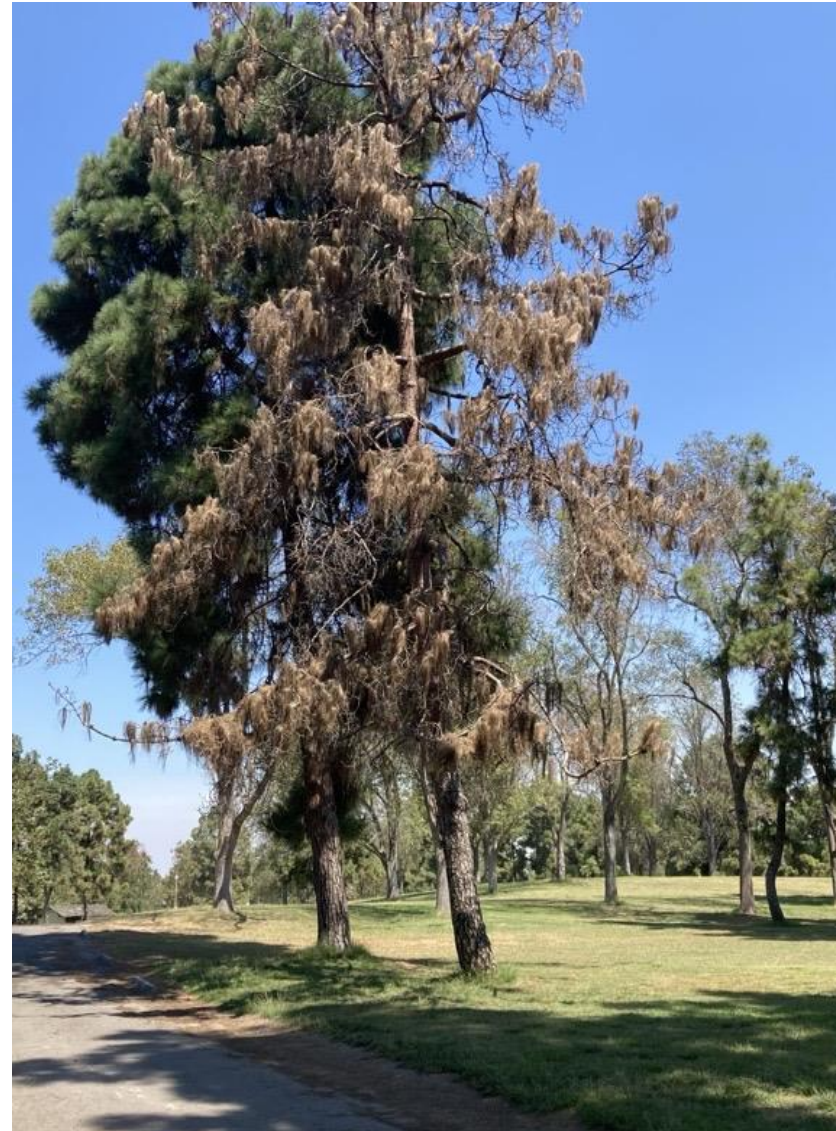
Dead Tree

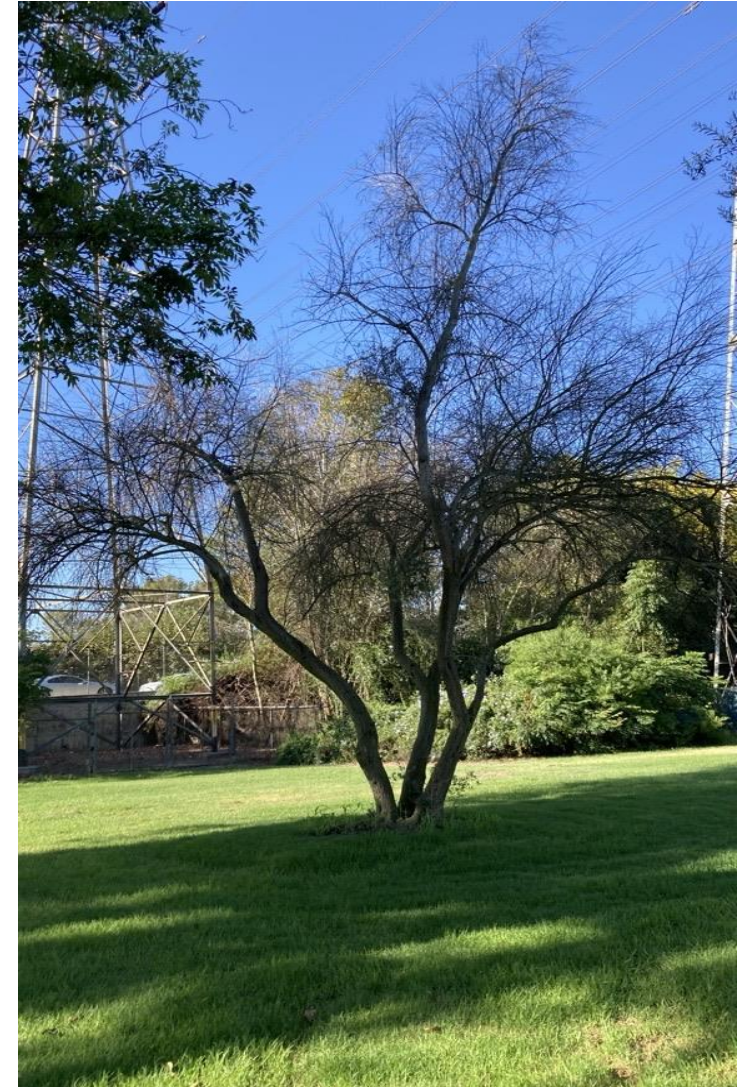
Dead Tree

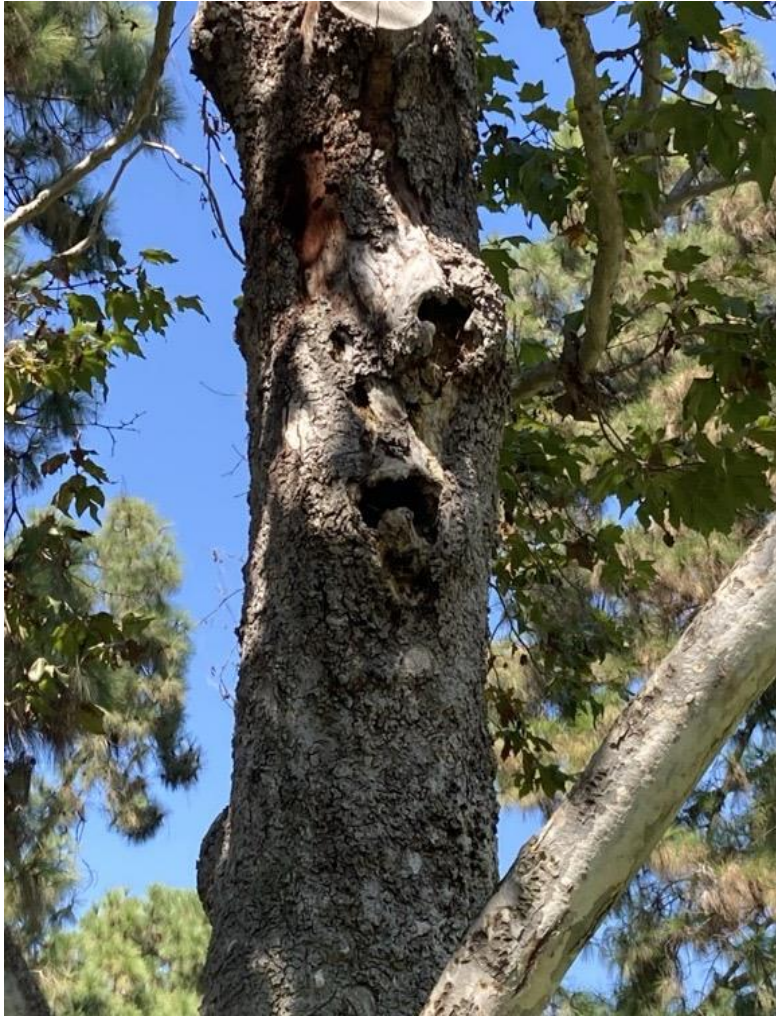
Tree with multiple cavities in the tree

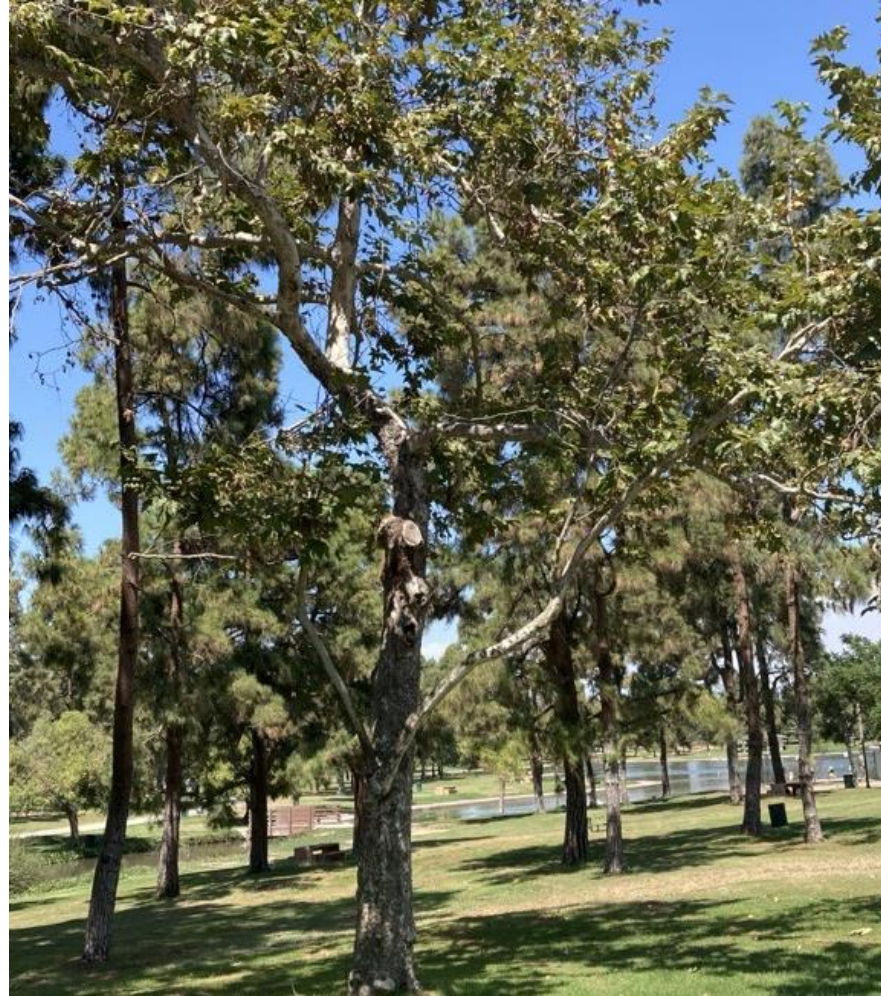
Overall photo of the tree.

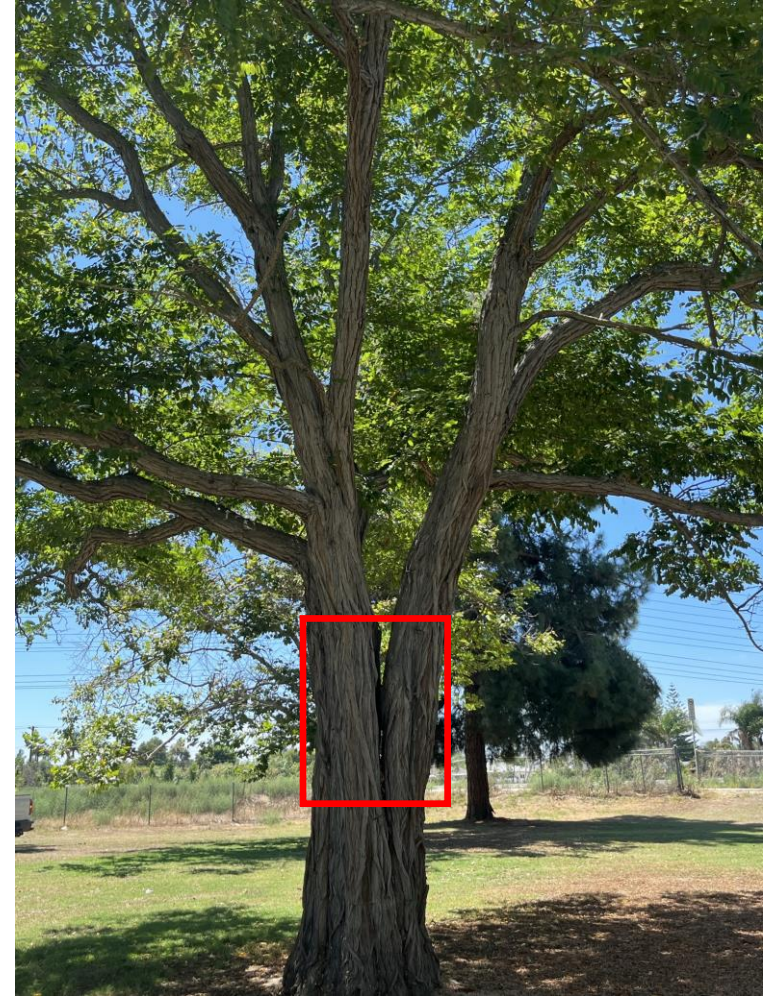
Overall photo of tree beginning to split.

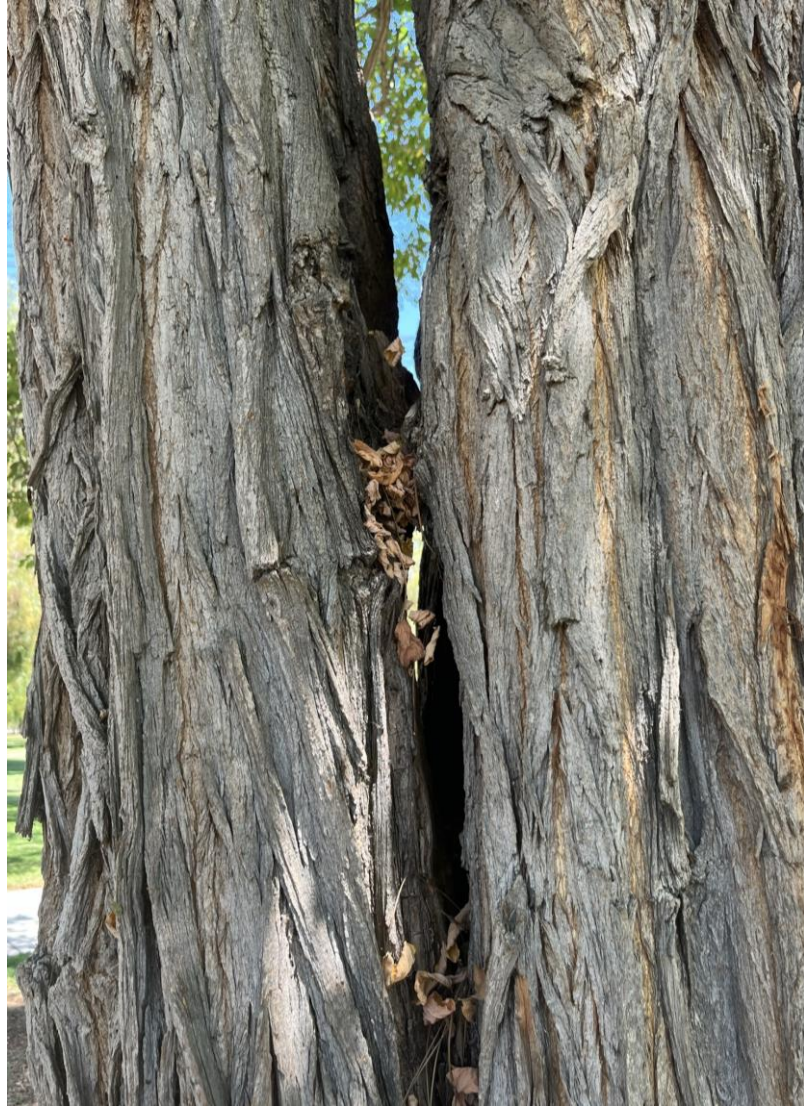
Close up of tree beginning to split

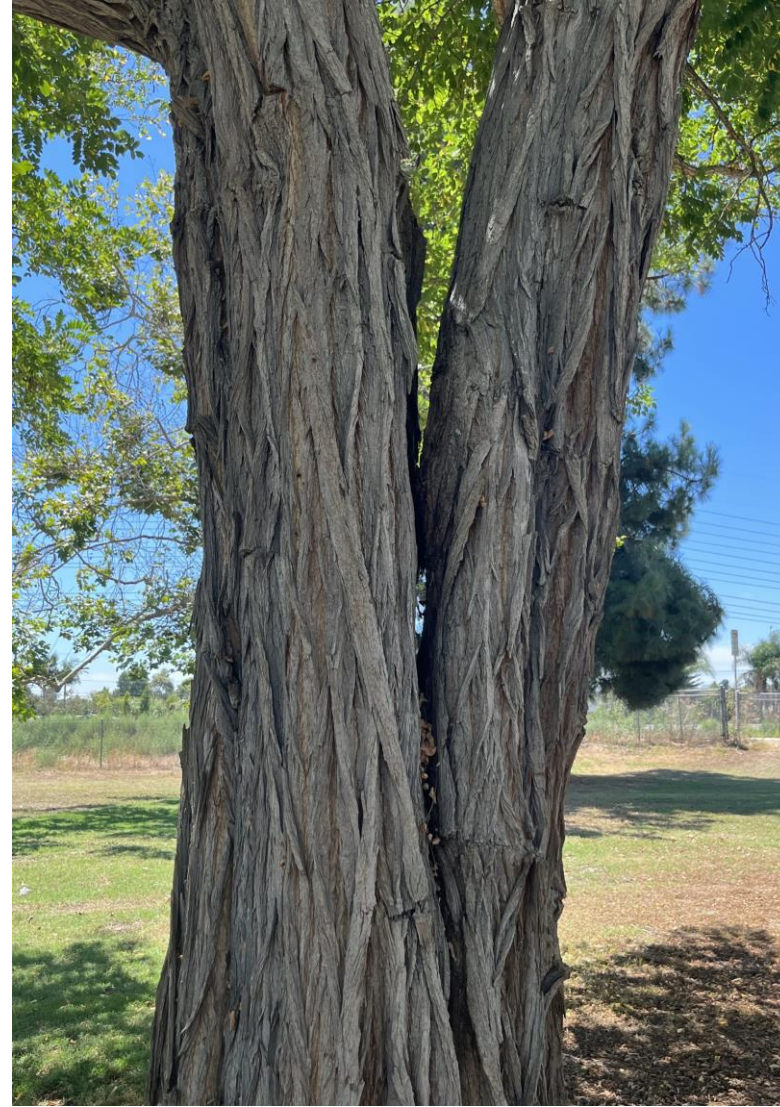
Tree beginning to split

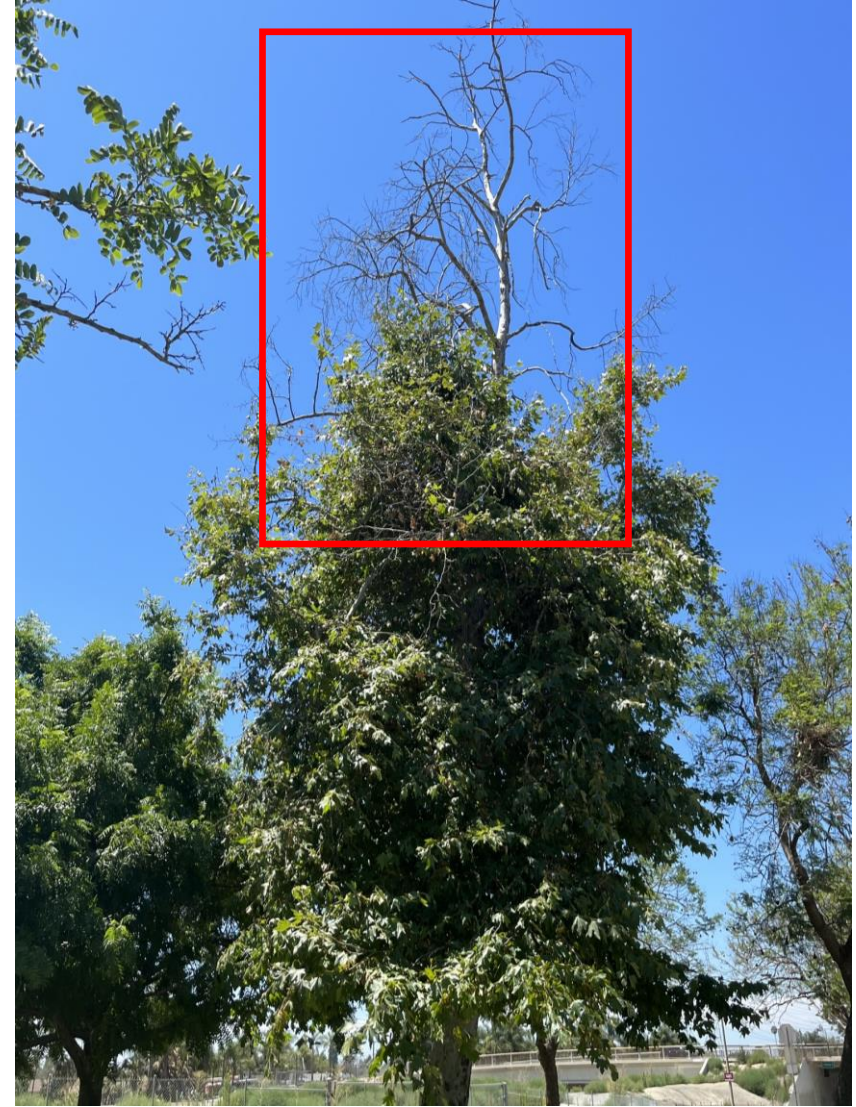
Tree with polyphagous shot hole bore. Dead primary leader.
