Heartwell Park

Area 1

9-16-2025

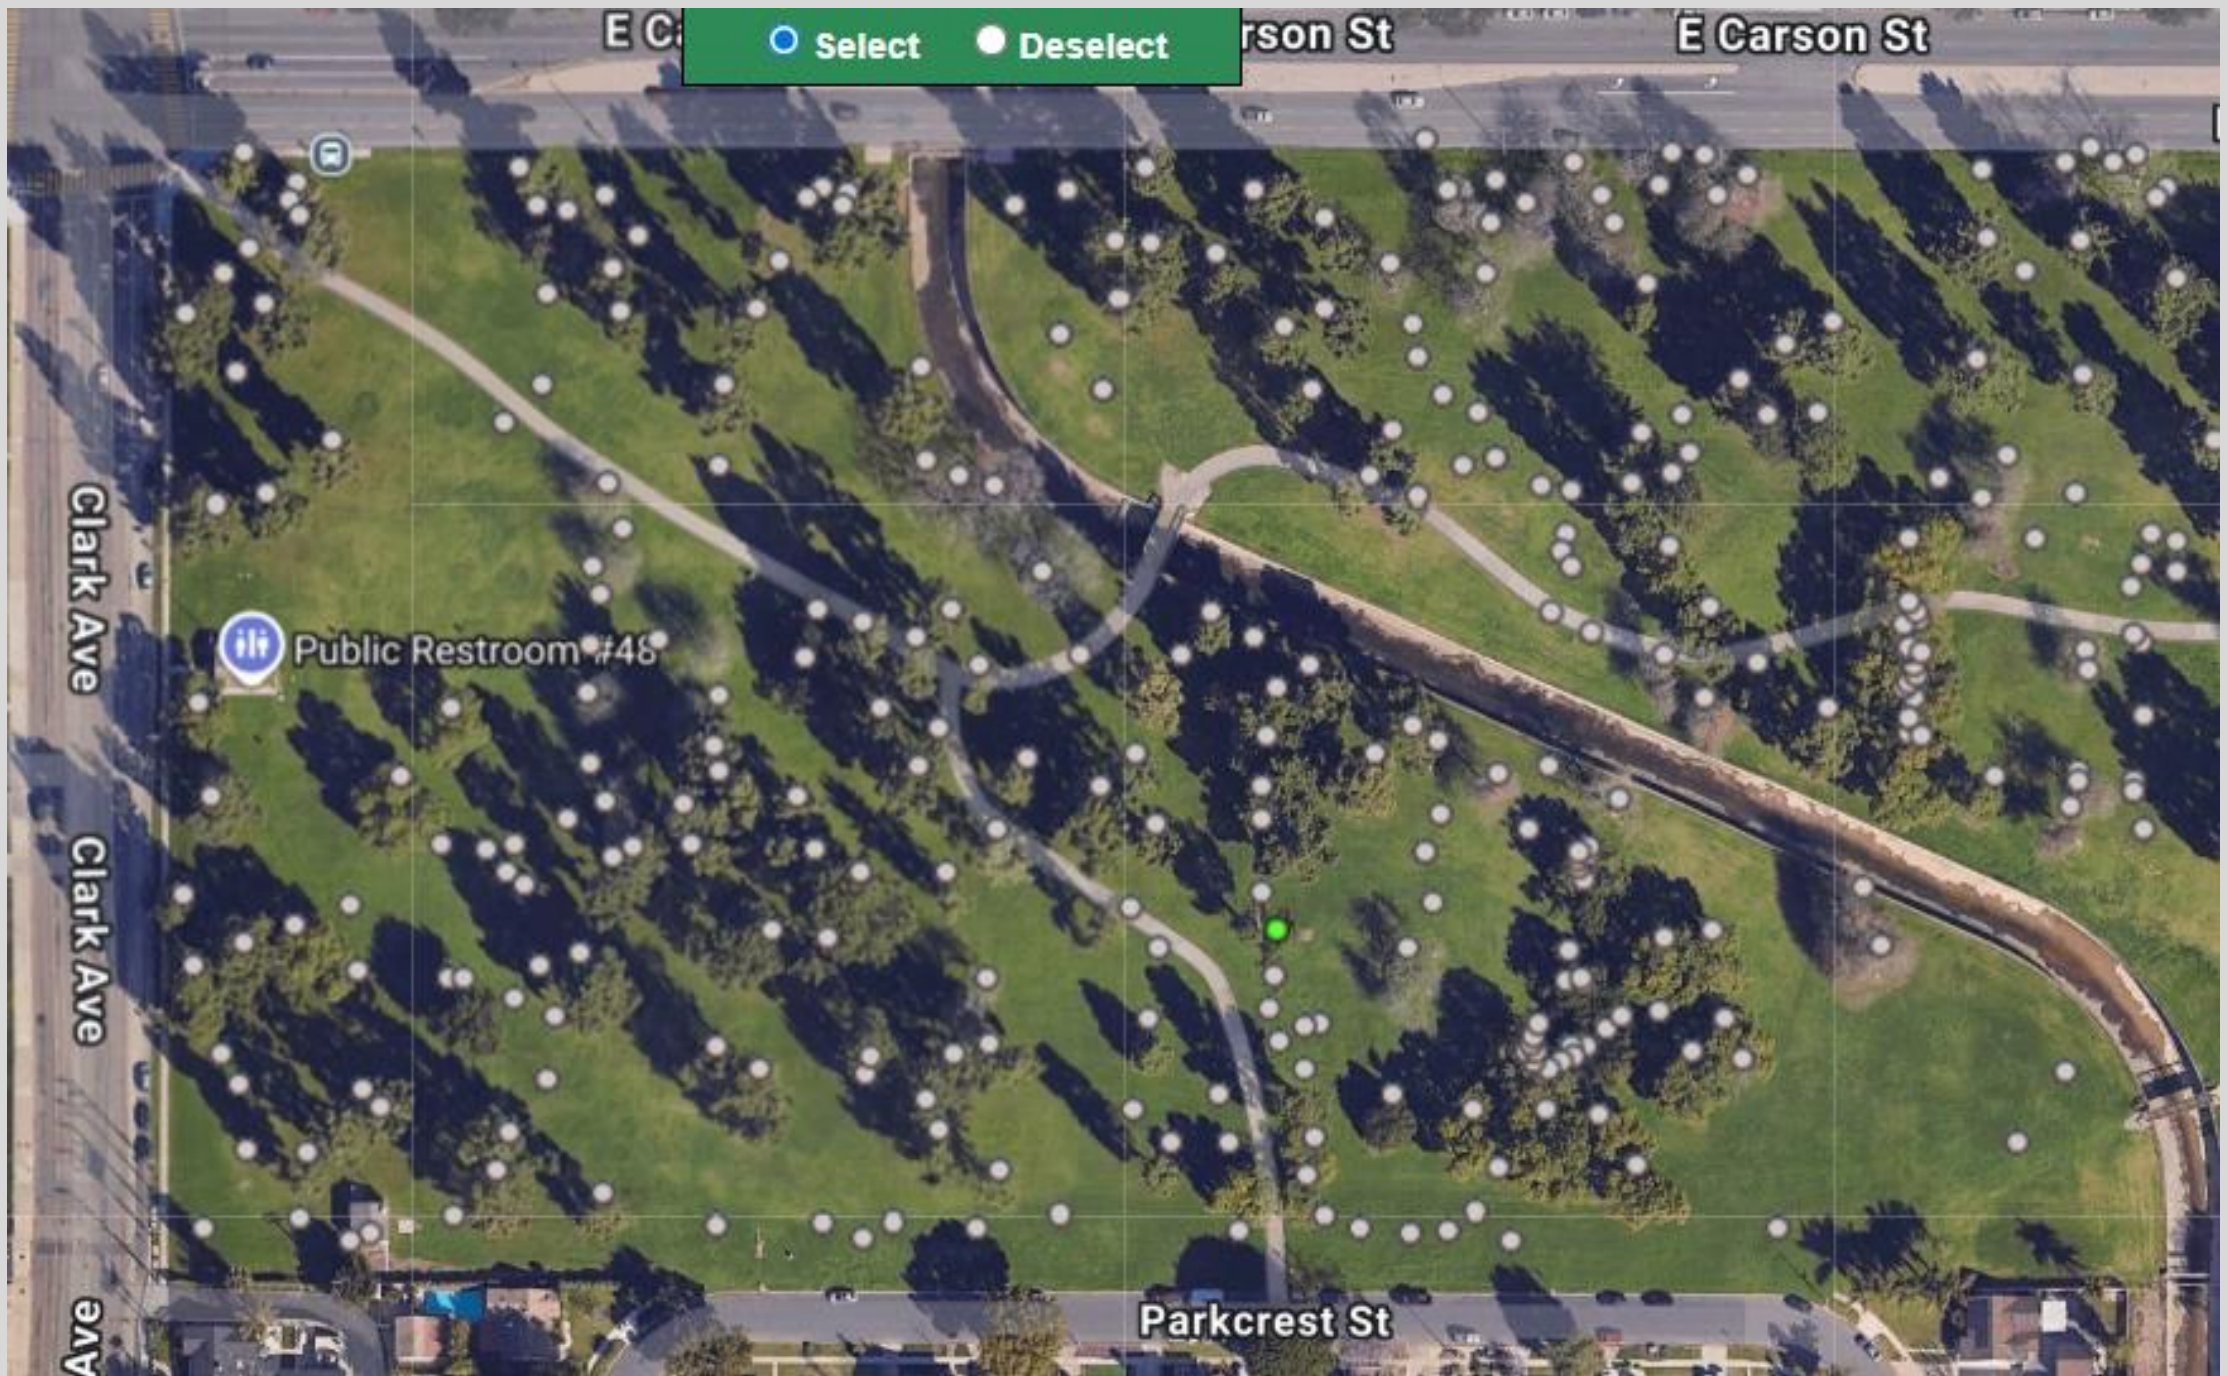
Overall tree needs to be removed due to multiple issues that can not be remedied by pruning. Area was originally cautioned taped due to a broken branch stuck within the tree.

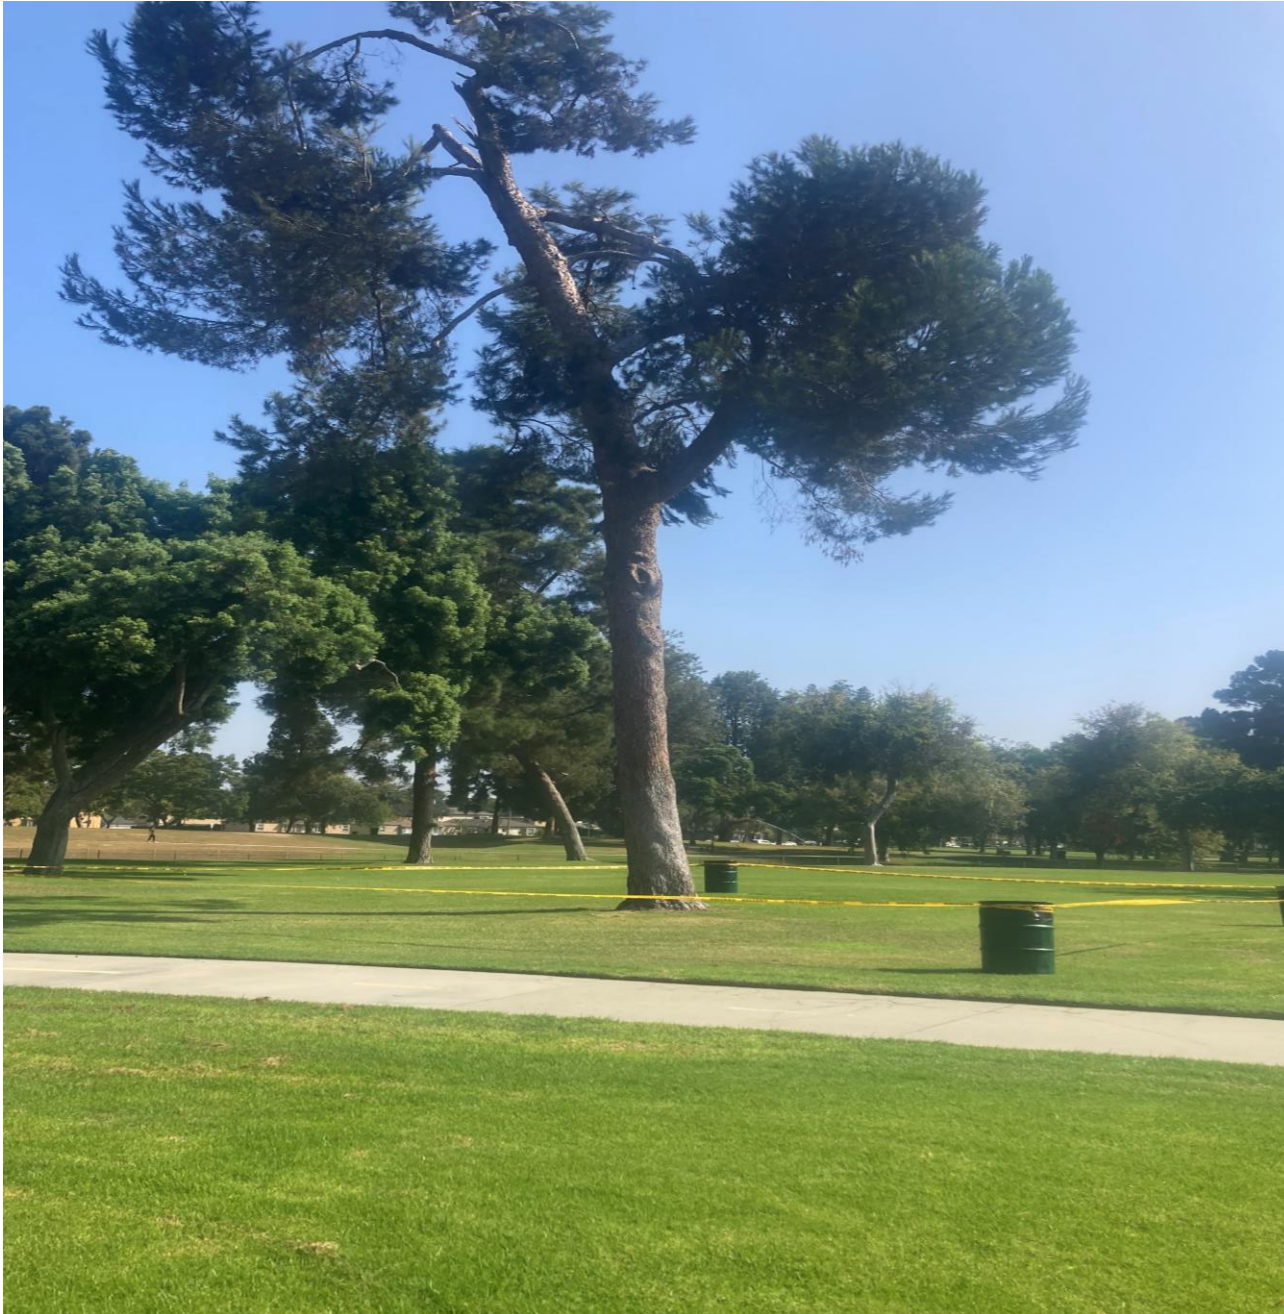
Old wounds within the tree. Needs to be removed

Cut needs to be made below the drawn line to the next joint.

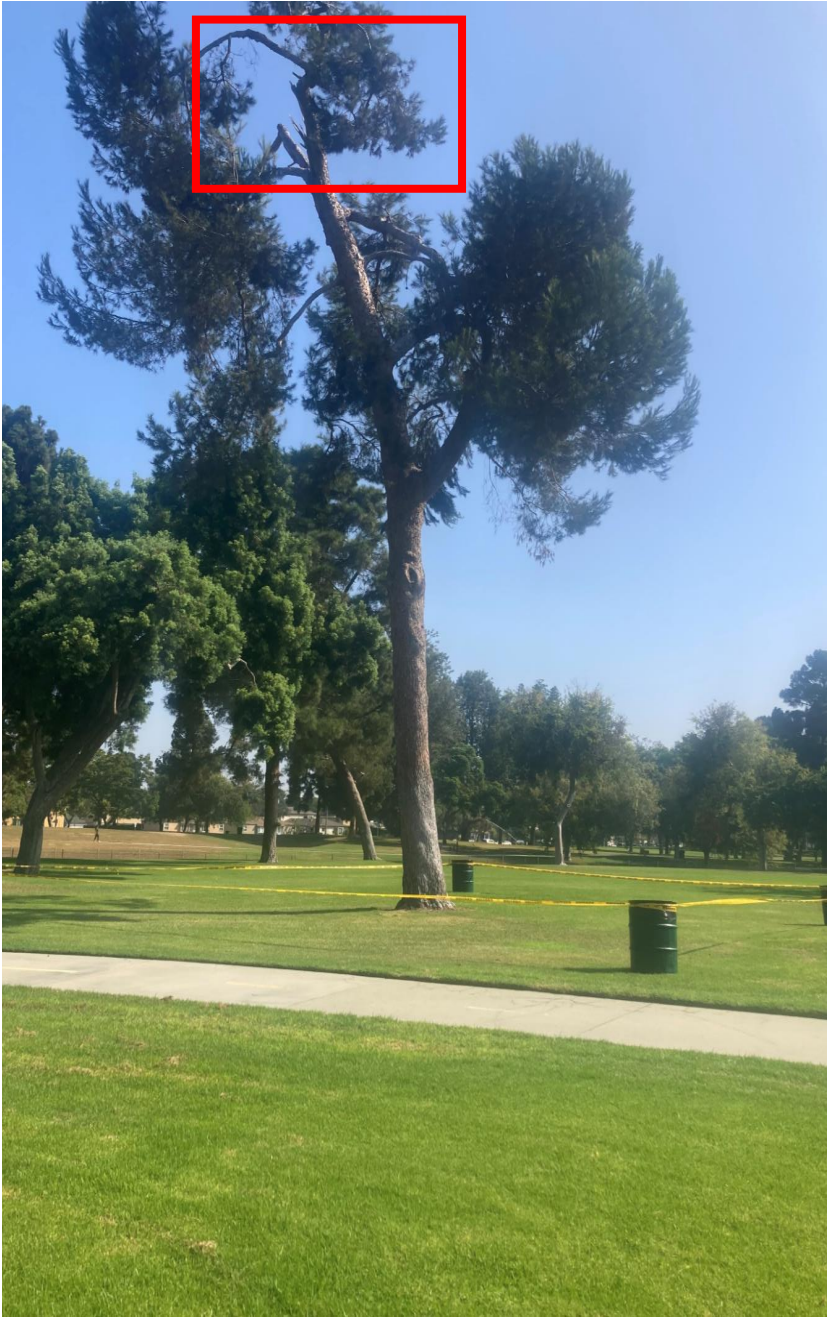
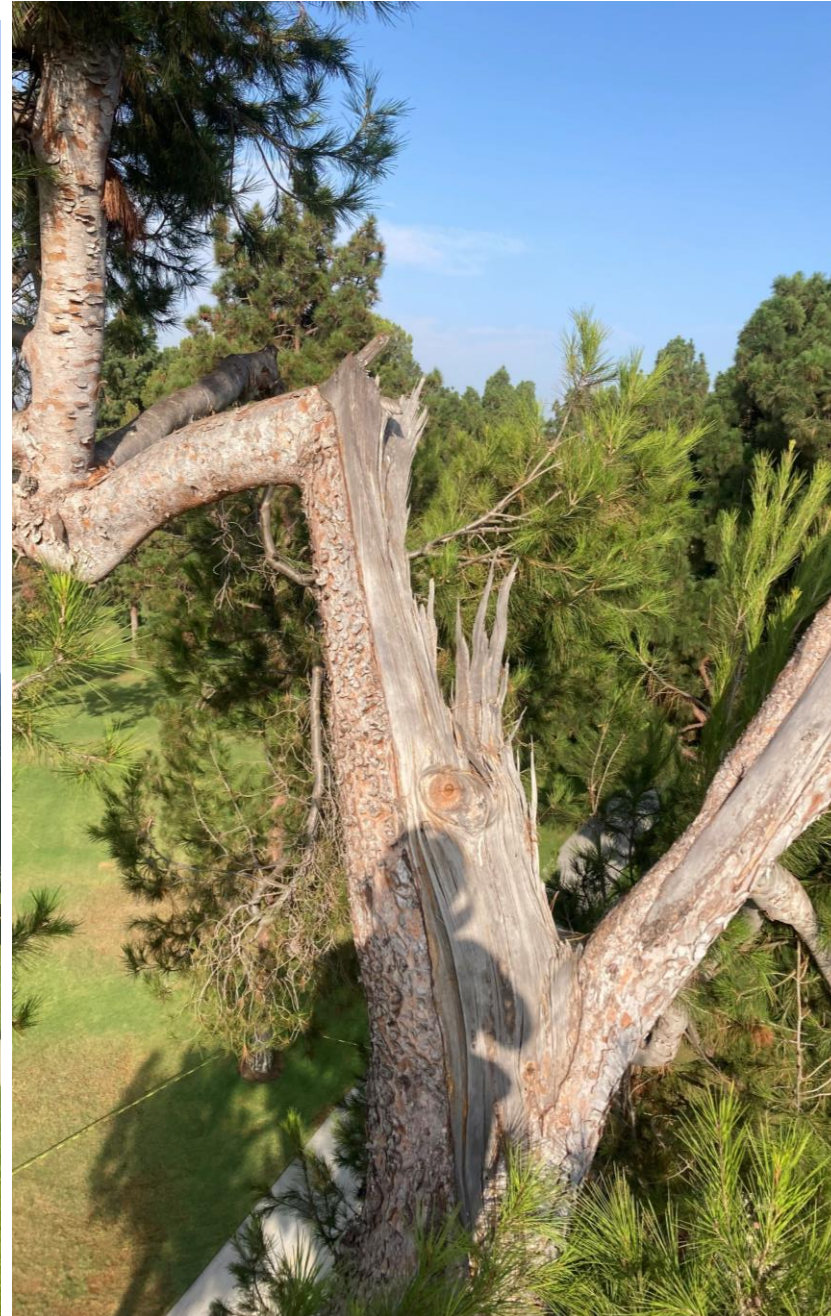
Branch needs to be removed as it is growing in a downward direction crossing other limbs. Long term this is not structurally sound condition. The green box show the location of the next photo.

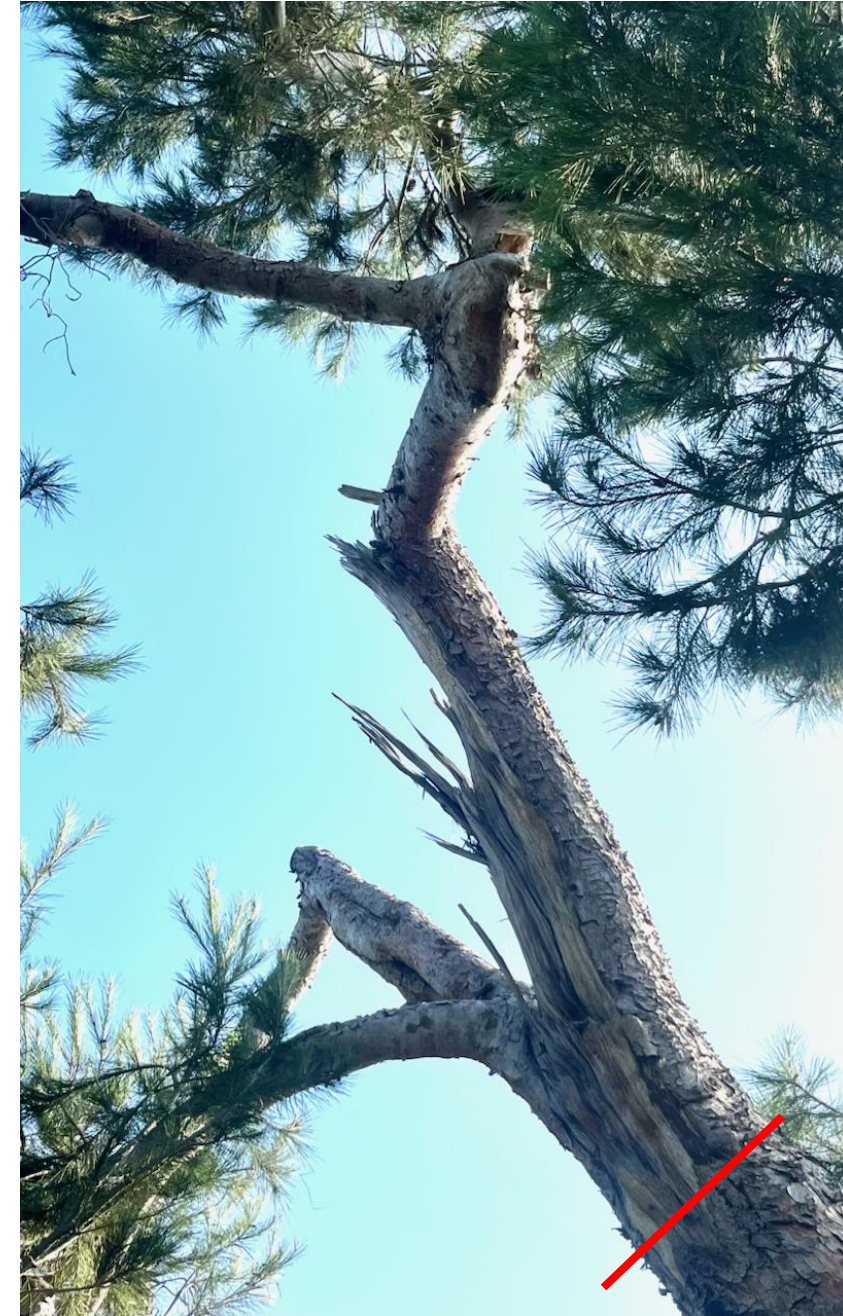
The limb in the photo has a cavity. This limb needs to be completely removed for safety reasons. The limb covering it is the same limb from the previous photo growing in a downward direction.

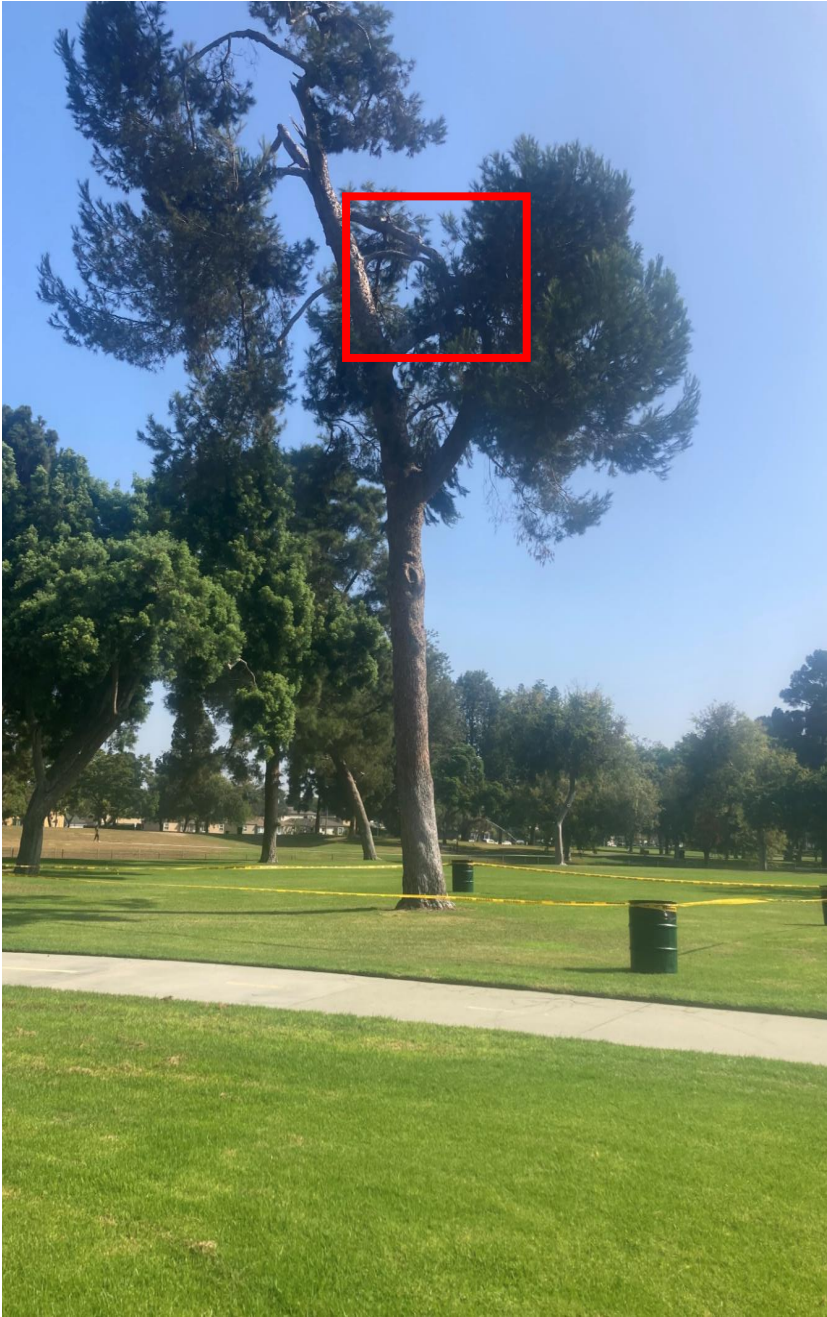
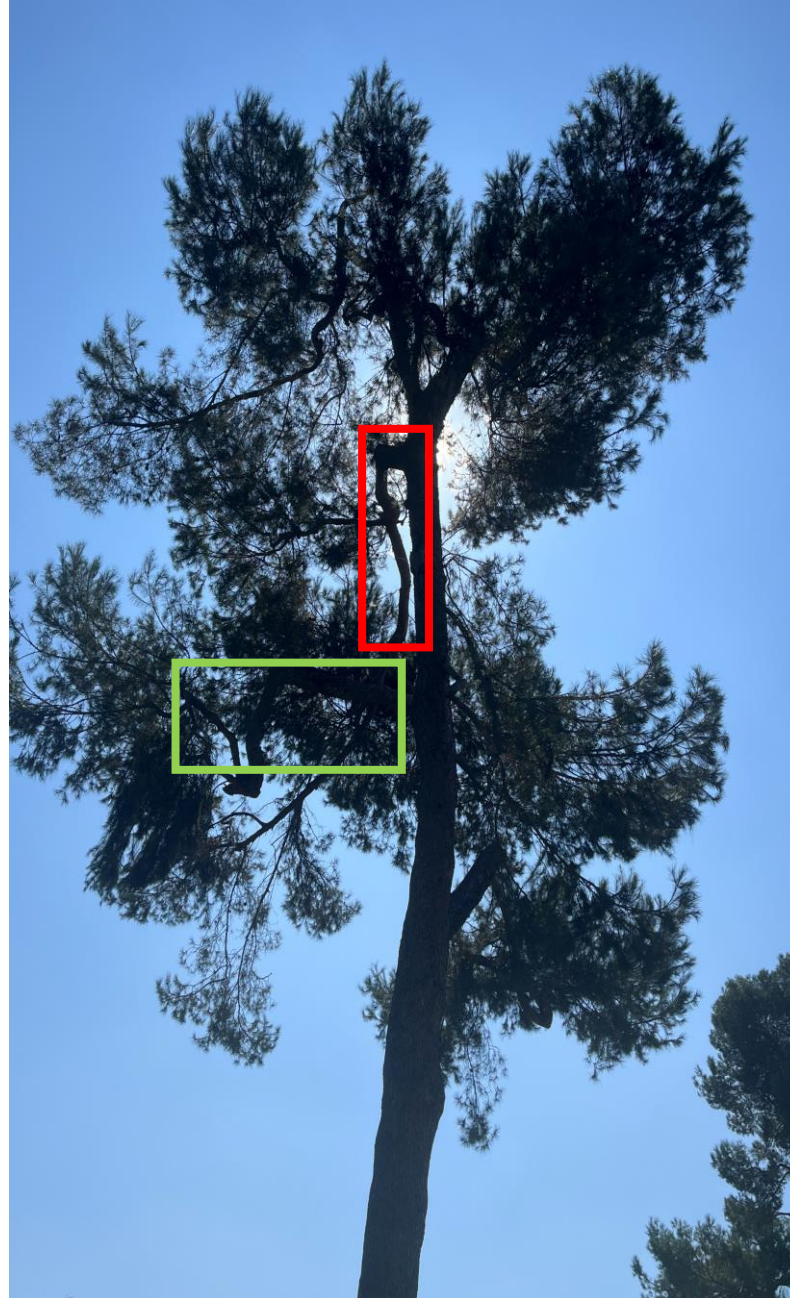
Limb is also growing in a downward direction along with damage to the park. Long term this would cause to potentially dangerous condition.

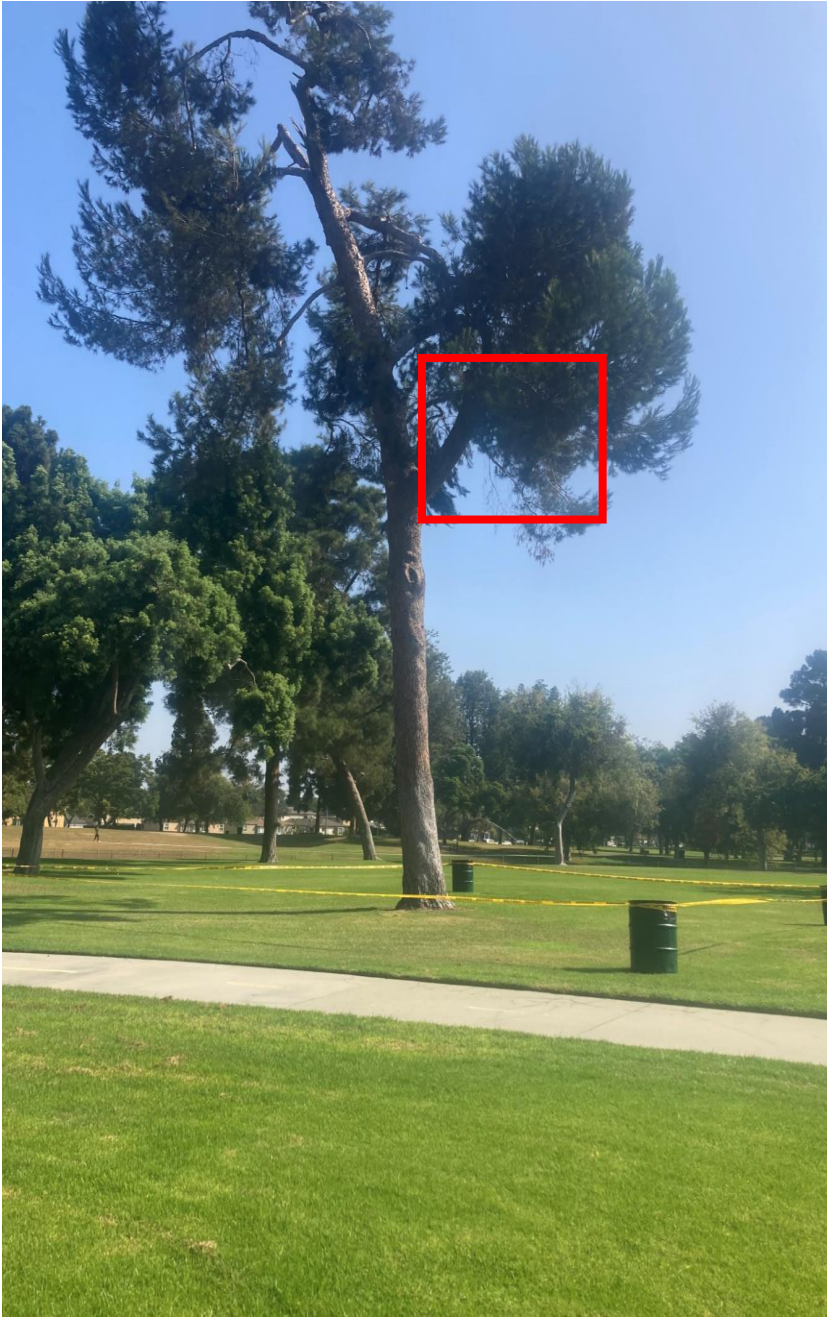
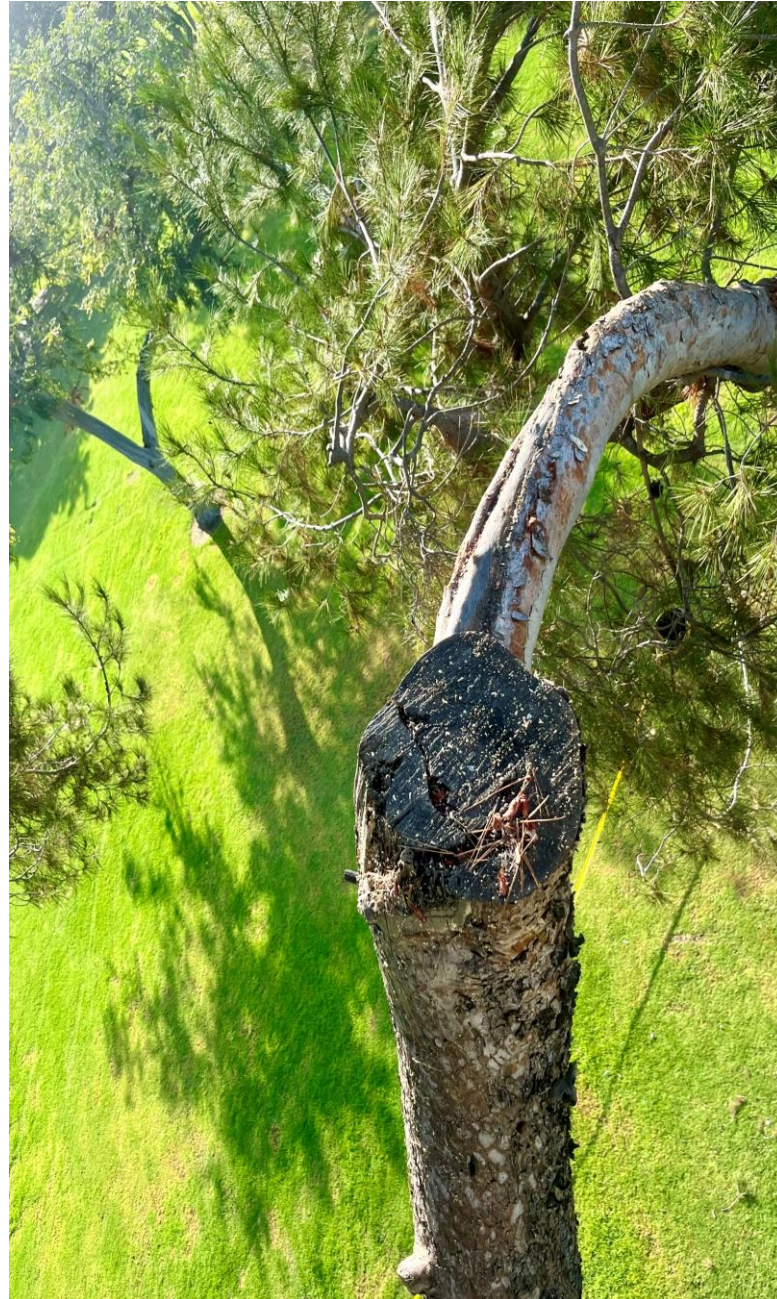
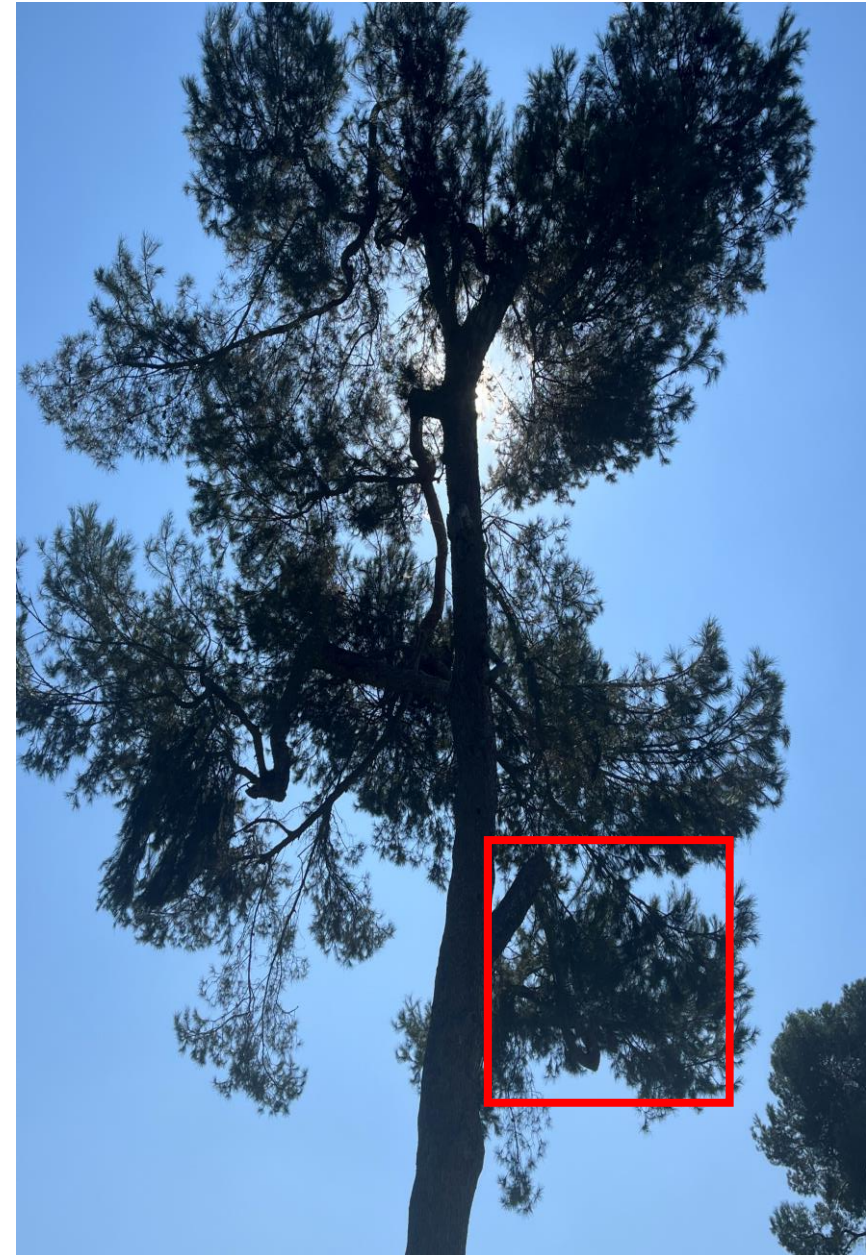
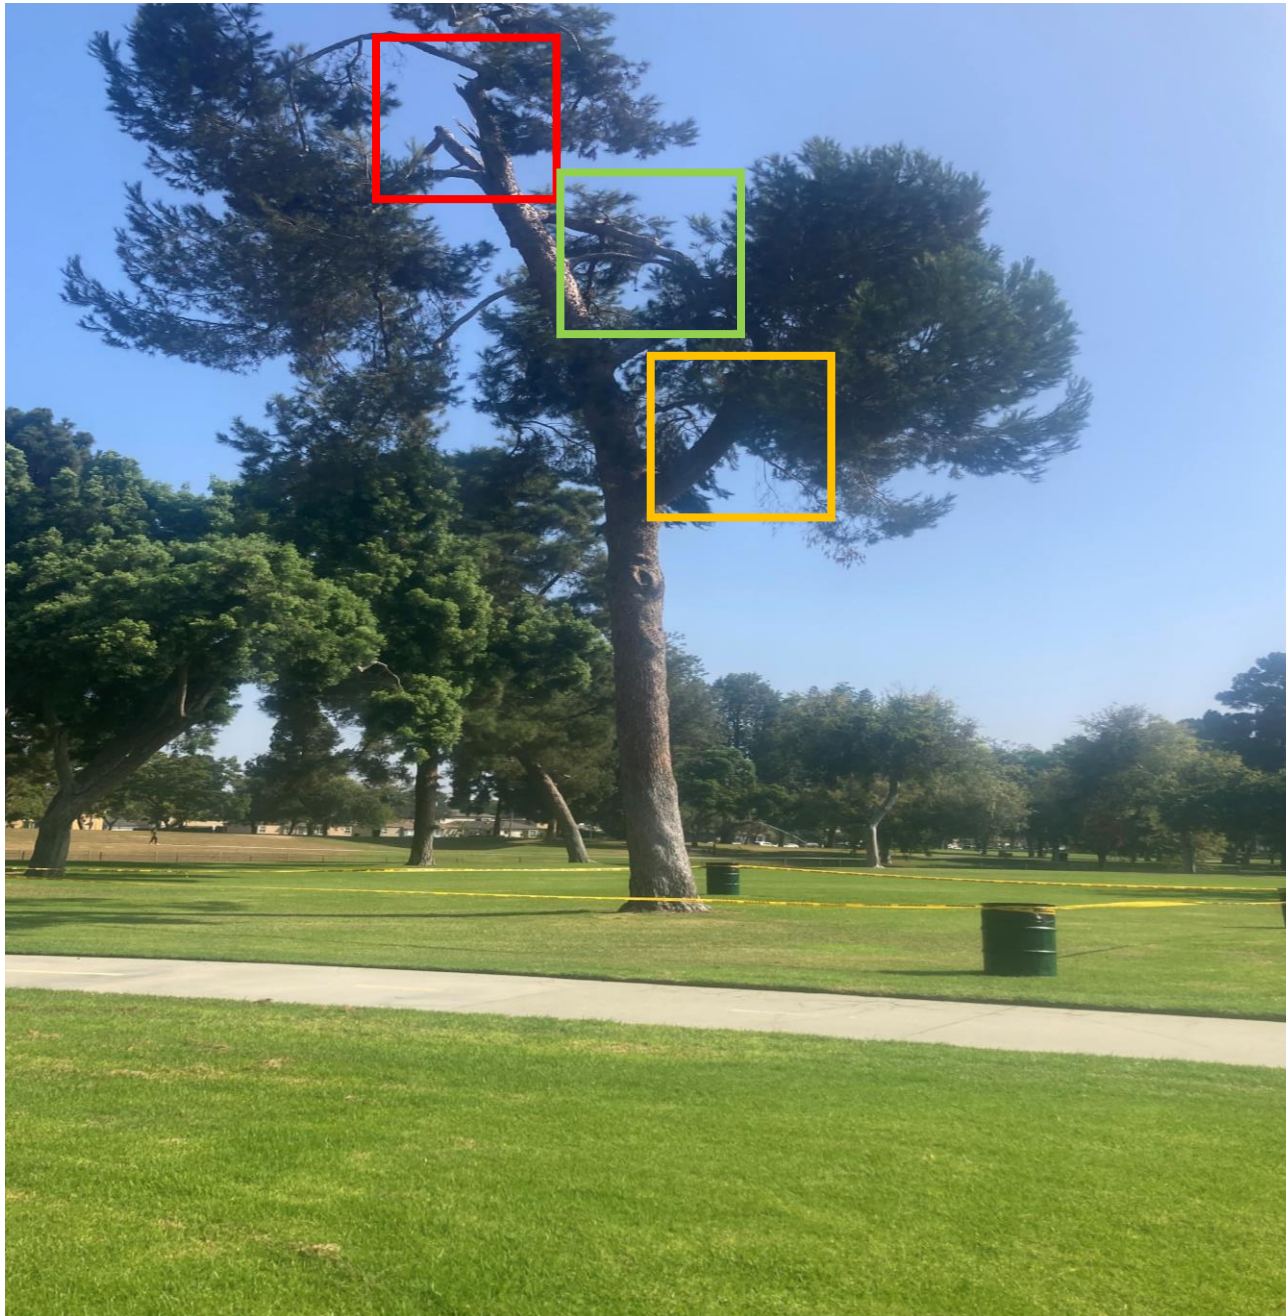
The tree has too many corrective cuts to be made would make it a candidate for removal.
