2810 E. 1<sup>st</sup> Street  
Long Beach, California

Historical Resource Report

February 2013

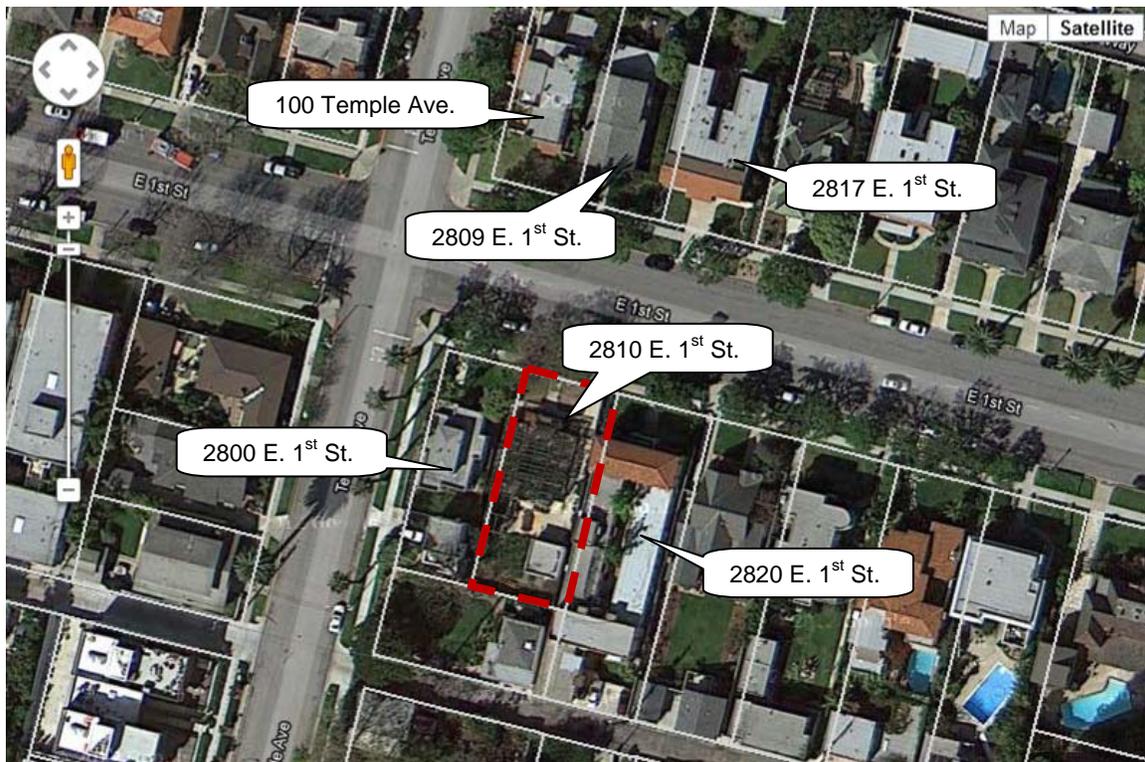
Figure 2: Map of contributing resources in the immediate vicinity of the project site. The project site is indicated by the dashed boundary line. Image courtesy of ParcelQuest.

- 2820 E. 1<sup>st</sup> Street (located to the east), a 12-unit apartment building constructed in 1921 in the Mediterranean Revival style.
- 100 Temple Avenue (located to the north and across the street), a single-family dwelling constructed in 1922 in the Mediterranean Revival style.
- 2809 E. 1<sup>st</sup> Street (located to the north and across the street), a single-family residence constructed in 1907 in the Shingle style.
- 2817 E. 1<sup>st</sup> Street (located to the north and across the street), a 4-unit apartment building constructed in 1920 in the Monterey style.

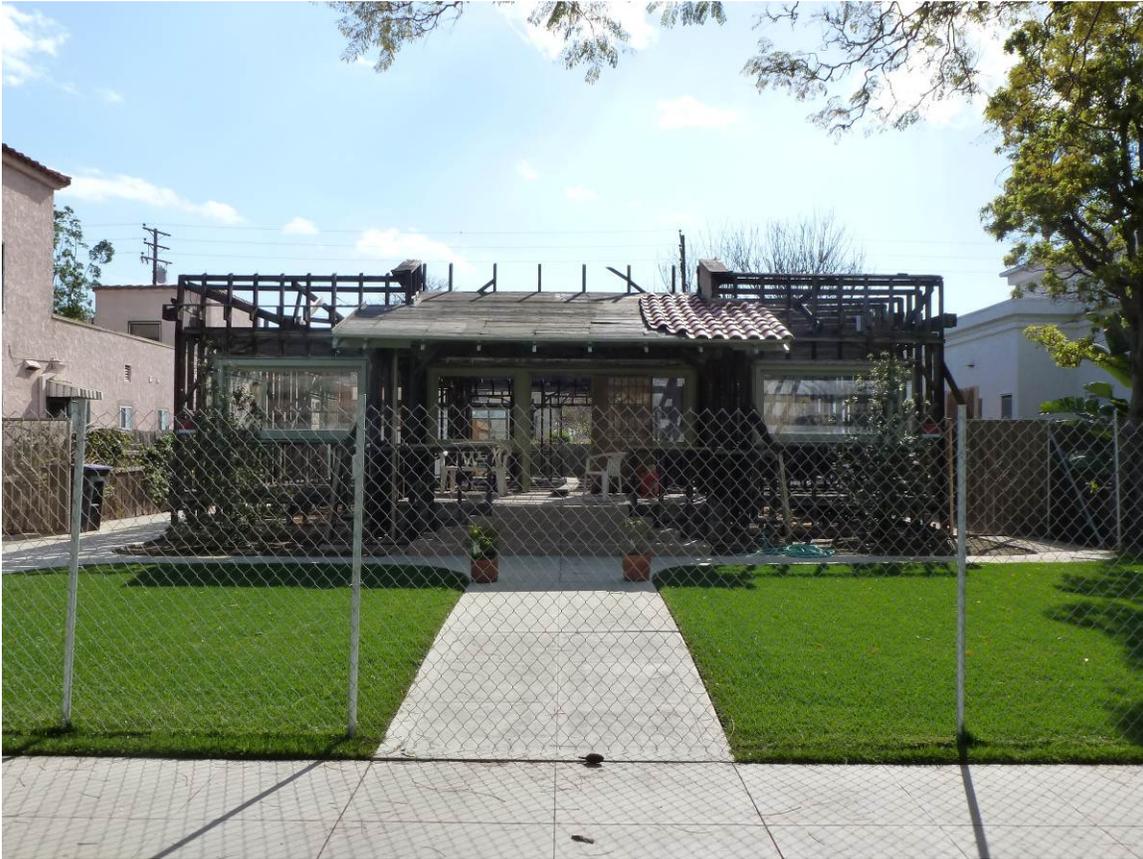
*Figure 3: 2810 E. 1<sup>st</sup> Street, view to the south, February 21, 2013. Source: GPA.*

The residence on the property is recorded by the County Assessor as 1,920 square feet of building living area. It is compact in plan, irregular in shape, with a projecting front porch and a southwest rear wing. The subject building currently lacks roof, walls, doors, and interior. It consists of mostly intact wood framing on a concrete foundation. Several windows remain in their frames. The roof over the porch is partially intact, and small sections of stucco cladding remain at the porch and around the base of the building. Removed roof tiles are stored onsite.

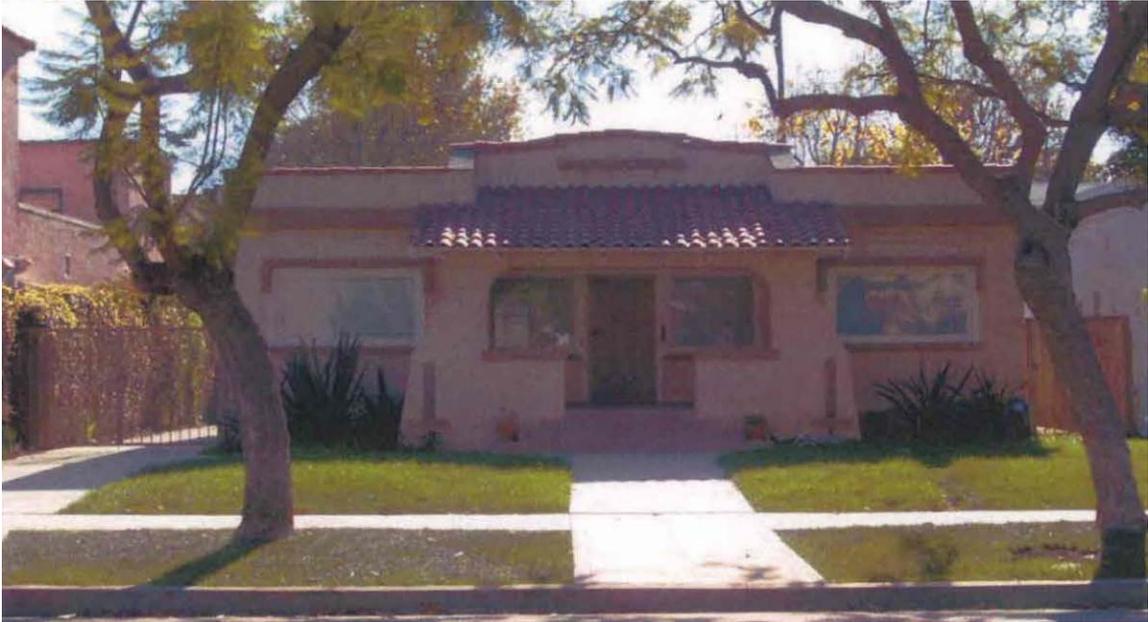
*Figure 4: Primary elevation of 2810 E. 1<sup>st</sup> Street, view to the south, December 1, 2004. Image courtesy of LSA Associates.*

2810 E. 1<sup>st</sup> Street is a one-story single-family residence constructed in 1921 with elements of the Mission Revival style. It has a flat roof, stucco cladding, and a concrete foundation. The bottom section of stucco wall is slightly raised across the base of the building. The primary elevation contains a wide partially enclosed, shed-roof entry porch at center. The porch roof is covered in Spanish clay tile and it has exposed carved wood rafters and beams. The corners of the porch feature decorative curving buttresses, pierced by narrow eyelet openings. The sides of the porch contain arched windows. The front of the porch is a wide basket-handle-arch opening with low wing walls. It is accessed by a short rise of concrete steps with rounded corners. A landing leads to the recessed entry door at center. It is a solid wood door, covered by a metal storm door with diamond-shaped detail, flanked by large square single-light wood windows. A pair of undivided wood picture windows flanks the porch. They feature heavy label mold decorations. The front elevation terminates in a mission-style parapet broken into three sections. The side sections are flat and capped with Spanish tile. The bell-shaped middle section, located over the main entry, is higher and recessed, with sloped pier walls connecting it to the lower sections. Its face is pierced by a neat row of small, square openings below a decorative band. The middle section also features tile coping. Below the parapet, a stucco cornice runs across the façade, broken at the porch, and continues around the sides; a lighter band runs in parallel below it. A metal gate with diamond-shaped detail is located at the northeast corner of the house across the driveway.

The side elevations of the residence display stucco cladding, flat parapet rooflines with Spanish tile coping, and continuous stucco cornice and lighter band below, which are continued from the primary elevation. The east side elevation contains a three-part wood picture window at the front and a pair of windows at the back. The picture

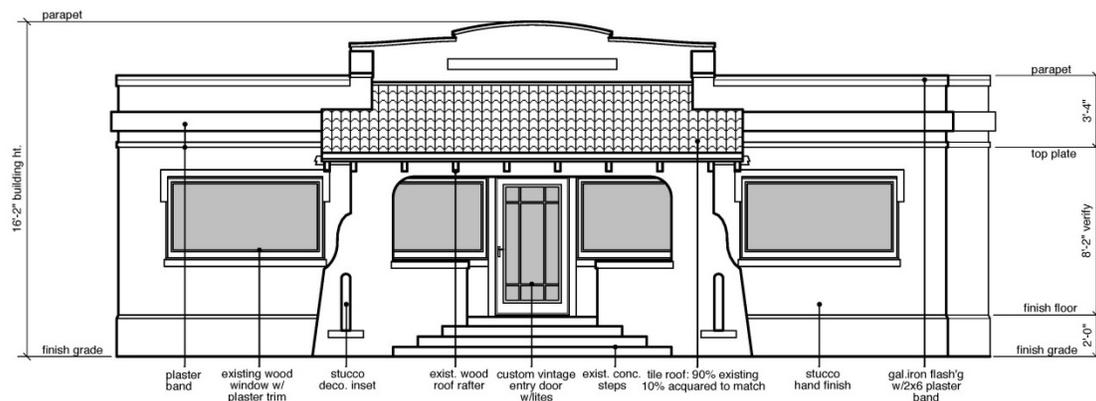
Figure 5: Front elevation drawing of the proposed restoration project.

- Foundation: Retain and reuse 100 percent of the existing foundation, and sister a new engineered foundation for structural support.
- Timbers and Wood: Retain and reuse over 80 percent of the existing framing. Remove the existing dry rotted wood, replace with new structural wood, and sister the existing timbers, per engineering standards. Chemically treat all framing for wood destroying organisms.
- Roof Framing: Frame roof as per original design and structural upgrades.
- Roofing: Reuse 90 percent of the existing roofing tile (located onsite). Replace the non-extant 10 percent of roofing tile with in-kind materials.

- Windows: Repair, restore and reuse the existing windows; replace missing windows with historically compatible windows.
- Exterior Door: Replace missing doors with historically compatible doors.

- Front Metal Gates and Door Screen: Retain, repair and restore matching metal gates at front of property and front door screen.
- Architectural Detail: Restore architectural detail as per historical photos and onsite framing details.

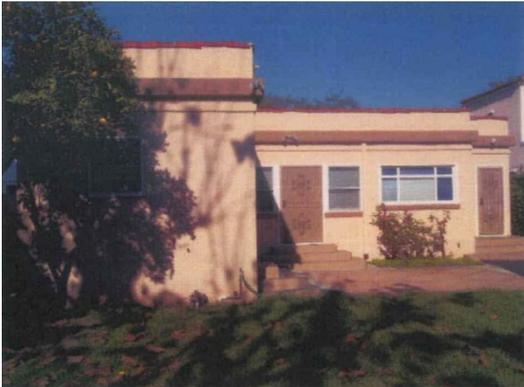
Figure 13: Rear elevation of 2810 E. 1<sup>st</sup> Street, view to the north, December 1, 2004. Image courtesy of LSA Associates.

The south (rear) elevation displays the same materials and decorative features as the sides. It is divided into three bays, which project to increasing lengths from east to west. The eastern bay is narrow and contains an entry door with metal screen accessed by rounded concrete steps. The central bay is wide and contains a picture window at the east side and an identical door with steps flanked by double-hung wood windows at the west side. The picture window is divided into two bands and six lights. The western bay is narrow and features a double-hung wood window and another identical door and steps on the in-facing wall, and a smaller square wood double-hung window at the south wall. (See additional photographs of the subject building on page 27.)

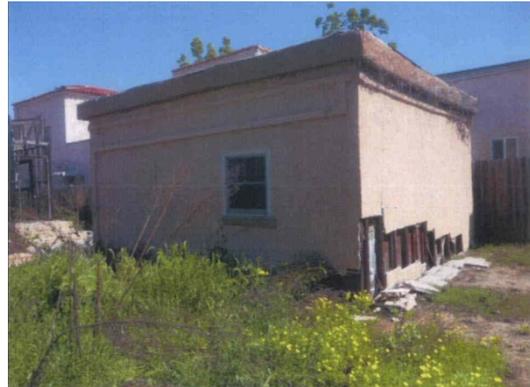
Figure 14: Garage at 2810 E. 1<sup>st</sup> Street, view to the northwest, March 9, 2011. Image courtesy of LSA Associates.

- Garage: Retain and maintain the existing garage. Repair and grade the existing garage roof to prevent water intrusion.
- Garage Doors: Replace existing garage door with historically compatible doors.

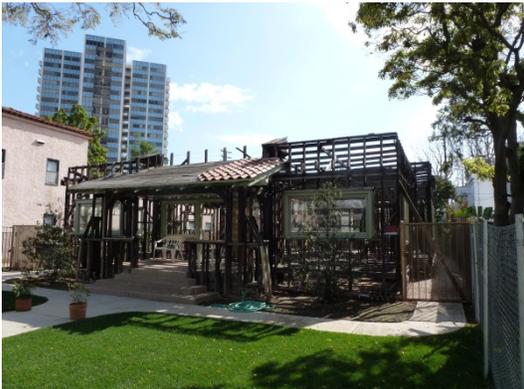
Figure 15: Front elevation of 2810 E. 1<sup>st</sup> Street, view to the southeast, February 21, 2013. Source: GPA.

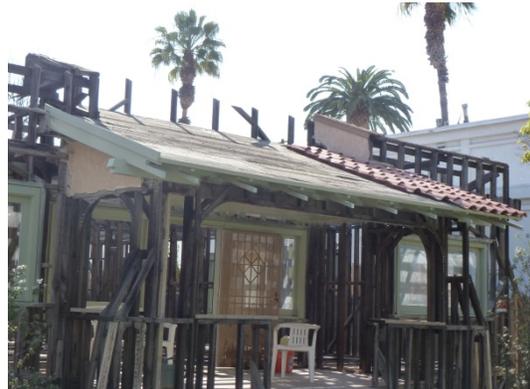
Figure 16: Front porch details, 2810 E. 1<sup>st</sup> Street, view to the southeast, February 21, 2013. Source: GPA.

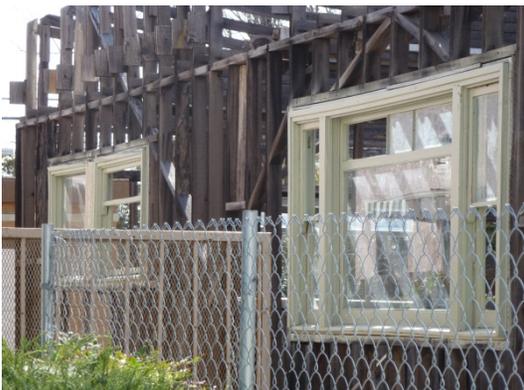
Figure 17: Window details at east side elevation, 2810 E. 1<sup>st</sup> Street, view to the southwest, February 21, 2013. Source: GPA.

window consists of a large fixed central pane with a three-light upper band and narrow double-hung windows in the sidelights. The pair of windows includes a wood double-hung sash and a fixed single-light. At the west side elevation of the residence, the front section contains a single double-hung wood window; the back section, which jogs out, contains a band of three double-hung wood windows.

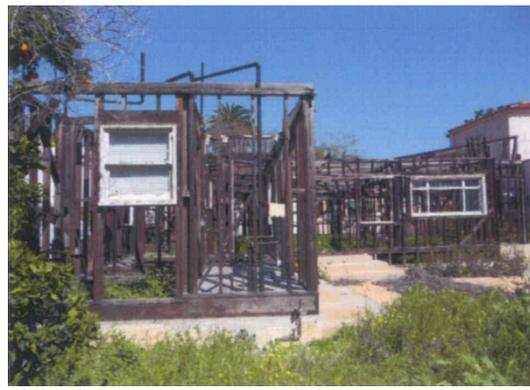
Figure 18: Rear elevation of 2810 E. 1<sup>st</sup> Street, view to the north, March 9, 2011. Image courtesy of LSA Associates.

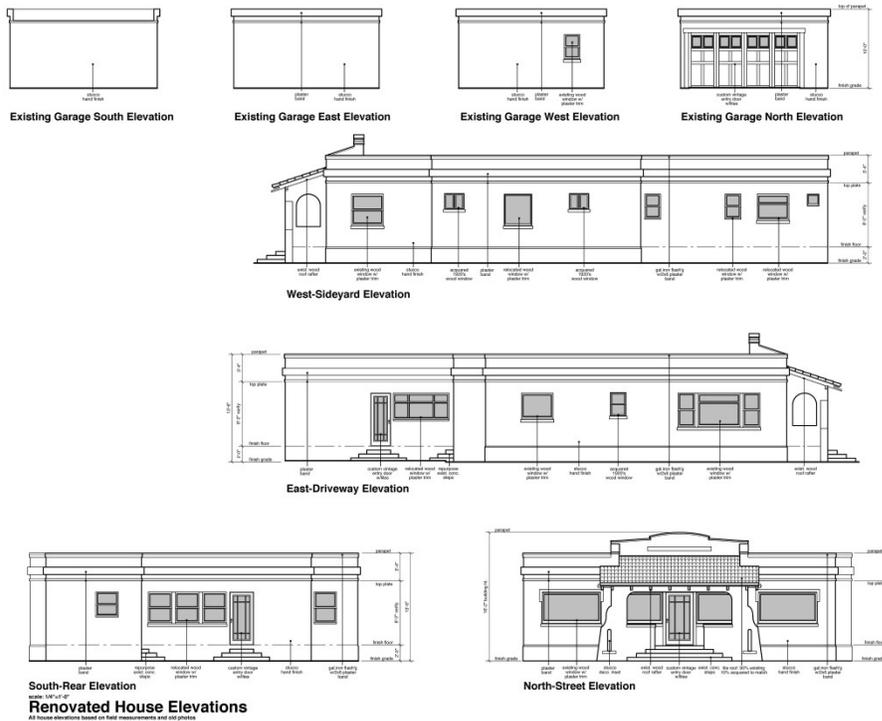
Figure 19: Elevation plans of the proposed restoration project at 2810 E. 1st Street.

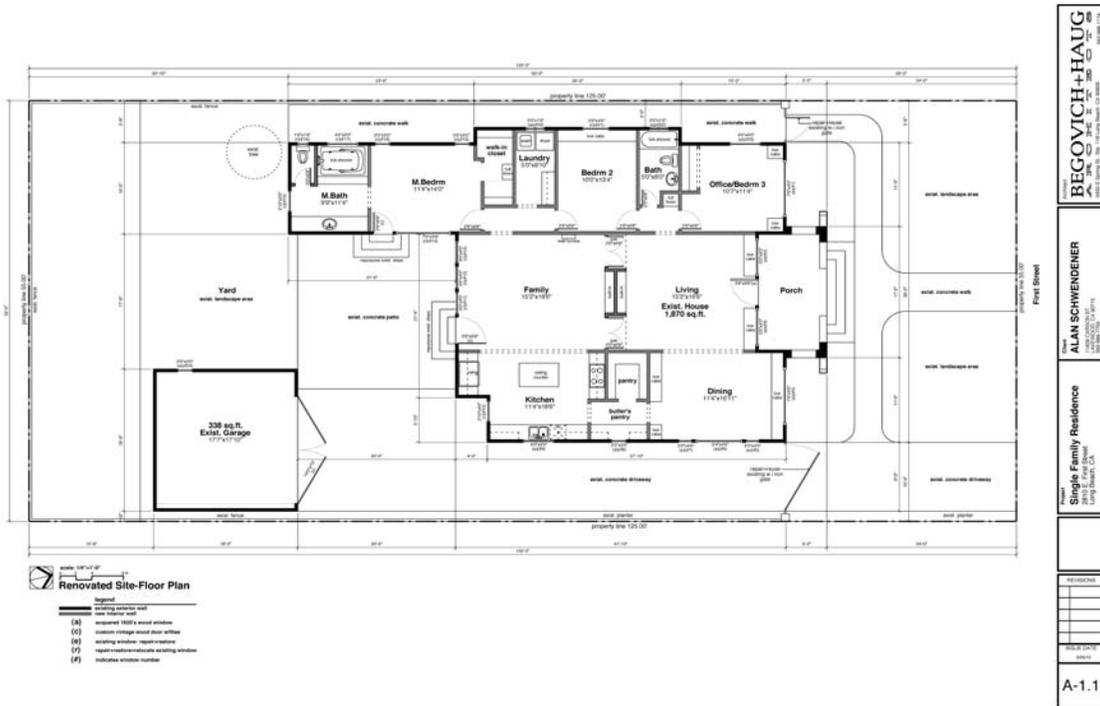
Figure 20: Site plan of the proposed restoration project at 2810 E. 1st Street.
