PHASE I ENVIRONMENTAL SITE ASSESSMENT REPORT

3rd and Pacific

125 West 3rd Street
Long Beach, California 90802

Report Date: January 4, 2017
Partner Project No. 16-173388.1

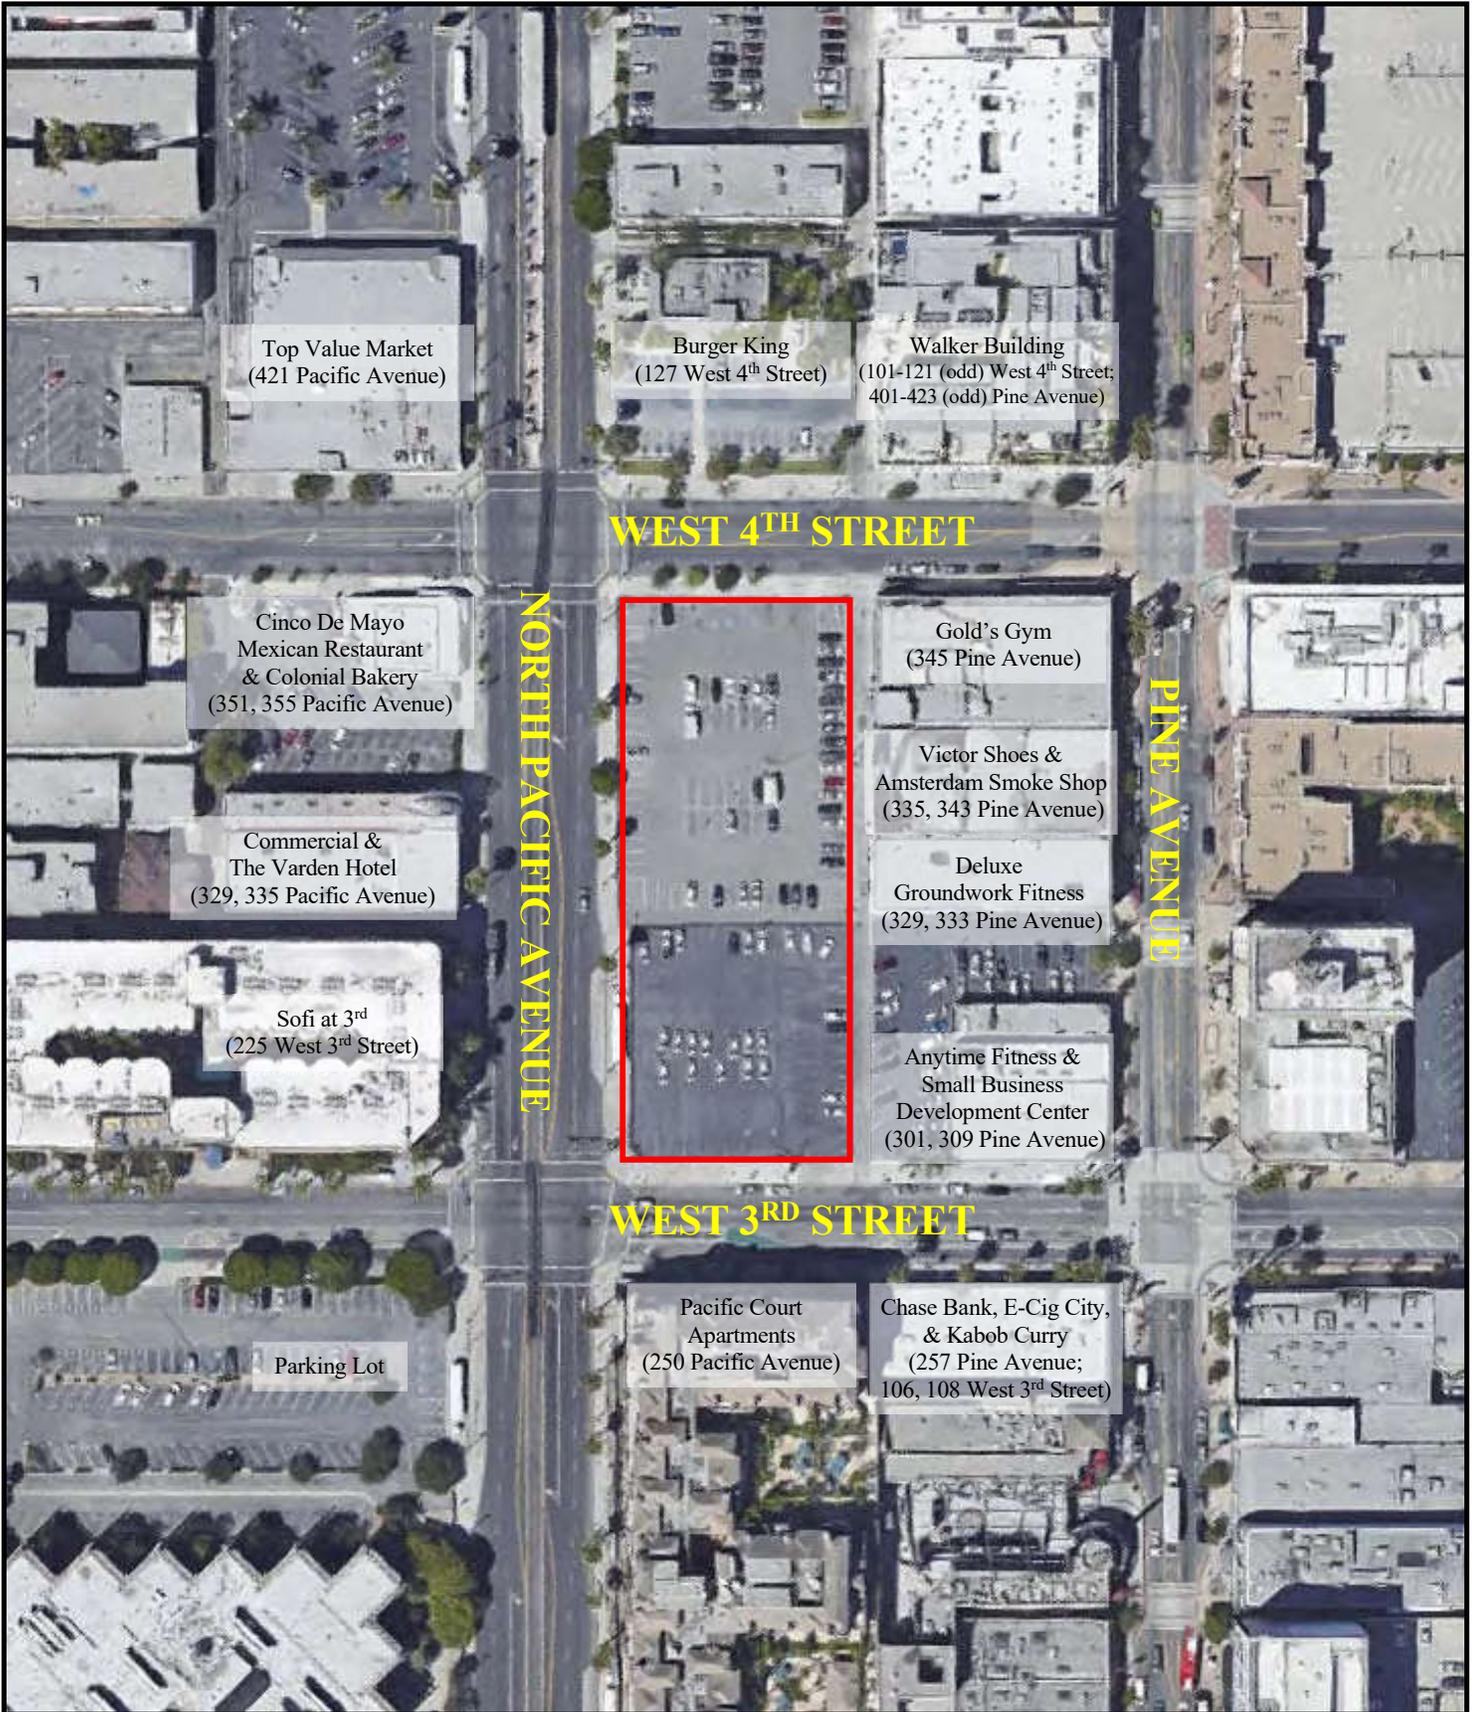
FIGURE 2: SITE PLAN
 Project No. 16-173388.1

GROUNDWATER FLOW

According to topographic map interpretation, the direction of groundwater in the vicinity of the subject property is inferred to flow toward the southwest. The nearest surface water in the vicinity of the subject property is the Pacific Ocean located approximately 0.63 miles and south of the subject property. No settling ponds, lagoons, surface impoundments, wetlands or natural catch basins were observed at the subject property during this assessment.

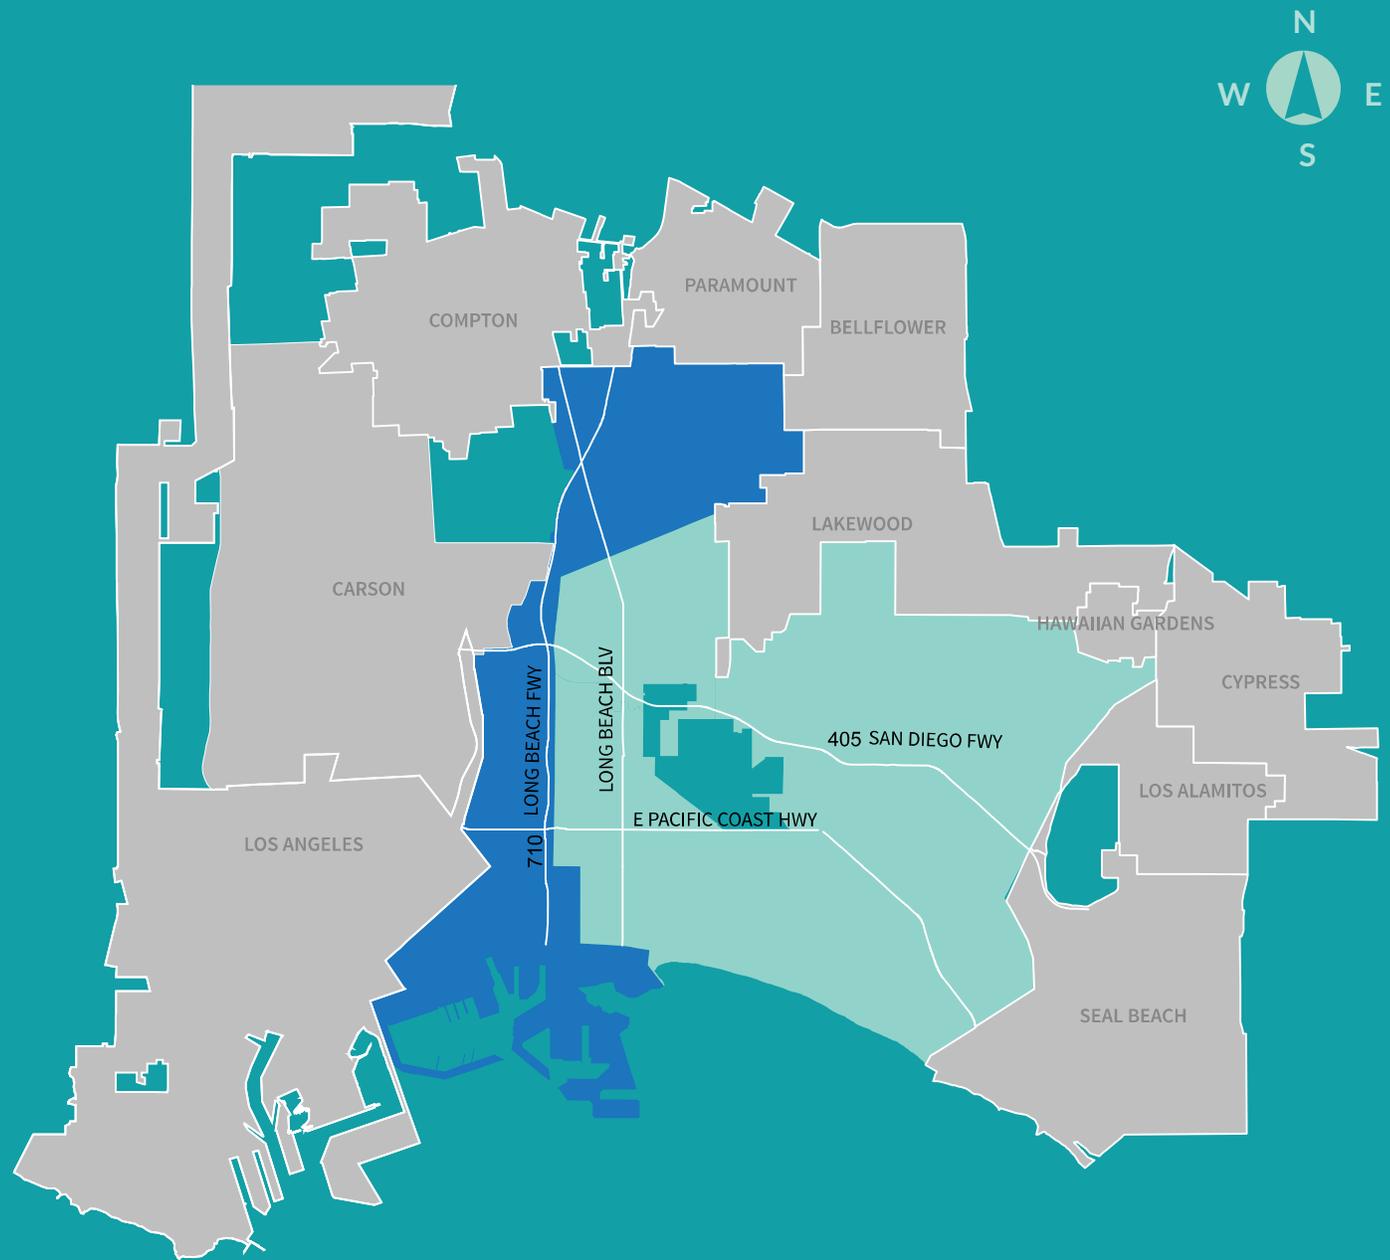
For hydraulic reasons, the Long Beach service area may be divided into two main regions: the MWD

zone, which primarily receives purchased treated surface water, and the blended zone, which may receive a combination of treated groundwater and purchased treated surface water. LBWD sometimes changes the blends of water in our system, and the residents may notice the associated mineral content (hardness) changes to the water quality. Regardless of the area in Long Beach that you work, play or live in, LBWD’s goal is to provide water meeting or surpassing all water quality regulations at the most reasonable cost to our customers. The graph on the next page shows the areas that may be affected by a change in the water blend. ■

Primarily MWD Water

Primarily Groundwater

The groundwater area in the map above may be affected by a change in the water blend.

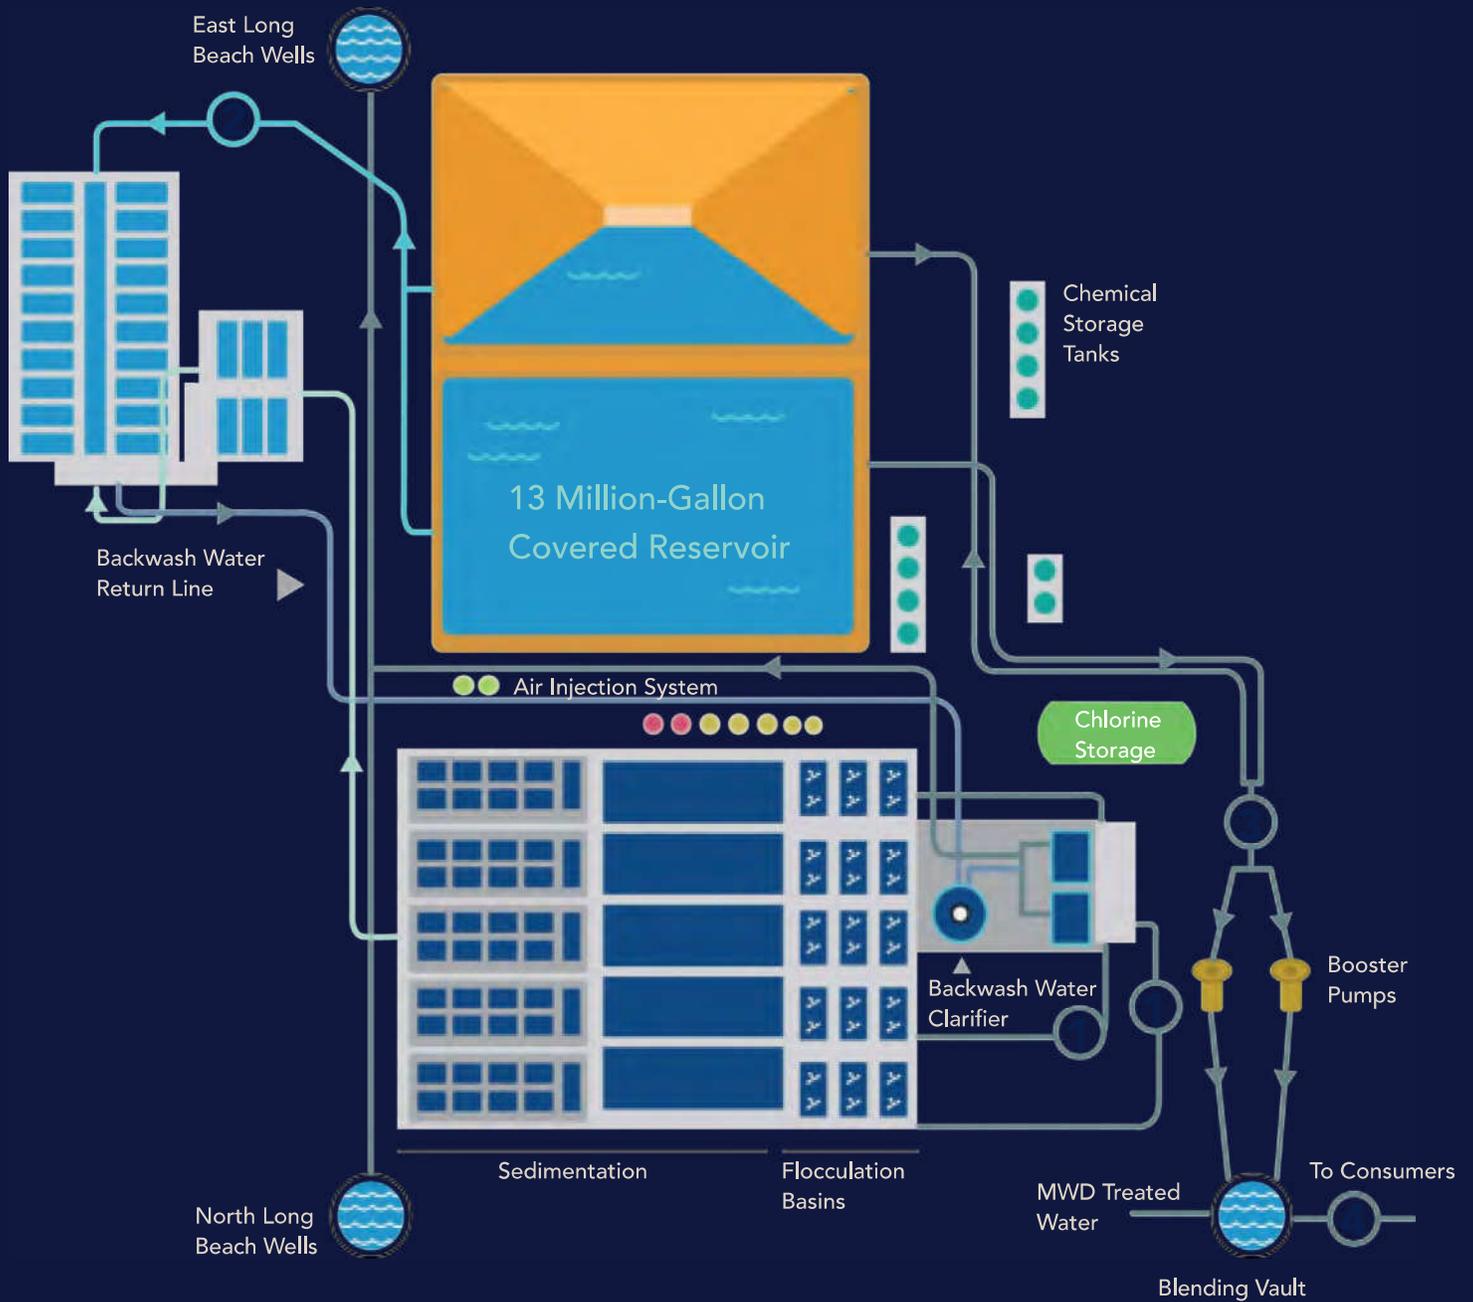
Water Treatment Process

The treatment process consists of a series of steps.

Finally, fluoride (used to prevent tooth decay) is added and the pH is adjusted (to protect distribution system pipes against corrosion) before the water is pumped to drinking water reservoirs, and into your neighborhood, home or business.

1 Ferric Chloride (FeCl_3)
 Polymer (Poly)
 Aluminum Chlorohydrate (ACH)

2 Chlorine (Cl_2)

3 Chlorine (Cl_2)
 Ammonia (NH_3)
 Sodium Hydroxide (NaOH)
 Fluoride (F)

4 Sodium Hydroxide (NaOH)
 Fluoride (F)

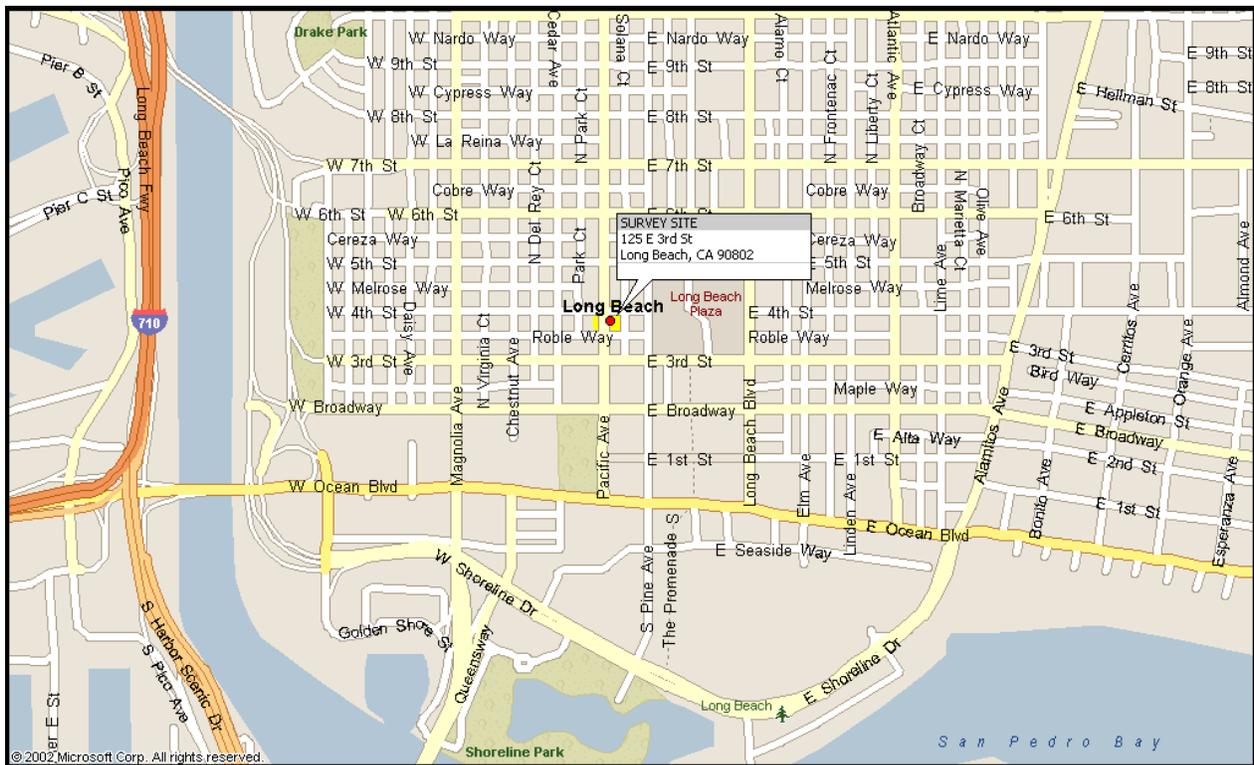
FIGURE 1. Site location map.

Survey Design – The parking lot was reported to be the location of a former gas station. A possible focus area for a service station was provided by the client and was suggested to be in the northwest corner of the lot, although all portions of the subject property was searched for any unusual subsurface feature. The four proposed boreholes were eventually placed within or adjacent to several unusual anomalies of interest.
