Memorandum

Subject: **Update on Queen Mary Lease Management - REVISED**

CRITICAL STRUCTURAL REPAIRS STRUCTURAL ANALYSIS: STRESS RESULTS & TANK TOP REPAIR

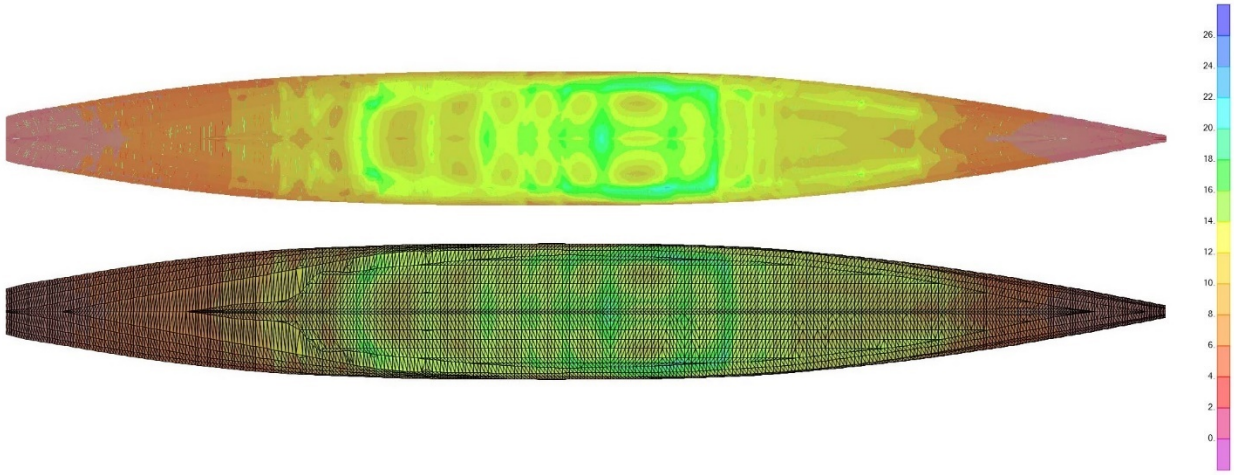
Over the length of the ship, there are no interior hull elements exceeding the allowable stress of 26.1 ksi (see Figure 3). The heat map of the entire inner hulls shows that the higher stress concentrations are generally in the middle of the ship. This is a reasonable result since the deflected shape of the ship is hogging 14 inches.

Figure 29. Heat map of the von Mises stresses on the entire interior hull (values in the legend are in ksi) [plan view]

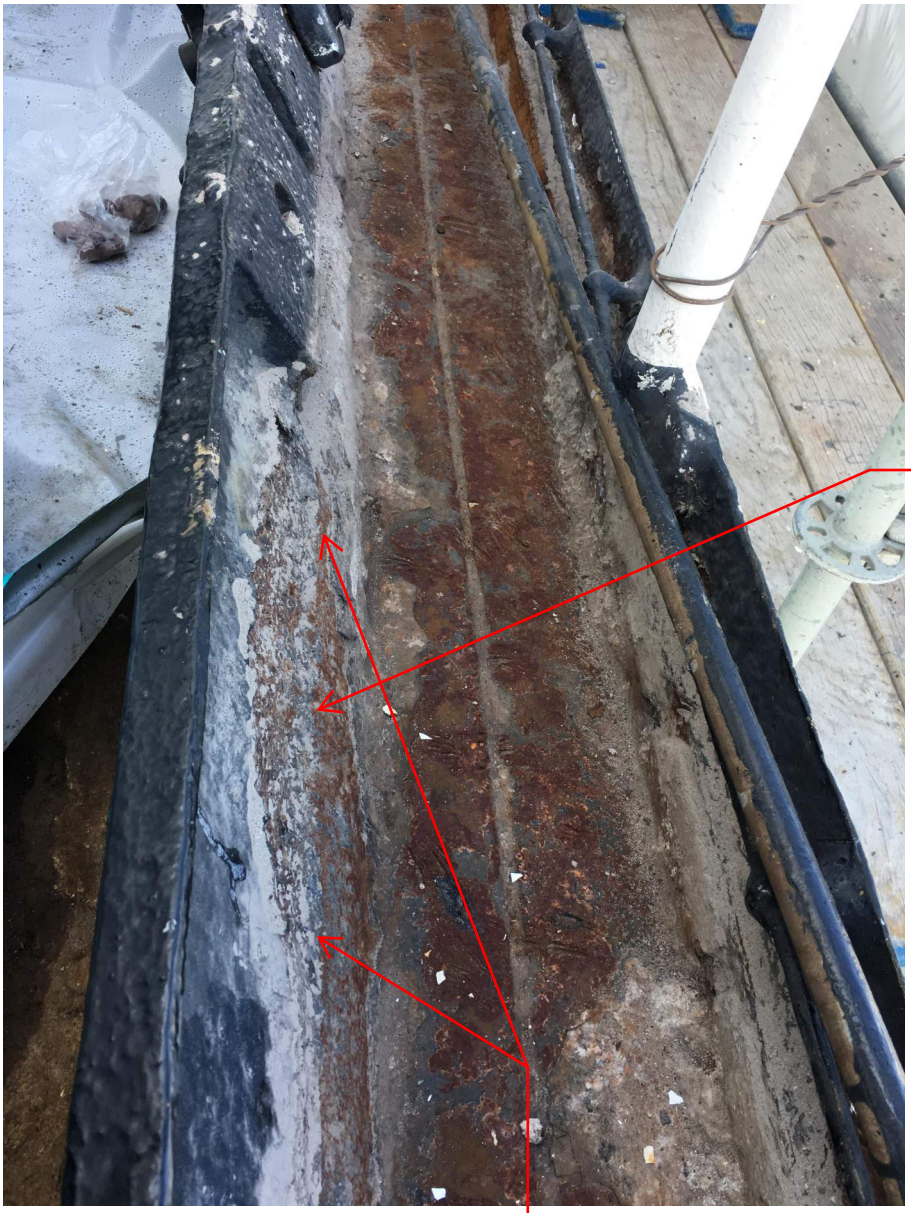
Photo 1 - Existing continuous bent plate corrosion

On the port side, the steel plate had several areas where it had rusted completely through. (Only the thinner plate, not the thick gusseted portions where the clevis attached).

The primary concern is this plates integrity and the integrity of the plate's connection to the ship.

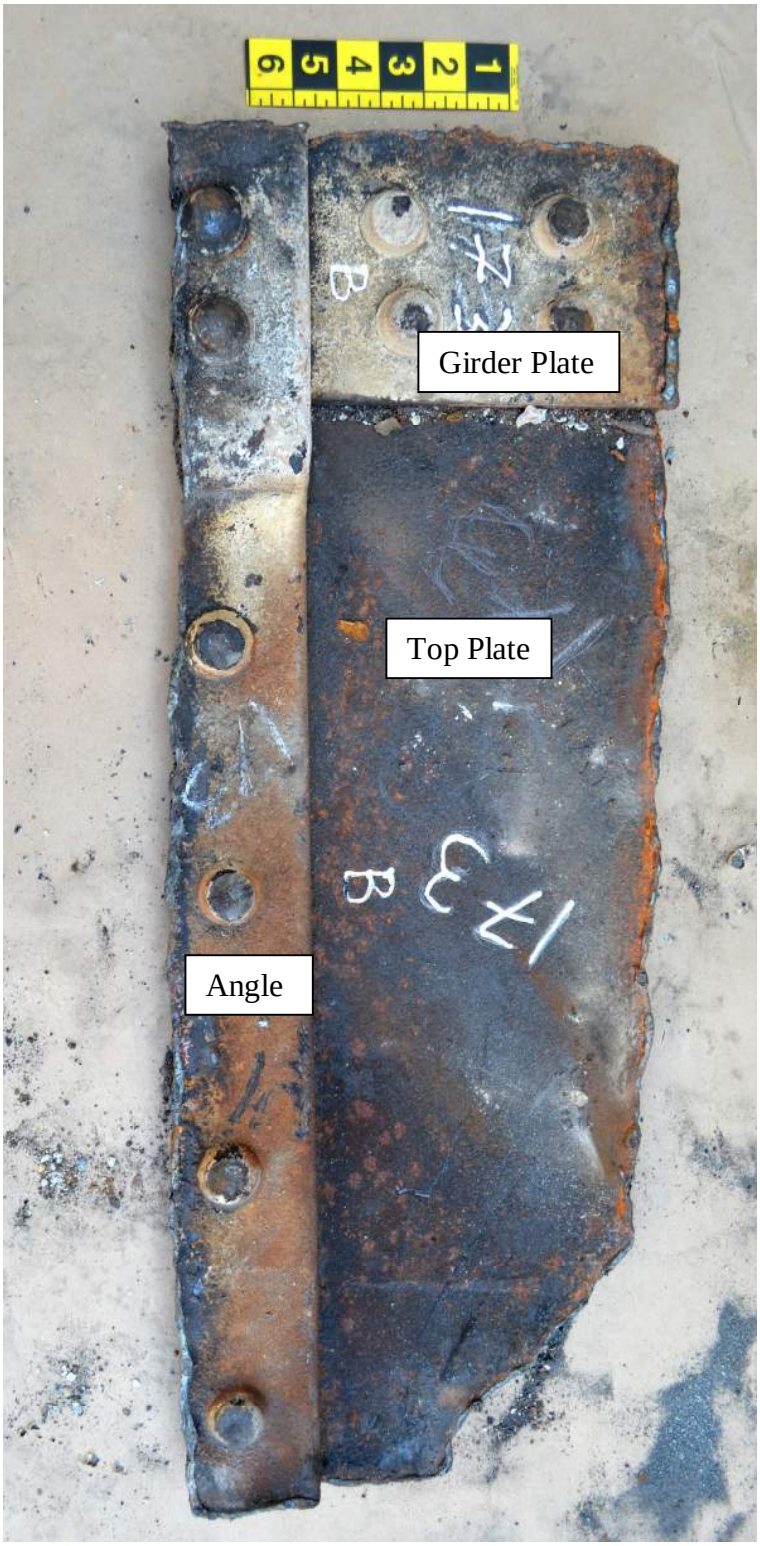
173 B

Right-Hand View Of Above

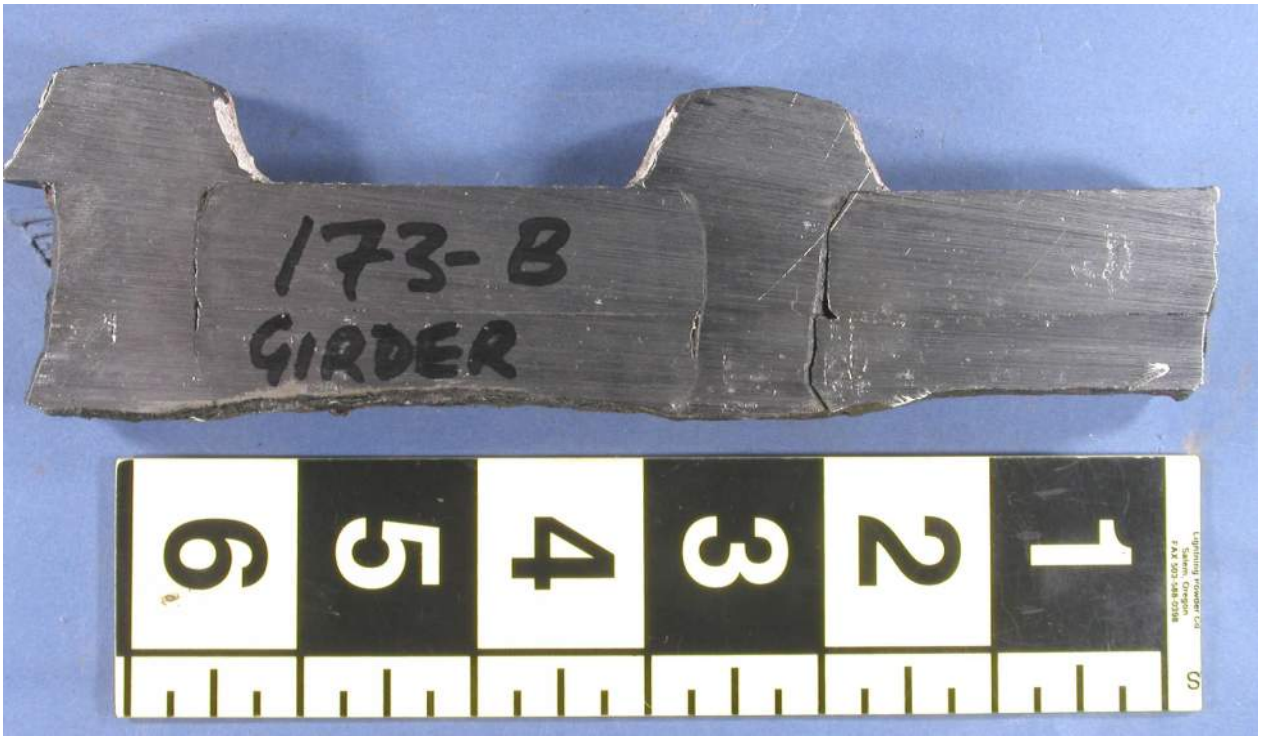
Rivets From Girder Of Section 173 - B
