Subject: **Update on Queen Mary Lease Management & Information Request**

CRITICAL STRUCTURAL REPAIRS STRUCTURAL ANALYSIS: STRESS RESULTS & TANK TOP REPAIR

QUEEN MARY LONG BEACH, CALIFORNIA

Queen Mary Aft Mast Repair Structural Narrative

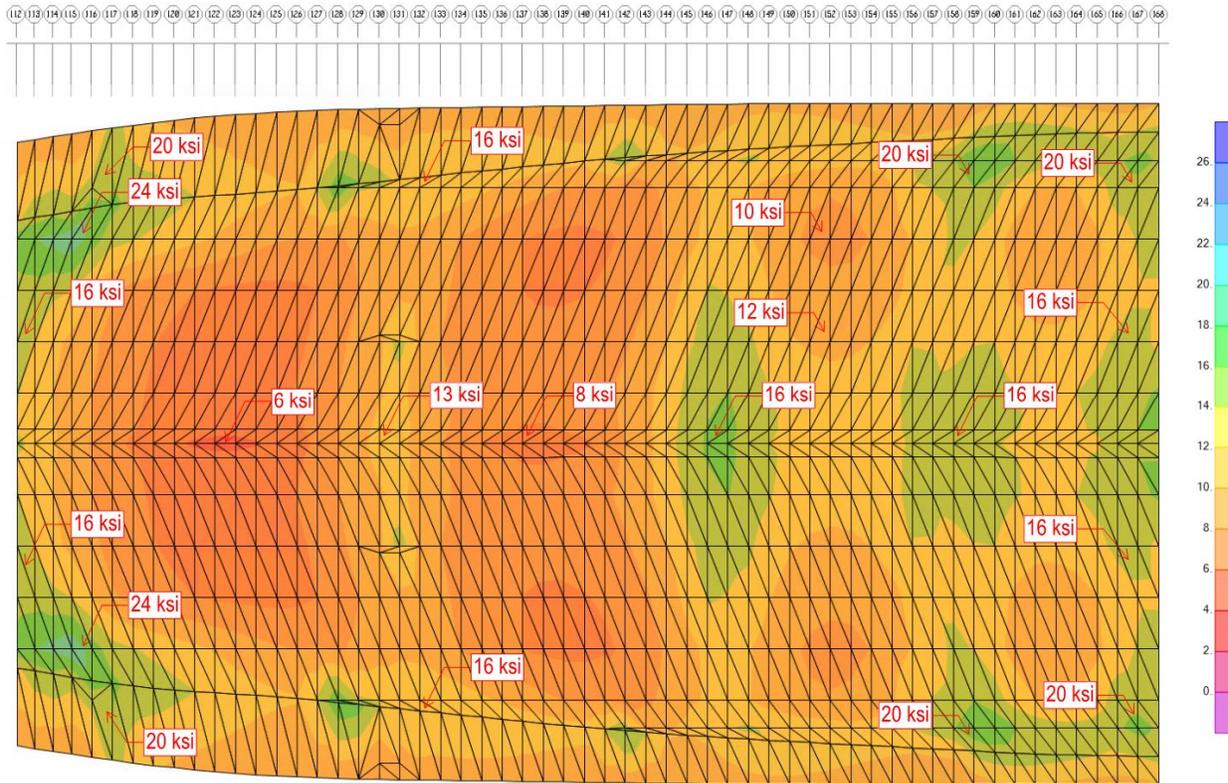
Per existing 1930's drawings, the interior hull tank top plate thickness in the exhibition area varies anywhere from 0.42 to 0.8 inches. The thinnest most common plate thickness was 0.67 inches. To address for possible corrosion, we created an additional FEA model that conservatively uses a reduced plate thickness of 0.25 inches for the entire inner hull. We enveloped our analysis by checking stresses for both inner hull thicknesses. Plate reduction from the thinnest most common plate thickness of 0.67 inches to 0.25 inches increased the von Mises stresses an average of 35%. The highest von Mises stress demand for the interior hull is 23.8 ksi (elements 40556 and 37375; see Table 2, column 13), which is below the allowable stress capacity of 26.1 ksi. Most of the stresses on the inner hull plates are well below this with the average being around 10-12 ksi. See the stress heat maps shown in Figures 1 and 2 below.

Figure 27. Heat map of the von Mises stresses in the interior hull in the exhibition area (values in the legend are in ksi) [plan view]

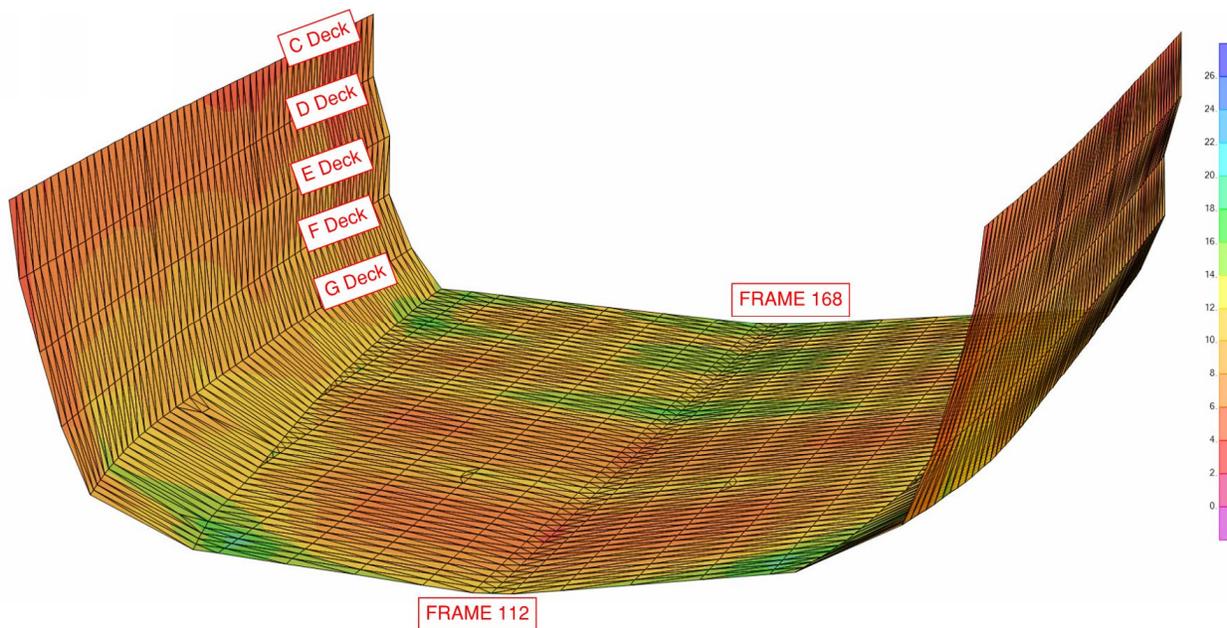
Figure 28. Heat map of the von Mises stresses in the interior hull in the exhibition area (values in the legend are in ksi) [3D view]

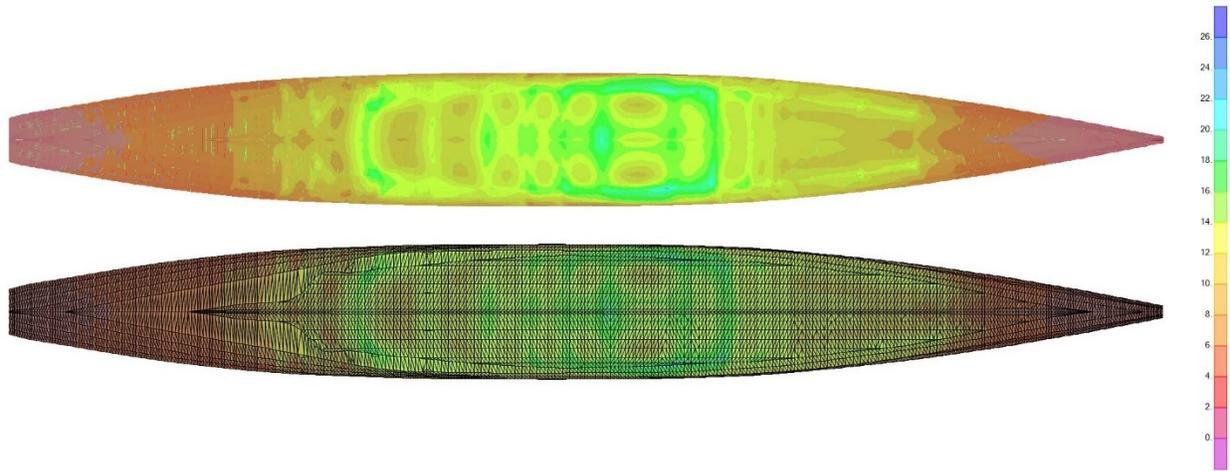
Over the length of the ship, there are no interior hull elements exceeding the allowable stress of 26.1 ksi (see Figure 3). The heat map of the entire inner hulls shows that the higher stress concentrations are generally in the middle of the ship. This is a reasonable result since the deflected shape of the ship is hogging 14 inches.

**Figure 29. Heat map of the von Mises stresses on the entire interior hull
(values in the legend are in ksi)
[plan view]**

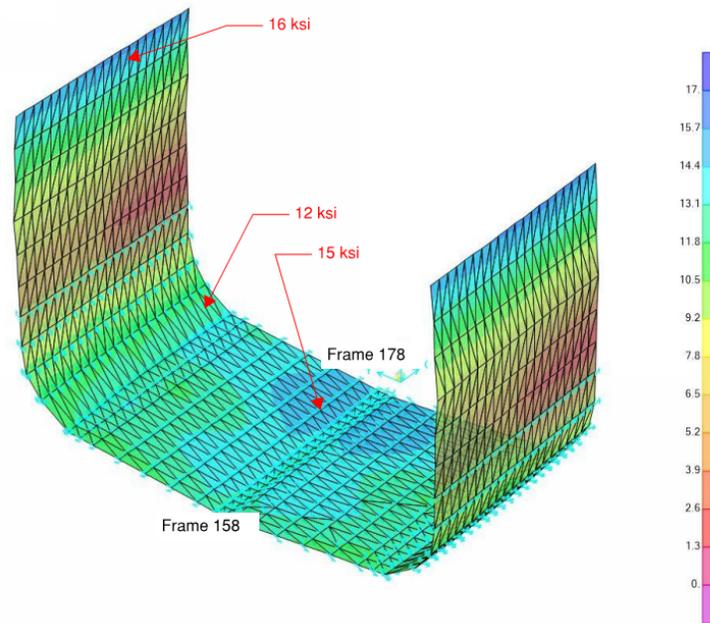
SAP Model v.57
Exterior Hull von Mises Stresses
Vessel with existing weights

Figure 33. Von Mises stresses in the exterior hull of the original model [Max stress = 15 ksi].

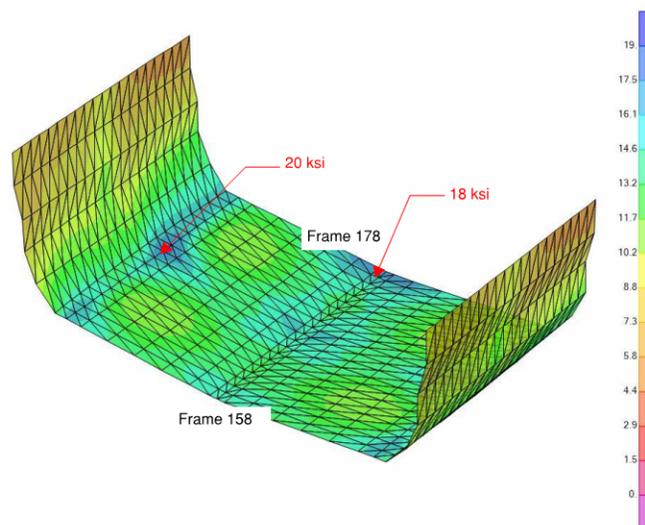
SAP Model v.57
Interior Hull von Mises Stresses
Vessel with existing weights

Figure 34. Von Mises stresses in the interior hull of the original model [Max stress = 20 ksi].

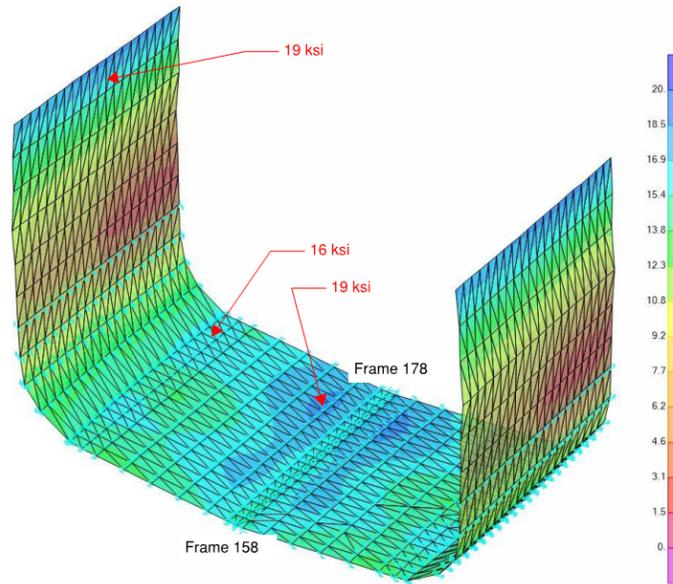
SAP Model v.57
 Exterior Hull von Mises Stresses
 20ft of water behind bulkhead 112

If bulkhead 112 were sealed and water could accumulate up to a height of 20 ft., based on the FEA model it is estimated that the AP segment of the vessel would be submerged by an additional 11 ft., which means the vessel could potentially hit the bottom of the lagoon. Based on the FEA model, the stresses on the exterior hull would increase by 19%, and by 25% on the interior hull. The stress increase on the interior hull would exceed the allowable material strength limits. Due to the uneven loading conditions created by adding 20 ft. of water behind bulkhead 112, a simple beam analogy approach is no longer valid for this scenario. Therefore, the conclusions drawn for the second scenario are based on the FEA model, and cannot be corroborated by a simple beam analogy.

Figure 35. Von Mises stresses in the exterior hull of the model with 20 ft of water behind bulkhead 112 [Max stress = 19 ksi].

The calculations and subsequent recommendation to allow flooding through the bulkhead at frame 112 in the event of flooding aft of frame 112, produces a condition that is more favourable than if the bulkhead was to be intact, for this vessel in its current stationary location. This condition of "Cross-flooding" is an established aspect of ship design to reduce stresses and minimize the list and trim of a vessel during flooding.

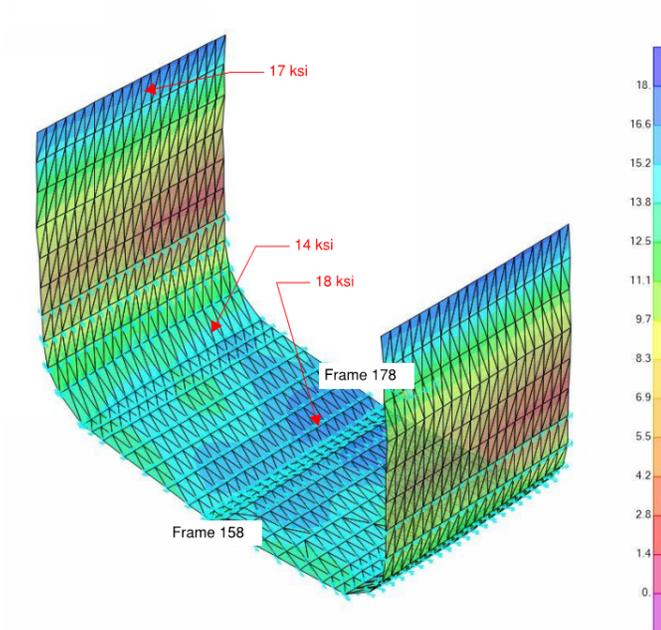
SAP Model v.57
 Exterior Hull von Mises Stresses
 4.8 ft of uniform water above top tank

Figure 37. Von Mises stresses in the exterior hull of the model with uniform water [Max stress = 18 ksi].

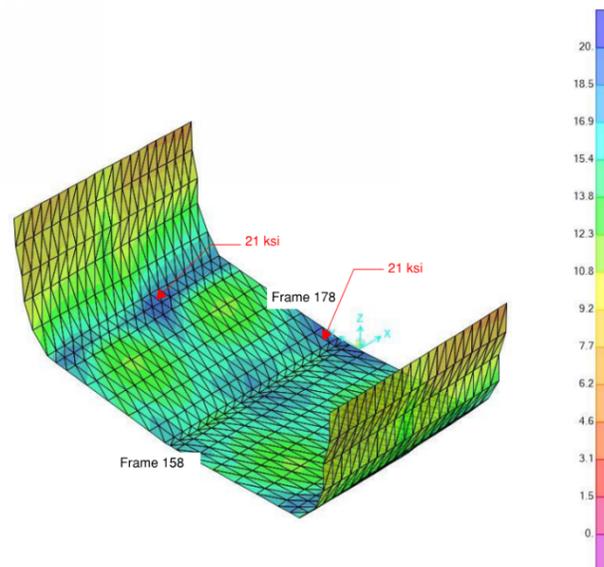
SAP Model v.57
 Interior Hull von Mises Stresses
 4.8 ft of uniform water above top tank

Figure 38. Von Mises stresses in the interior hull of the model with uniform water [Max stress = 21 ksi].

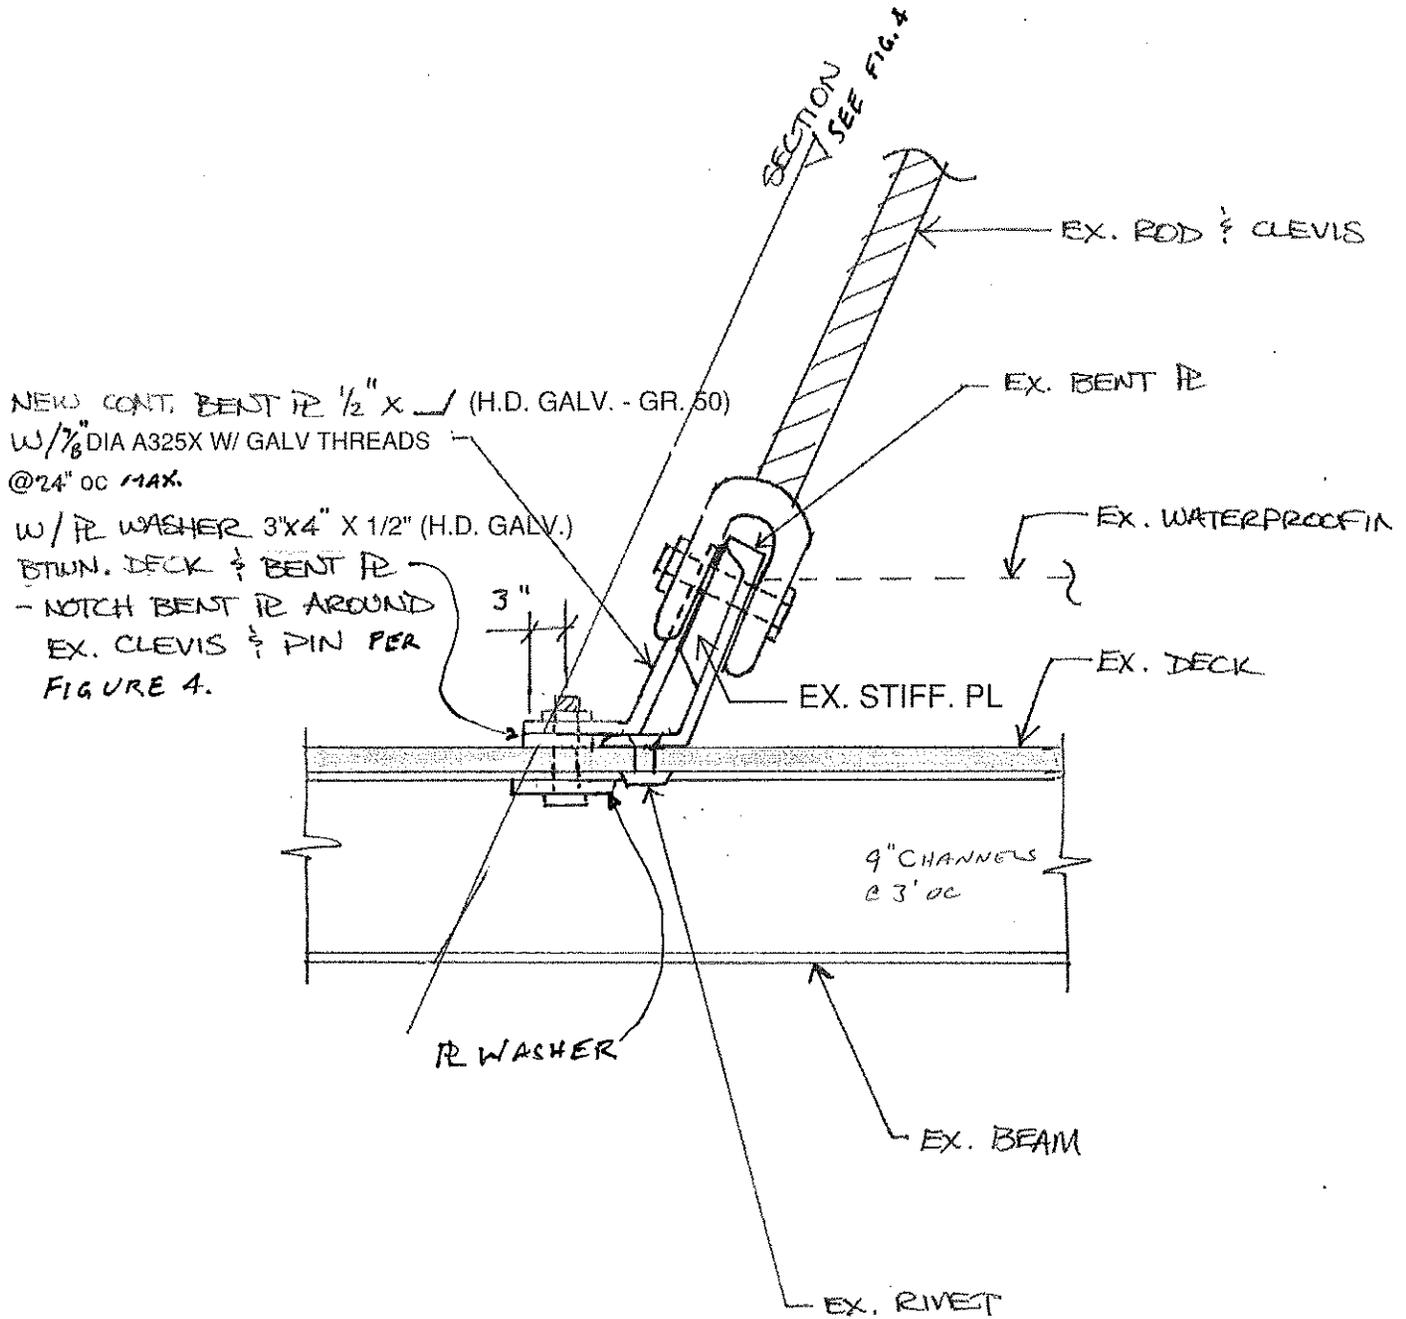
Architect _____ Sheet _____ of _____
 Project QUEEN MARY Job No. 17057
AFT Mast ANCHORAGE Date _____
REPAIR CORRODED PLATE Engineer BSJ

Based on our structural observations subsequent to those by SGH and after exposed areas were re-waterproofed, little damage was visible, thus our assumption is only the anchorage plates are damaged, and the deck and supporting beams below the anchorage plates are structurally sound and sufficient to resist cable loads. Photos by SGH show corrosion damage to the base of existing anchorage plates near the deck surface (Photos 1 through 7, attached). This damage reduces the ability of the plate to transfer cable loads to rolled structural steel deck beams below.

Assuming the plate damage is significant, a reinforcing bent plate has been designed to transfer the load of a single cable to two beams below the deck surface. New plates used to reinforce the damaged plate are designed to span the load from existing cables to the beams below. Existing details showing the attachment of cables to the deck are shown in Figure 2. As the original design loads are not known (loading was likely based on unknown sailing conditions), cables are assumed to carry loads equal to the root area at the threads multiplied by the cable yield stress. This is a conservative assumption that is safe and relatively easy to apply, but not too egregious. This plate will be notched around the existing cable clevis and designed to span between existing beams below the deck surface. To engage the plate with existing framing, the plate will be welded above the deck to the damaged plate, and it will be bolted through the new bent plate into existing beams supporting the deck (See Figures 3 and 4). Bolts are called out as twist-off bolts, installed from below the deck and requiring access only from the top to tighten, and will be galvanized to delay any possible future corrosion and the entire connection will be waterproofed again.

WELD (W) PLATE TO EX. BENT PLATE $\frac{5}{16}$ " FILLET 2" @ 12" OK BY INSPECTION

NOTE: REMOVE ALL PAINT AND CORROSION FROM EXISTING PLATE AND NEW BENT PLATE, EOR TO REVEIW EXISTING CONDITION OF EXISTING BENT PLATE AND BASE SUPPORT CONDITION PRIOR TO INSTALLING NEW BENT PLATE
