NAPLES SEAWALL STABILITY INVESTIGATION AND REPAIR RECOMMENDATIONS

LONG BEACH, CALIFORNIA

City of L. B. Project No. PW8110-14

FINAL REPORT Submitted: February 25, 2009
Approved by City: April, 2009

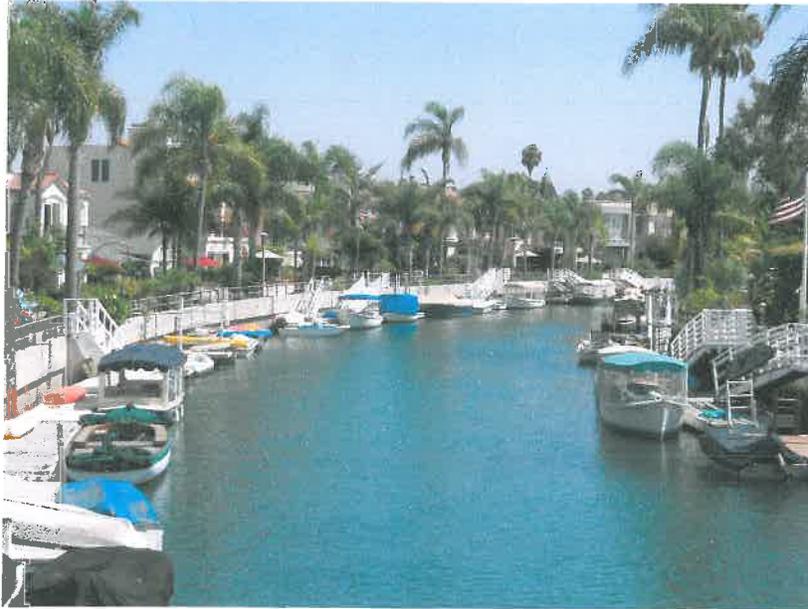
Photo 1 – Naples. Canal between Naples Island and Landside Segments. Taken from Ravenna Bridge looking southeast

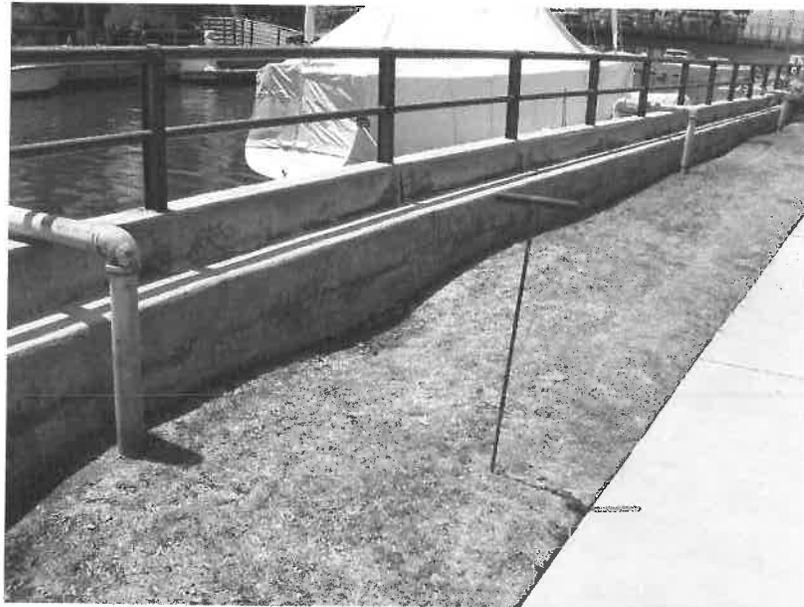
**Photo 2 – 1, Naples, Top Deck Survey: Naples Island, #15
Colonnade Canal. Typical grass sink hole. Probe used to test for soft soil.**

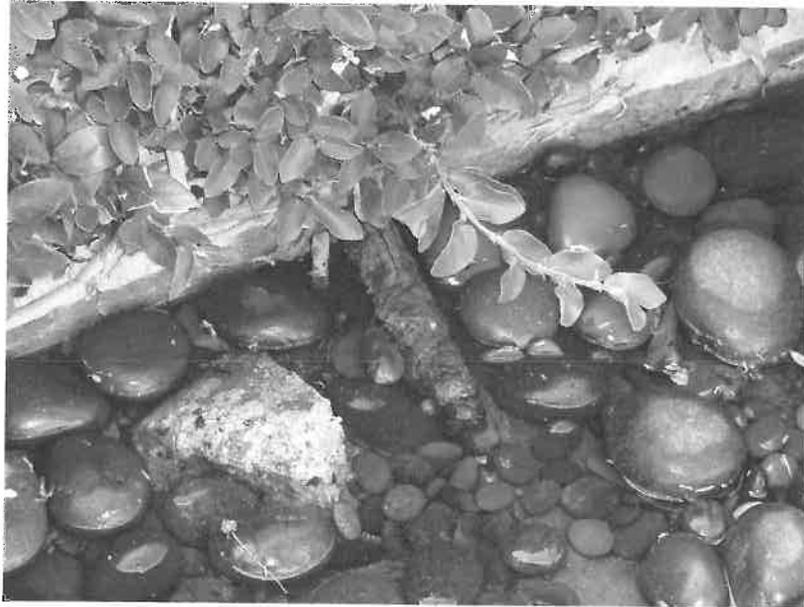
Photo 2 – 5, Naples, Top Deck Survey: Vista Del Golfo, #15
Tie rod protruding above ground.

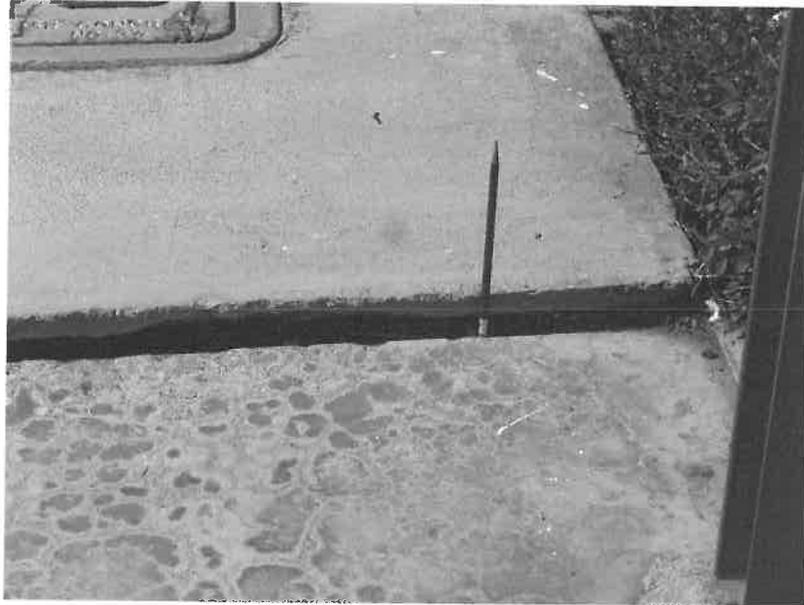
Photo 2 – 23, Naples, Top Deck Survey: Plaza Park
Vertical offset in sidewalk.

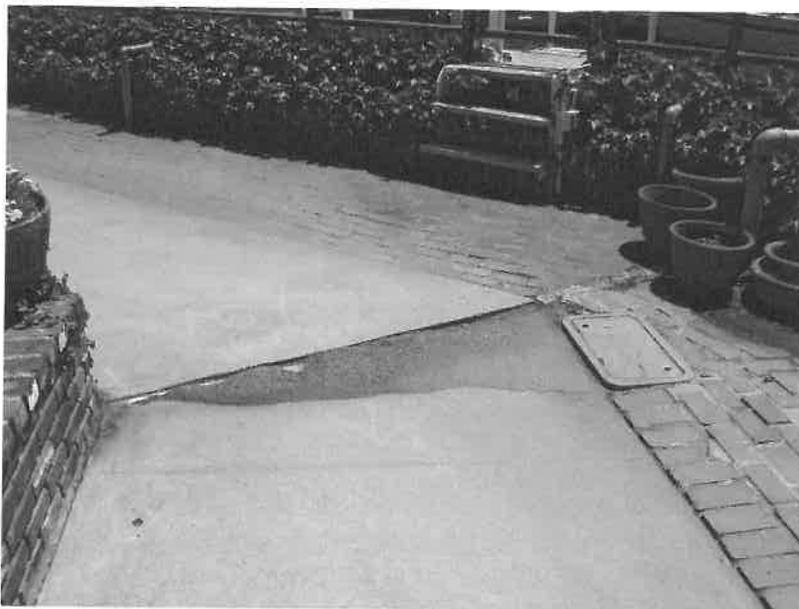
Photo 2 – 24, Naples, Top Deck Survey: Naples Canal, #5607
Sidewalk patching.

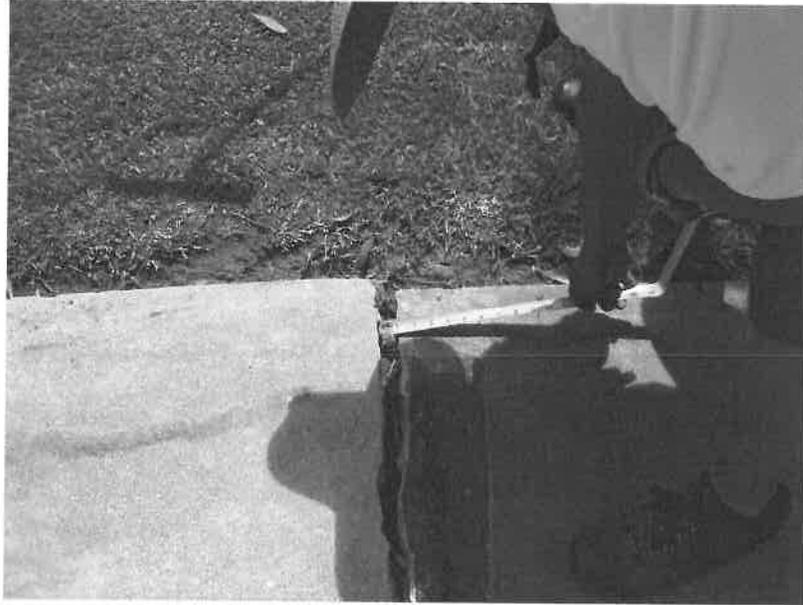
Photo 2 – 25, Naples, Top Deck Survey: Corso Di Napoli, #5679
Horizontal gaps in sidewalk. Note previous patching efforts.

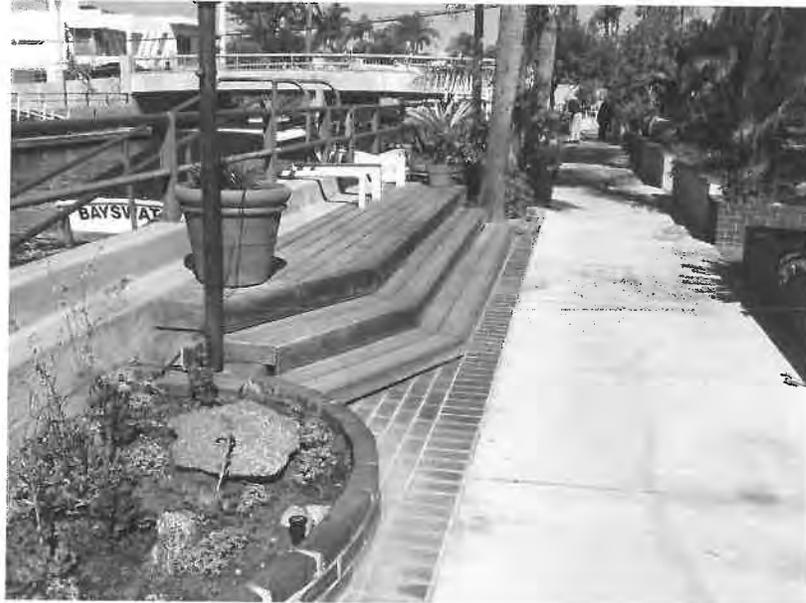
Photo 2 – 27, Naples, Top Deck Survey: Rivo Alto Canal, #86
Example of raised wood deck & planter.

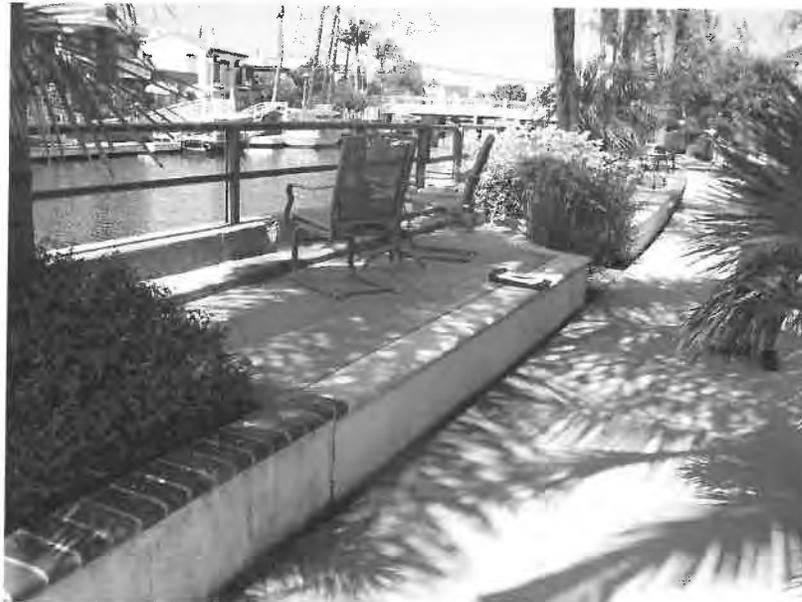
Photo 2 – 28, Naples, Top Deck Survey: Rivo Alto Canal, #115
Example of typical raised planter and decks with hard finishes.

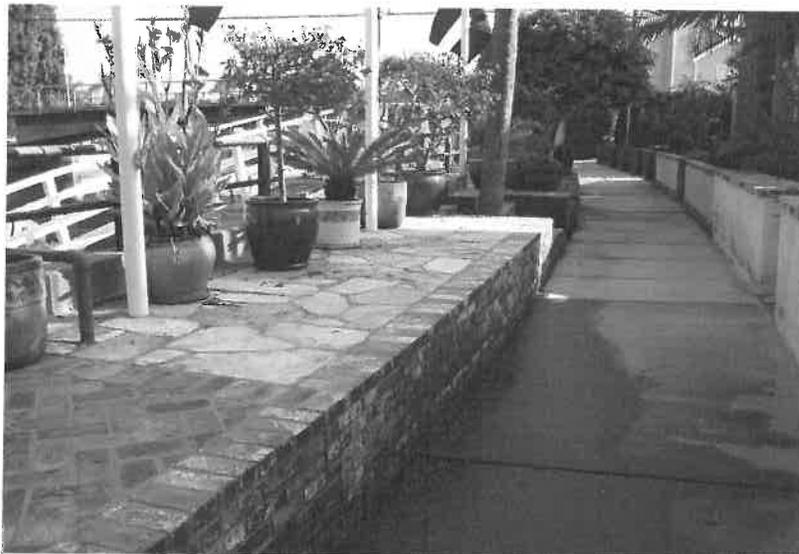
Photo 2 – 30, Naples, Top Deck Survey: Rivo Alto Canal, #171
Example of raised deck with stone finish.

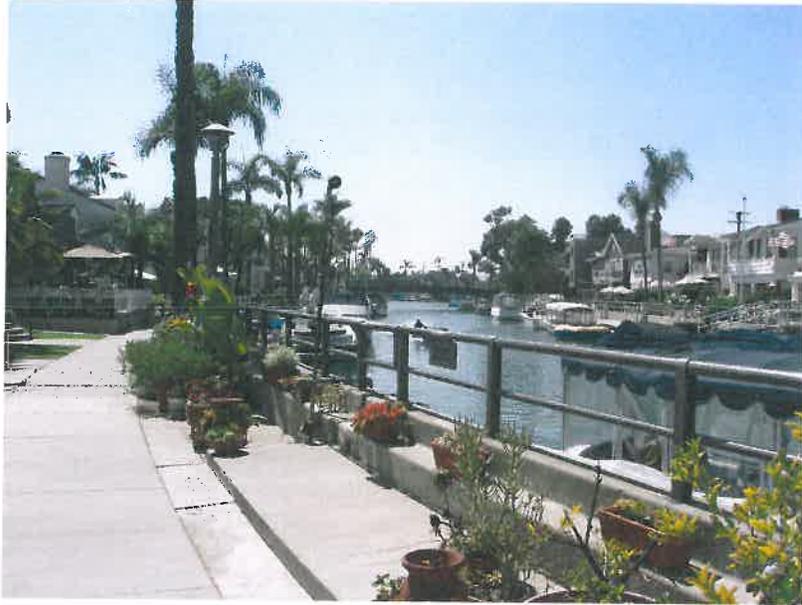
Photo 2 – 31, Naples, Top Deck Survey: Rivo Alto Canal, #183
Example of typical top deck planting area & sidewalk.

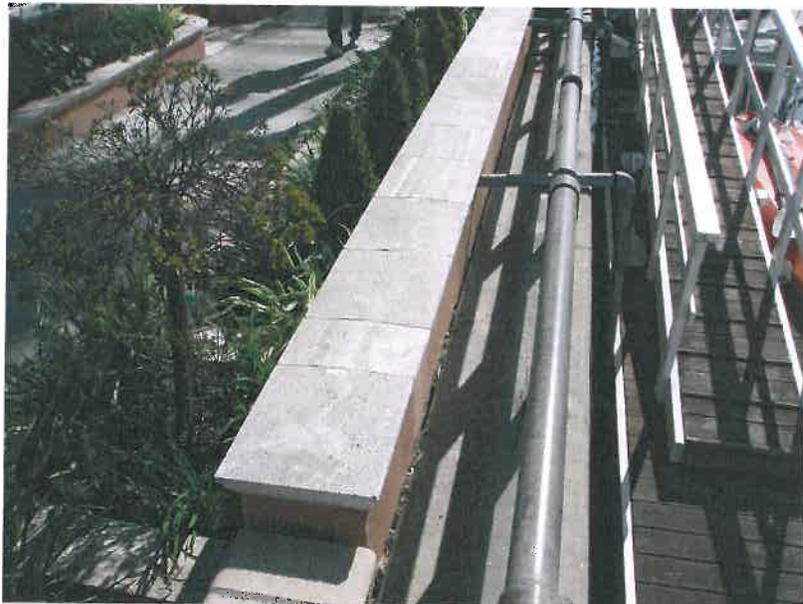
Photo 2 – 32, Naples, Top Deck Survey: Corso Di Napoli, #5655
Example of concrete wall in planter, adjacent to seawall.

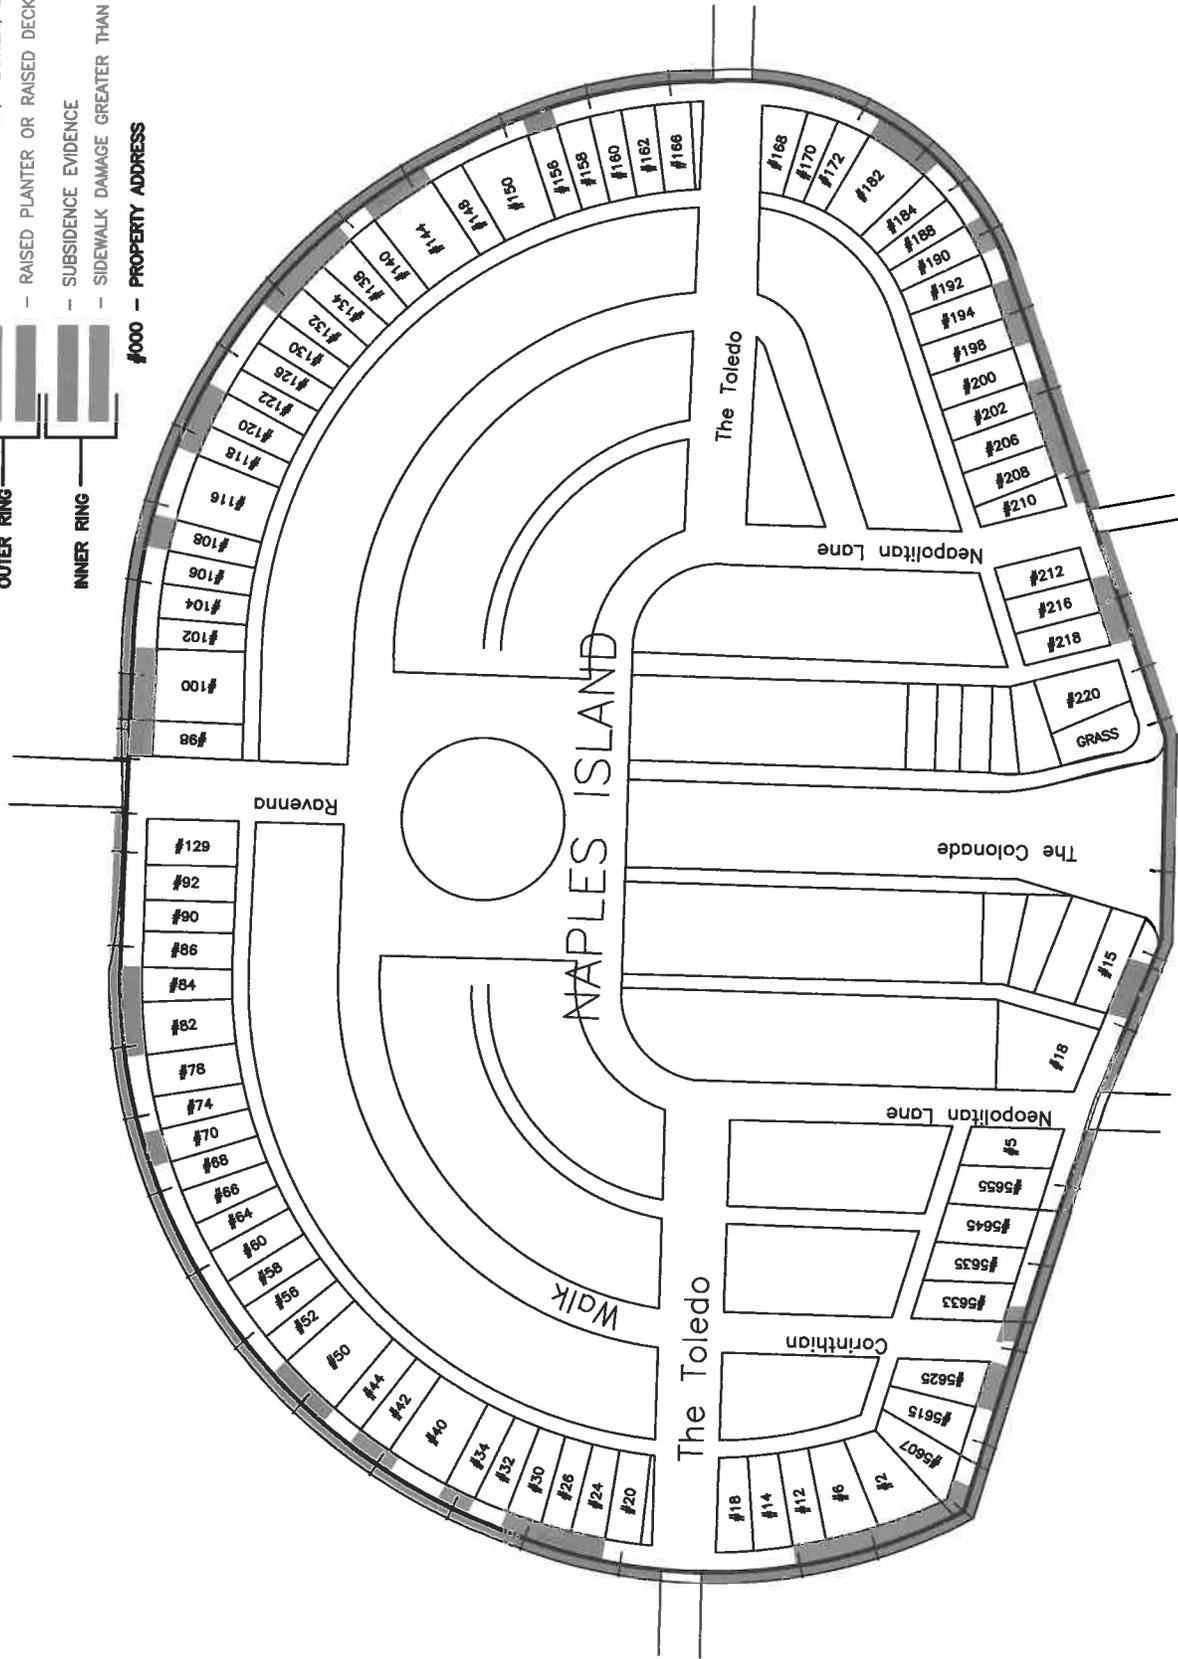
**FIGURE 2-1 NAPLES ISLAND
SIDEWALK & PLANTER
KEY PLAN**

Figure 2-1 (Naples Island), Figures 2-4a, b, c, d, e & f for (Landside) and Figure 2-7 for (Treasure Island) indicate the approximate extent which Raised Planters and solid Raised Decks occur throughout the Naples community. Raised decks & planters which match or exceed the height of the seawall cap create a "surcharge load" on the seawall which is estimated to increase the forces on the seawall system 11% to 14%, (see Section 7.3 of the Seawall Stability Analysis). Large trees can further increase this "surcharge load" in direct proportion to their weight. For this reason the City has created a set of Seawall Guidelines for waterside residents, (see page 1-11).

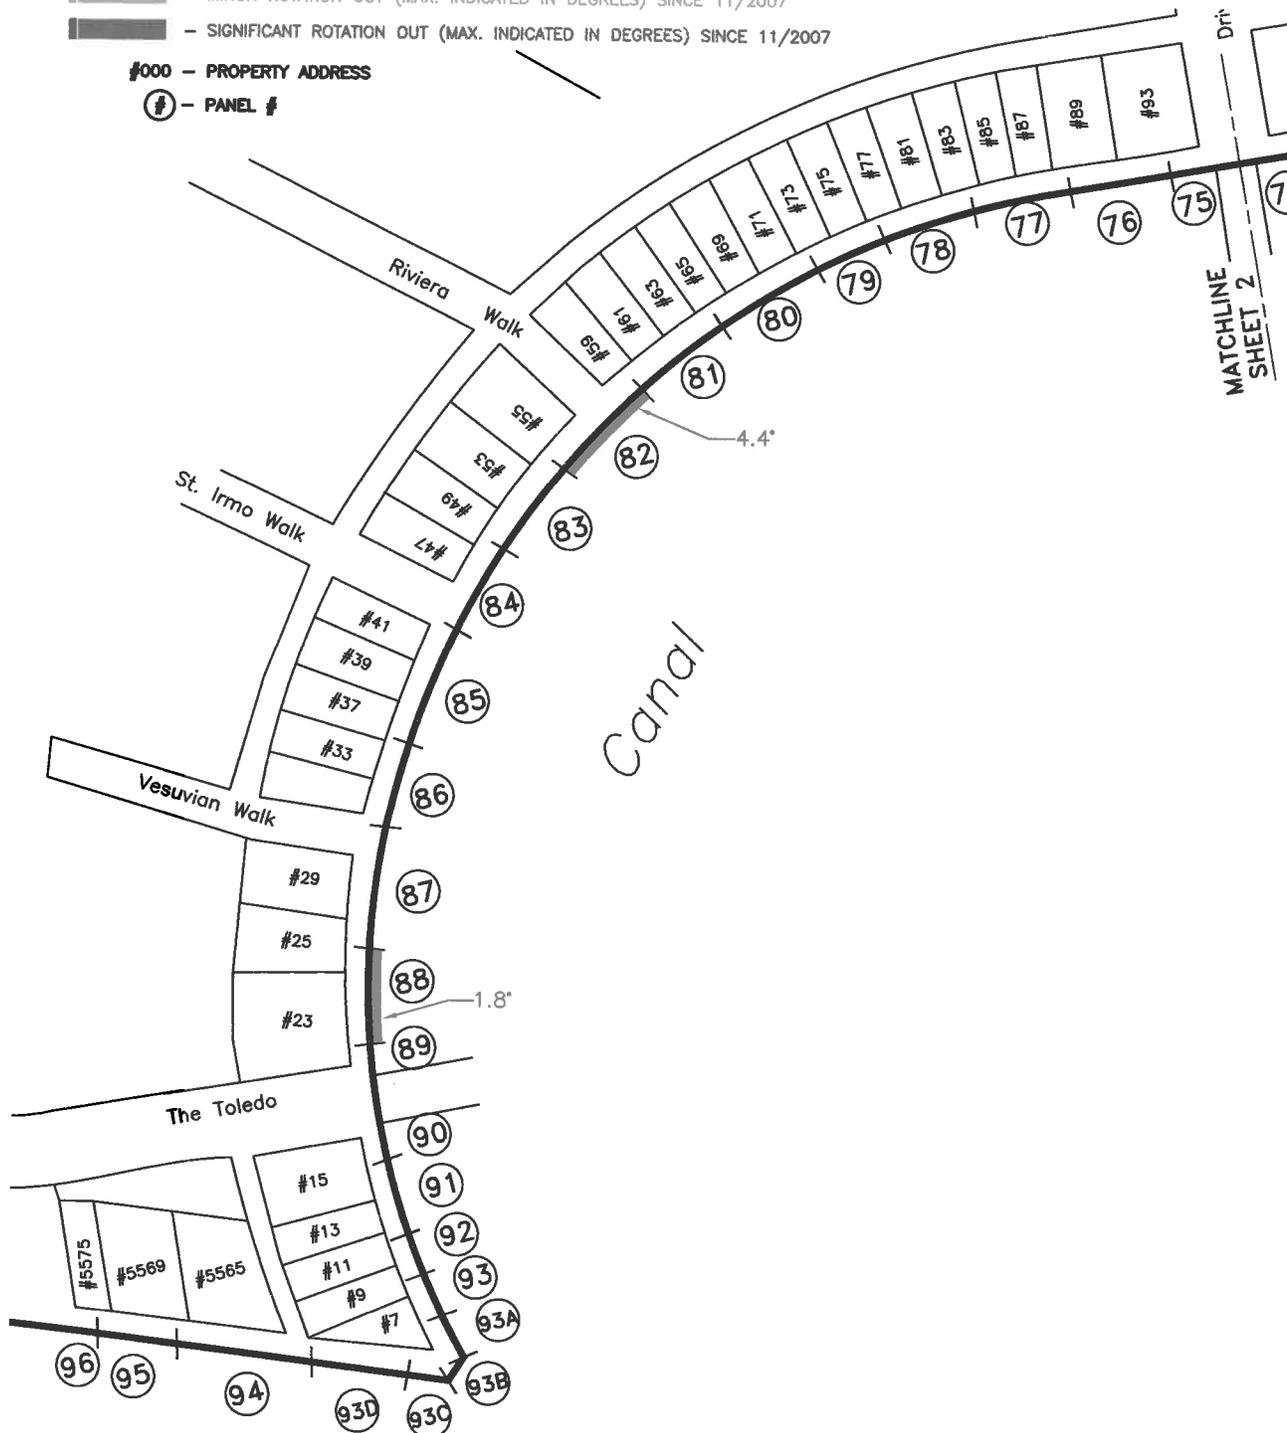
FIGURE 3-3a RESULTS OF WALL ROTATION ANALYSIS FROM SURVEY OF GUARDRAIL POSTS NAPLES LANDSIDE

Landside: 1.8 degrees or less “In” minor rotation at panel 88, (see Figure 3-3a on page 3-9). “In” movement does not concern tie-rods. Our dive team saw no evidence that any sheets have significant soil loss to allowing movement. It is considered safe to dismiss this finding since contradicted by other data.

Landside: 4.4 degrees or less “In” significant rotation at panel 82, (see Figure 3-3a on page 3-9). “In” movement does not concern tie-rods. Our dive team saw no evidence that any sheets have significant soil loss to allow movement. The next adjacent rail had only moved 0.7 degrees. It is considered safe to dismiss this finding since contradicted by other data. The rail may have been struck or we measured a different rail than in past.

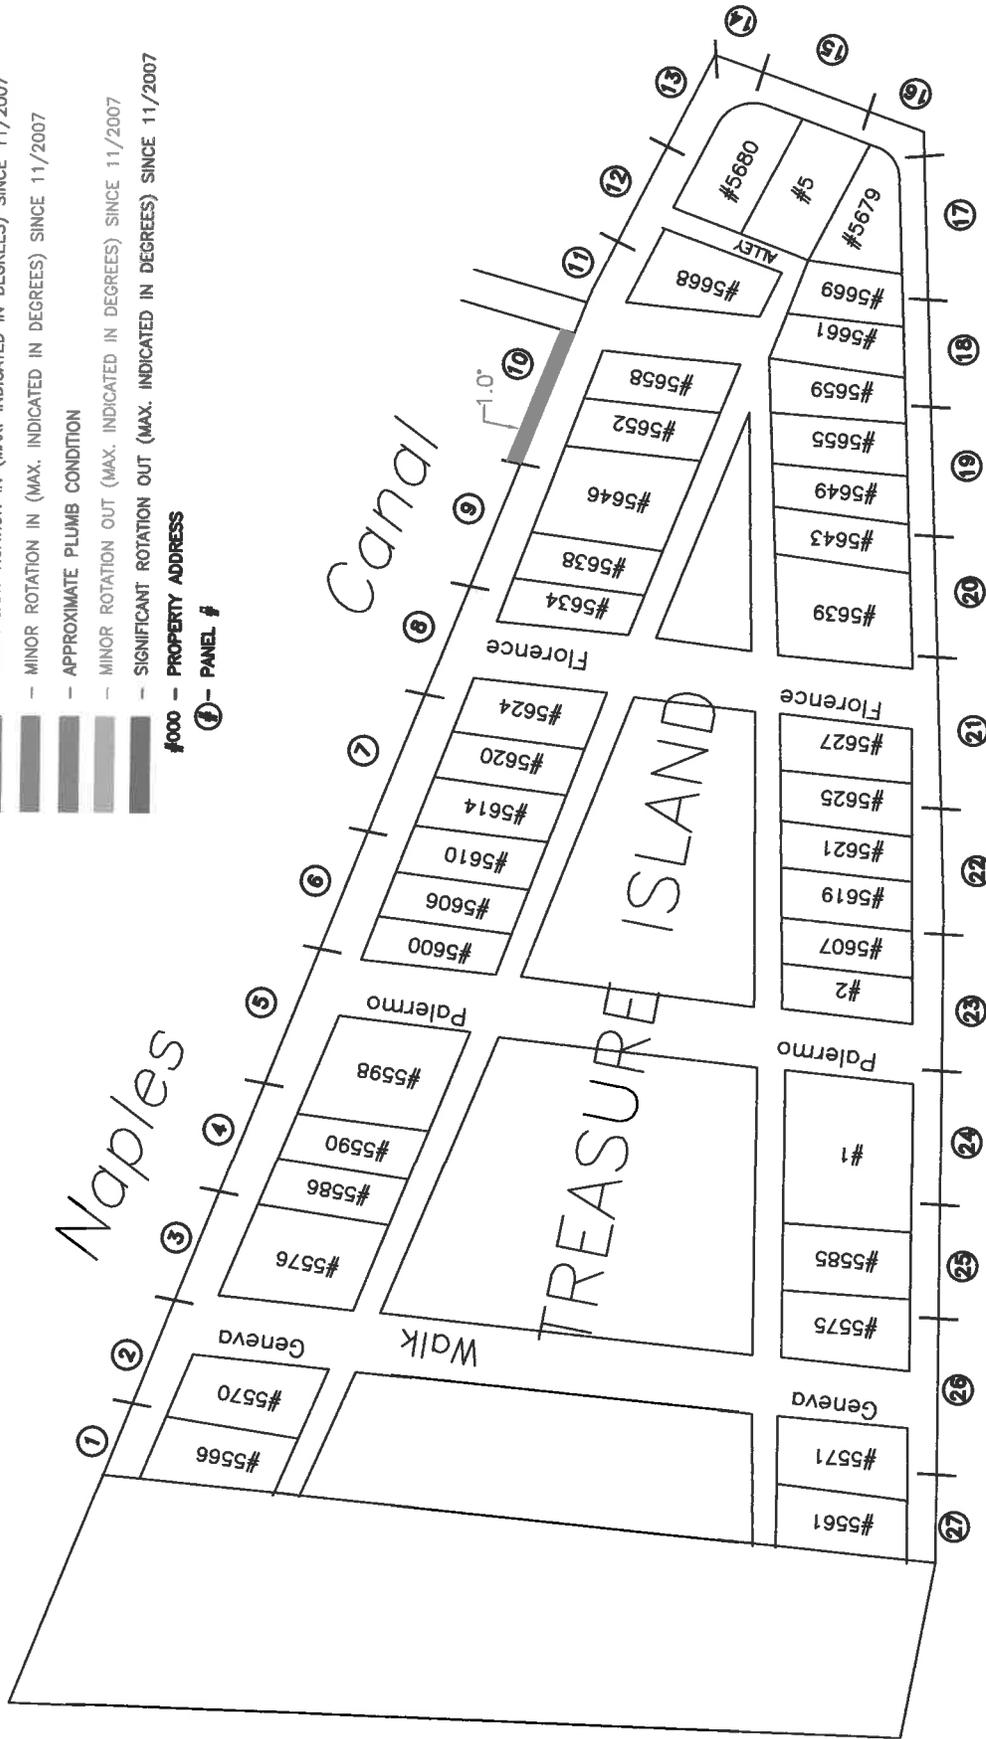
**FIGURE 3-5 NAPLES - TREASURE ISLAND
RESULTS OF WALL ROTATION ANALYSIS
FROM SURVEY OF GUARDRAIL POSTS**
SURVEY DATE 4/2008

Treasure Island: 1.0 degree or less “In” minor rotation at panel 10, (see Figure 3-5 on page 3-25). “In” movement does not concern tie-rods. Our dive team saw no evidence that any sheets have significant soil loss to allowing movement. It is considered safe to dismiss this finding since contradicted by other data.

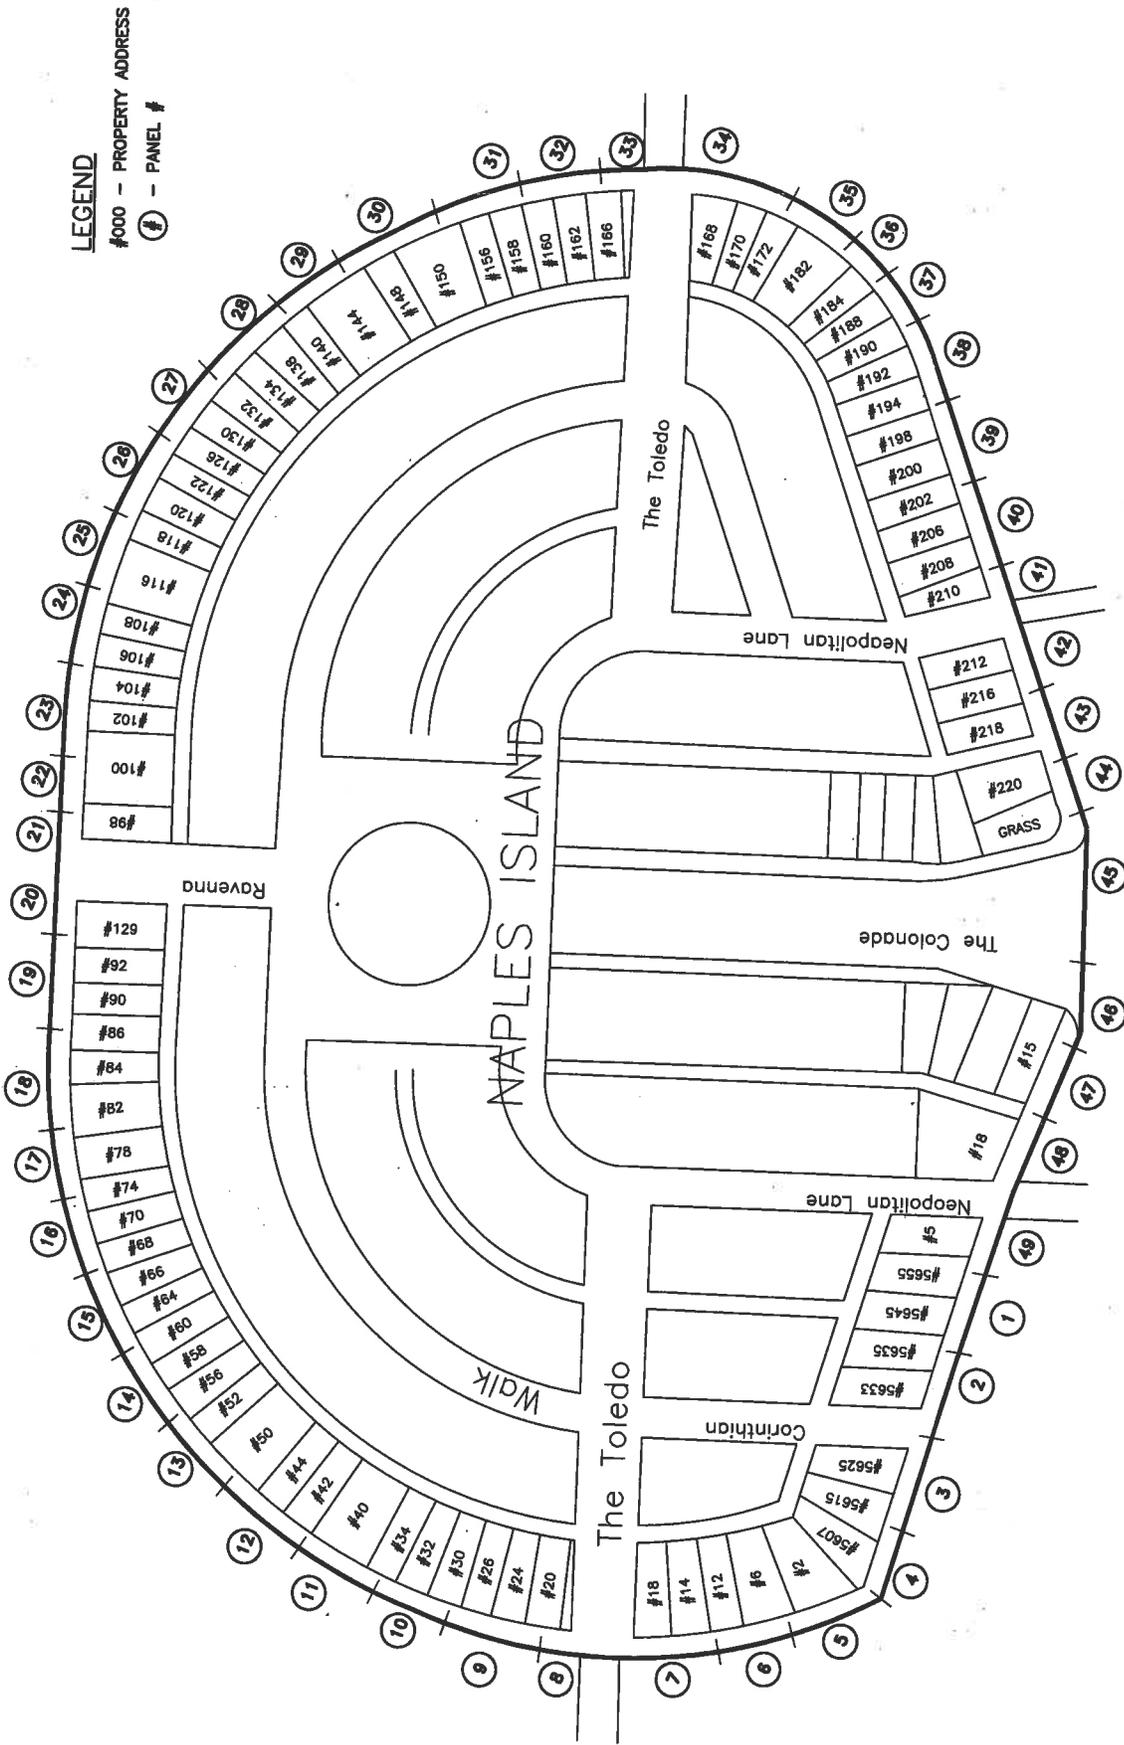
**FIGURE 4-5 NAPLES ISLAND
 JOINT PANEL KEY PLAN**

**Figure 4-6 Naples Island
Waterside Seawall Cap Cracking Quantities**

Panel #	Top Cap - Cracking	Bottom Cap - Cracking
Panel 1	0	44'
Panel 2	0	30'
Panel 3	6'	31.5'
Panel 4	0	48'
Panel 5	0	38'
Panel 6	0	30'
Panel 7	0	38'
Panel 8	13'	1.5'
Panel 9	2'	3.5'
Panel 10	0	42'
Panel 11	1	6'
Panel 12	0	28'
Panel 13	0	32'
Panel 14	0	25'
Panel 15	0	18'
Panel 16	0	5'
Panel 17	0	6'
Panel 18	4.5'	19'
Panel 19	0	12'
Panel 20	1'	12'
Panel 21	10	24'
Panel 22	4'	1'
Panel 23	2'	4'
Panel 24	2'	43'
Panel 25	0	5'

Panel #	Top Cap - Cracking	Bottom Cap - Cracking
Panel 26	6'	36'
Panel 27	0	3'
Panel 28	6'	45'
Panel 29	8'	34.5'
Panel 30	0	18'
Panel 31	4'	37'
Panel 32	17'	23'
Panel 33	4'	37'
Panel 34	5'	47'
Panel 35	0	5'
Panel 36	0	17'
Panel 37	0	14'
Panel 38	1'	43'
Panel 39	7'	22.5'
Panel 40	4'	16'
Panel 41	0	56'
Panel 42	0	62.5'
Panel 43	0	37'
Panel 44	4'	2'
Panel 45	13'	21'
Panel 46	4'	62'
Panel 47	8'	31'
Panel 48	2'	38'
Panel 49	1'	44'
Total Linear Ft.	133'	1297.5'

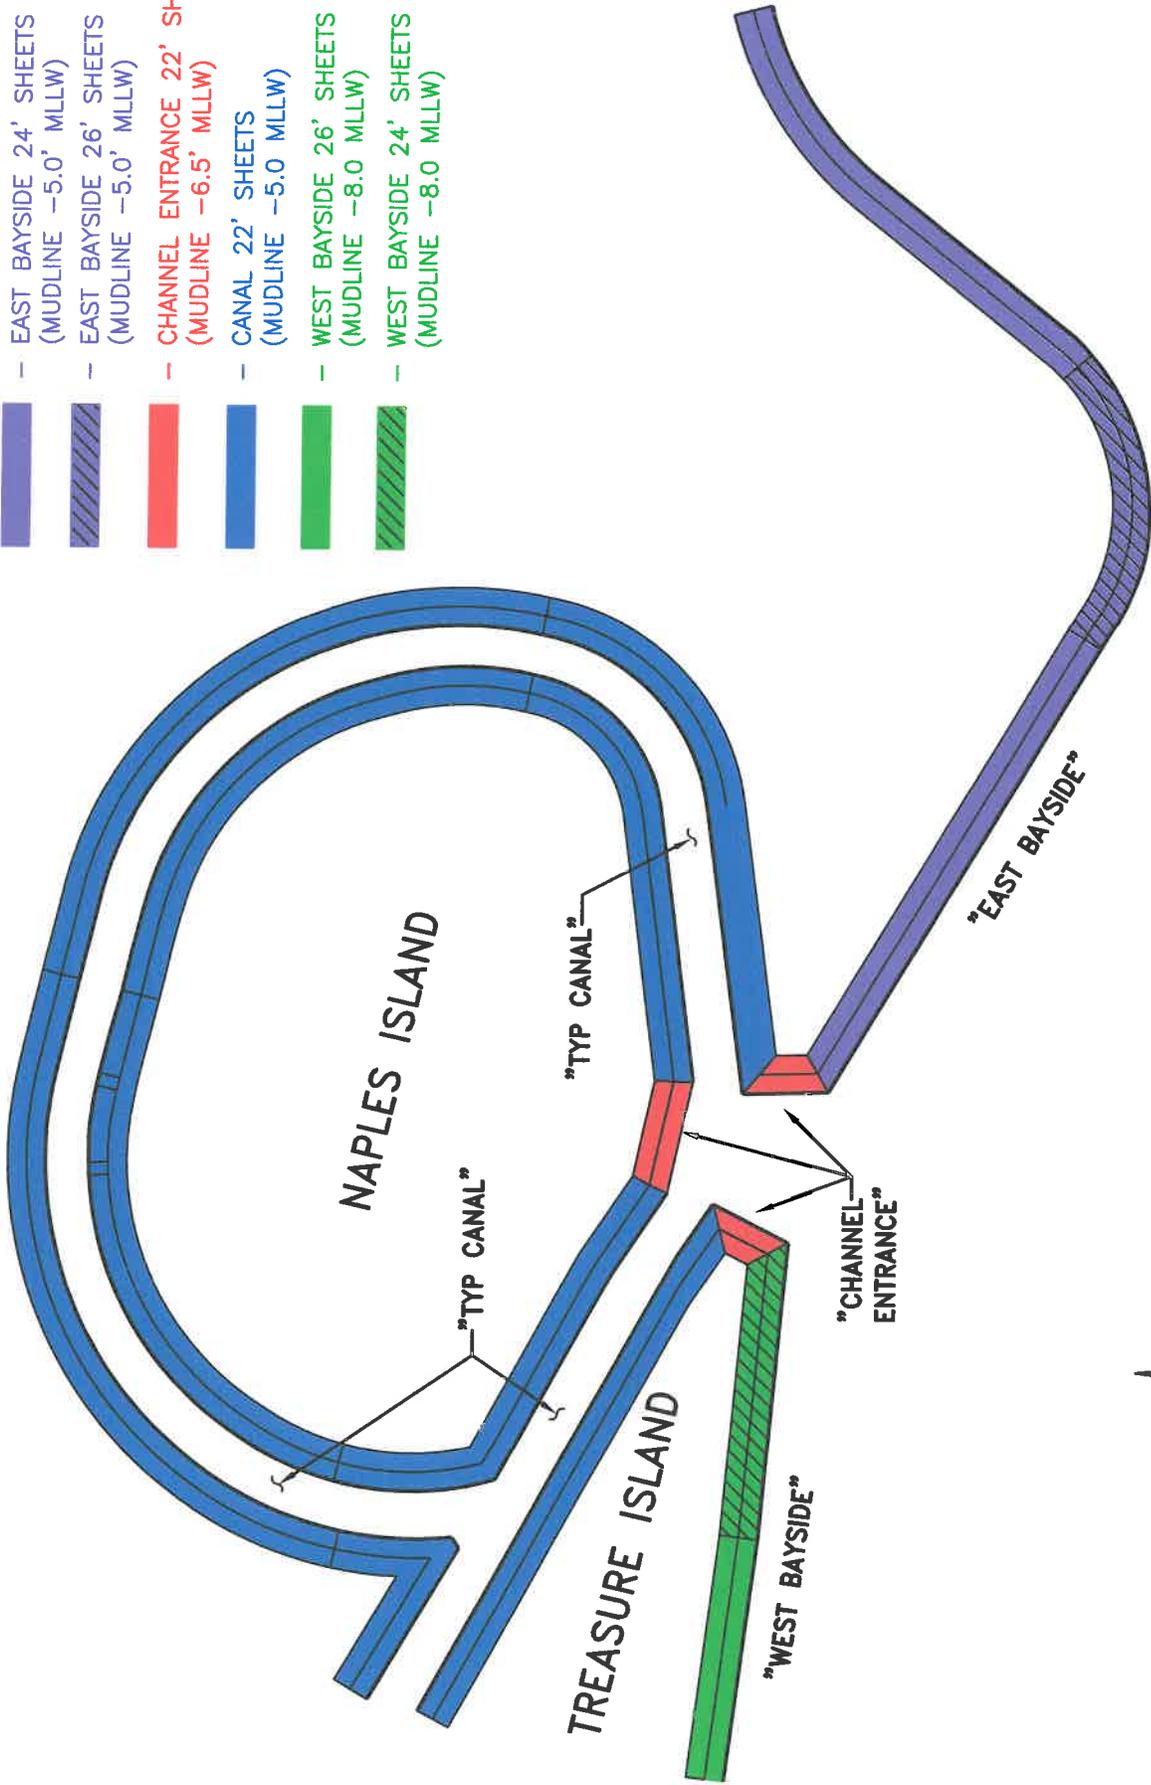
**FIGURE 7-1 SHEET PILE
KEY PLAN**

The Naples Seawalls are constructed with 3 different length concrete sheet piles. A review of original drawing details, City Drawing number B-761 and an excellent description of the wall construction in an engineering article titled "Precast Concrete Pile for Canal Walls at Long Beach" by John Blackman, November 19, 1940 provide sufficient information of the sheet pile construction that the sheet pile strength and stiffness can be modeled with reasonable accuracy. Efficient engineering design would have necessitated the use of various length sheet piles to address the various dredge depths or anticipated future dredge depths occurring in the project. For this analysis the sheet pile lengths are shown on Figure 7-1, pg 7-7.

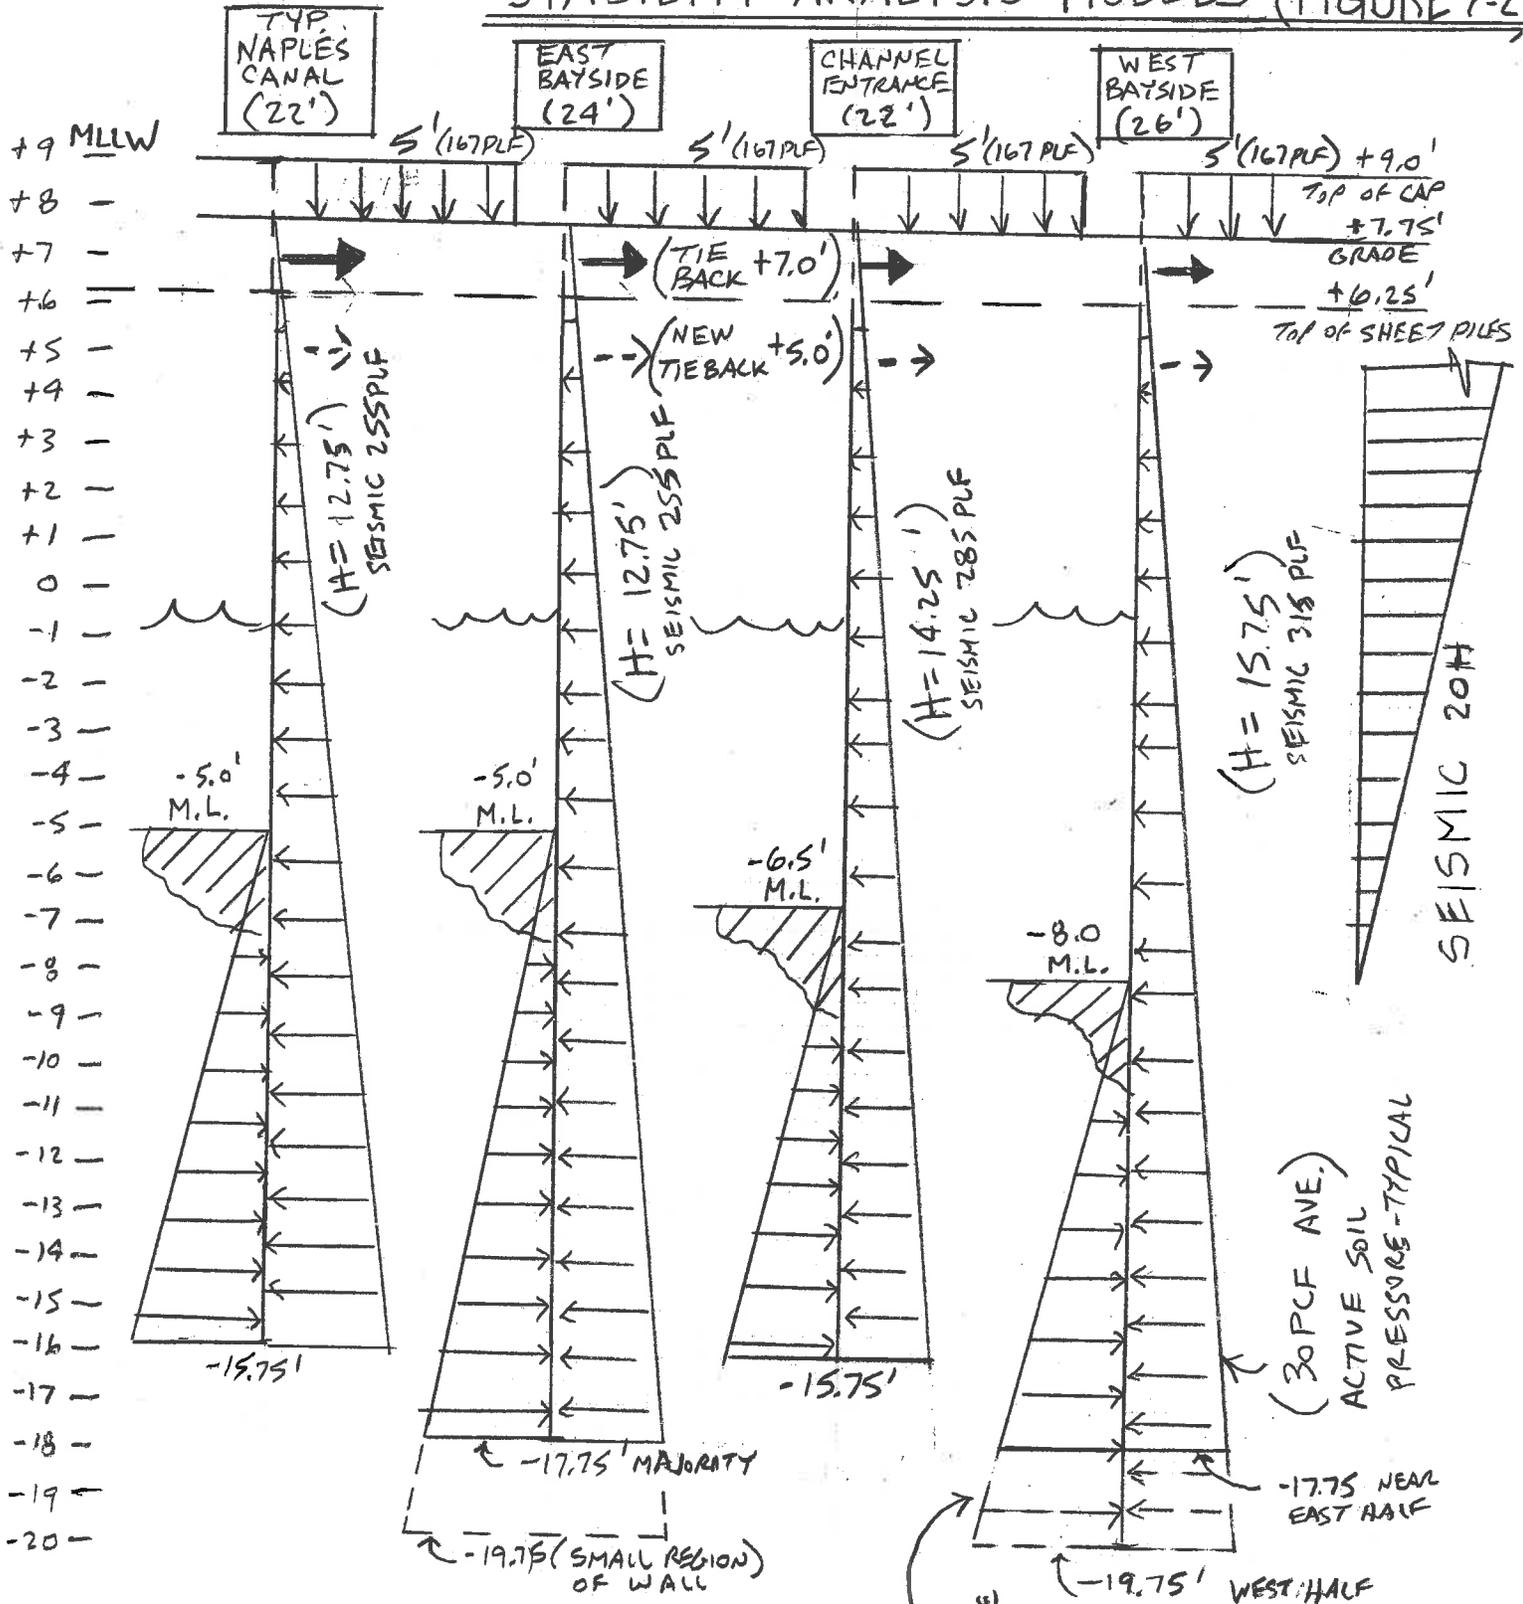
FIG 7-2
(FIGURE 7-2)

Soil Sliding – The standard Factor of Safety for passive soil pressure to resist sliding is 1.50 for static loads. When short term seismic loads are considered, a Factor of Safety of 1.20 is acceptable. A result between 1.20 and 0.95 represents a potential for failure during a seismic event and a result less than 0.95 represents an expected failure condition. Figure 7-2 tables the analysis results for each load case.

Tie Rod Tension – Steel elements are most commonly designed using "Allowable Stress" capacities which include Factors of Safety which are approved and accepted by the design industry. Building Codes permit a 1/3 increase in "allowable stress" capacities for short term loading conditions such as Seismic. The existing tie rods are 1 3/8" diameter and estimated to be Grade A6, Fy=35ksi steel, in use during that time period, which has an allowable load of 31,080# for static loads and 41,340# for load cases which include seismic. Tension values which exceed these limits for static or seismic conditions have a potential for failure. Existing Tie-rod conditions are believed to range from Fair to Very Poor, as evidenced by the tie-rod survey performed by Concept Marine Associates in 2004. For this reason it is not possible to quantify with accuracy the rod failure load. 1 3/8" diameter tie-rods in Good condition are expected to fail at 46,600# for all load cases. 1 1/2" diameter tie-rods, used at the 26' long sheet piles, are expected to fail at 55,500# for all load cases if in Good condition. Figure 7-2 tables the tension load on the tie rods for each load case.

Concrete Sheet Pile Bending – Concrete elements are most commonly designed using "Ultimate Strength" capacities which include Factors of Safety built into the coefficients used in the calculation of both the demand load and the allowable load. Figure 7-2 tables the ratio of the

Concrete Sheet Pile Shear - Concrete elements are most commonly designed using "Ultimate Strength" capacities which include Factors of Safety built into the coefficients used in the calculation of both the demand load and the allowable load. Figure 7-2 tables the ratio of concrete Shear Capacity vs. the maximum Shear Demand. A ratio below 1.00 represents a Factor of Safety less than prescribed by the Code. A ration between 0.95 and 0.75 are considered as having a significant potential for failure and Reinforced concrete in new condition will fail at a ratio near 0.75 for all load cases. Note: The existing concrete sheet piling has localized areas of significant concrete sulfate deterioration which should be considered in any interpretation of the analysis results.

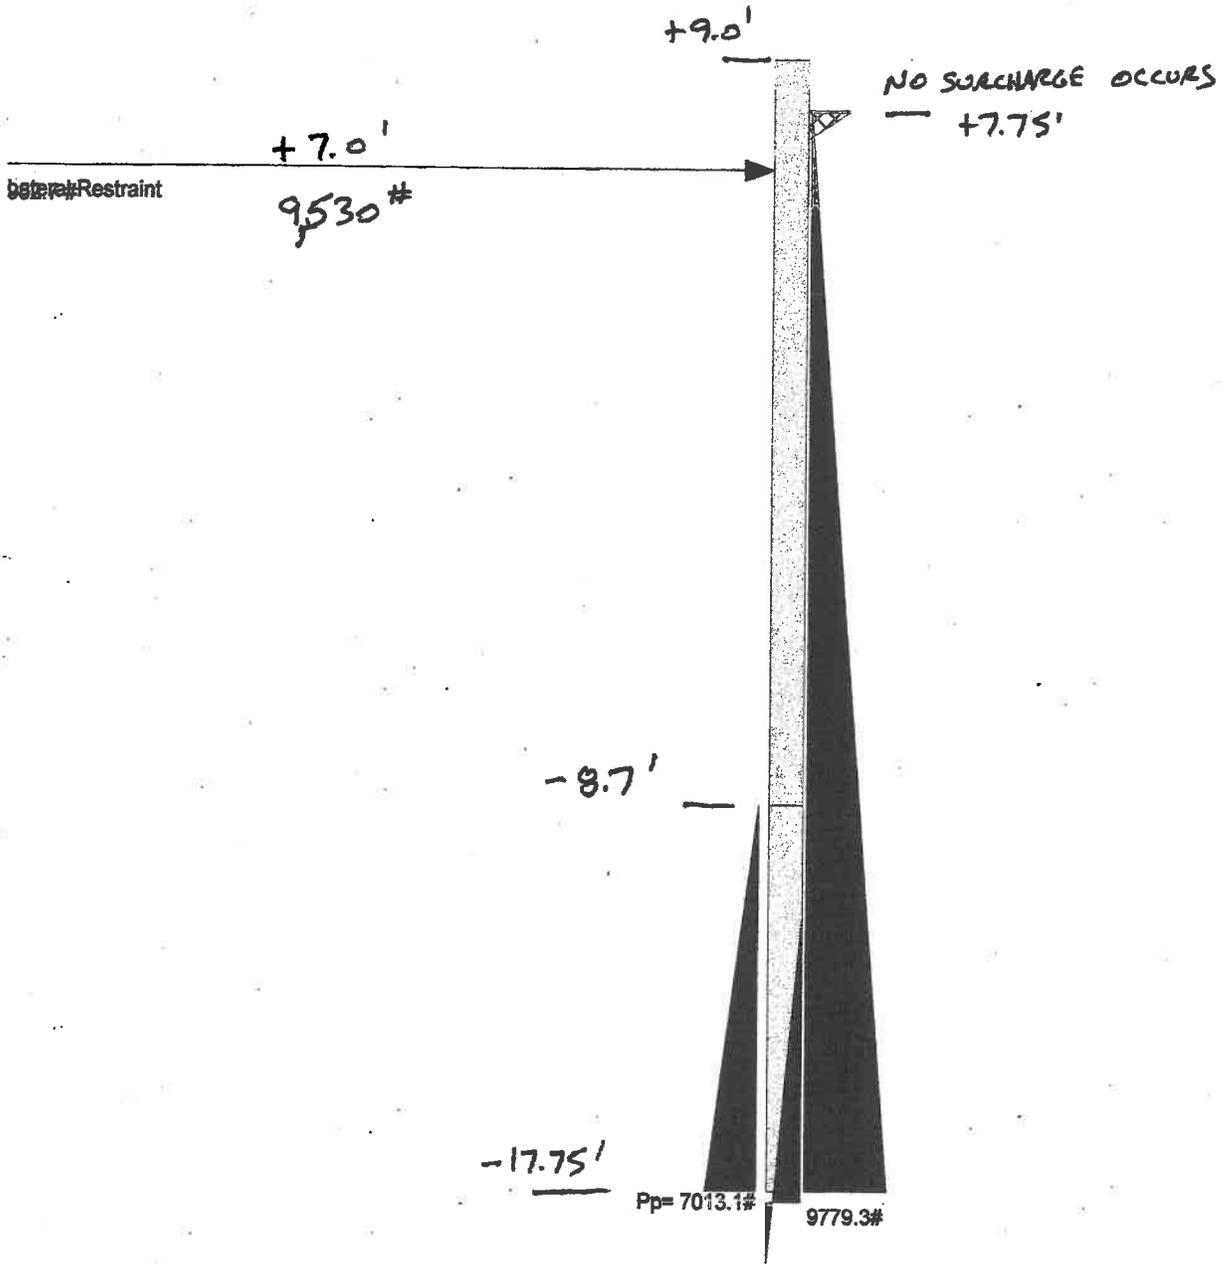
WEST BAYSIDE AT SCOUR CONDITION
NEAR CHANNEL ENTRANCE
(24' SHEETS, -8.7 MUDLINE)

2. There is one area of moderate scour near the main channel entrance, (see Figure 6-2 on page 6-2). It is marked in red on Figure 6-2. The lower mudline has the effect of increasing the bending and tieback loads on the sheet pile system and reducing the embedment into the soil. Based upon the results of the Seawall Stability Analysis, page 7-8, the channel entrance is also an area at greater risk of failure during an earthquake. If a major earthquake were to occur near or in Long Beach, these sheets may slide out rapidly into the canal, as happened during the 1933 earthquake. The West Bayside Segment, if added to the Channel Entrance works into an efficient size project for a contractor. The West Bayside seawalls have a risk of failure in an earthquake, second only to the Channel Entrance seawalls. Since they are both in the same work space, the combined area shown in brown on Figure 8-1, Phasing Plan, is ranked as the number 2 priority.
