NAPLES SEAWALL STABILITY INVESTIGATION AND REPAIR RECOMMENDATIONS

LONG BEACH, CALIFORNIA

City of L. B. Project No. PW8110-14

FINAL REPORT Submitted: February 25, 2009
Approved by City: April, 2009

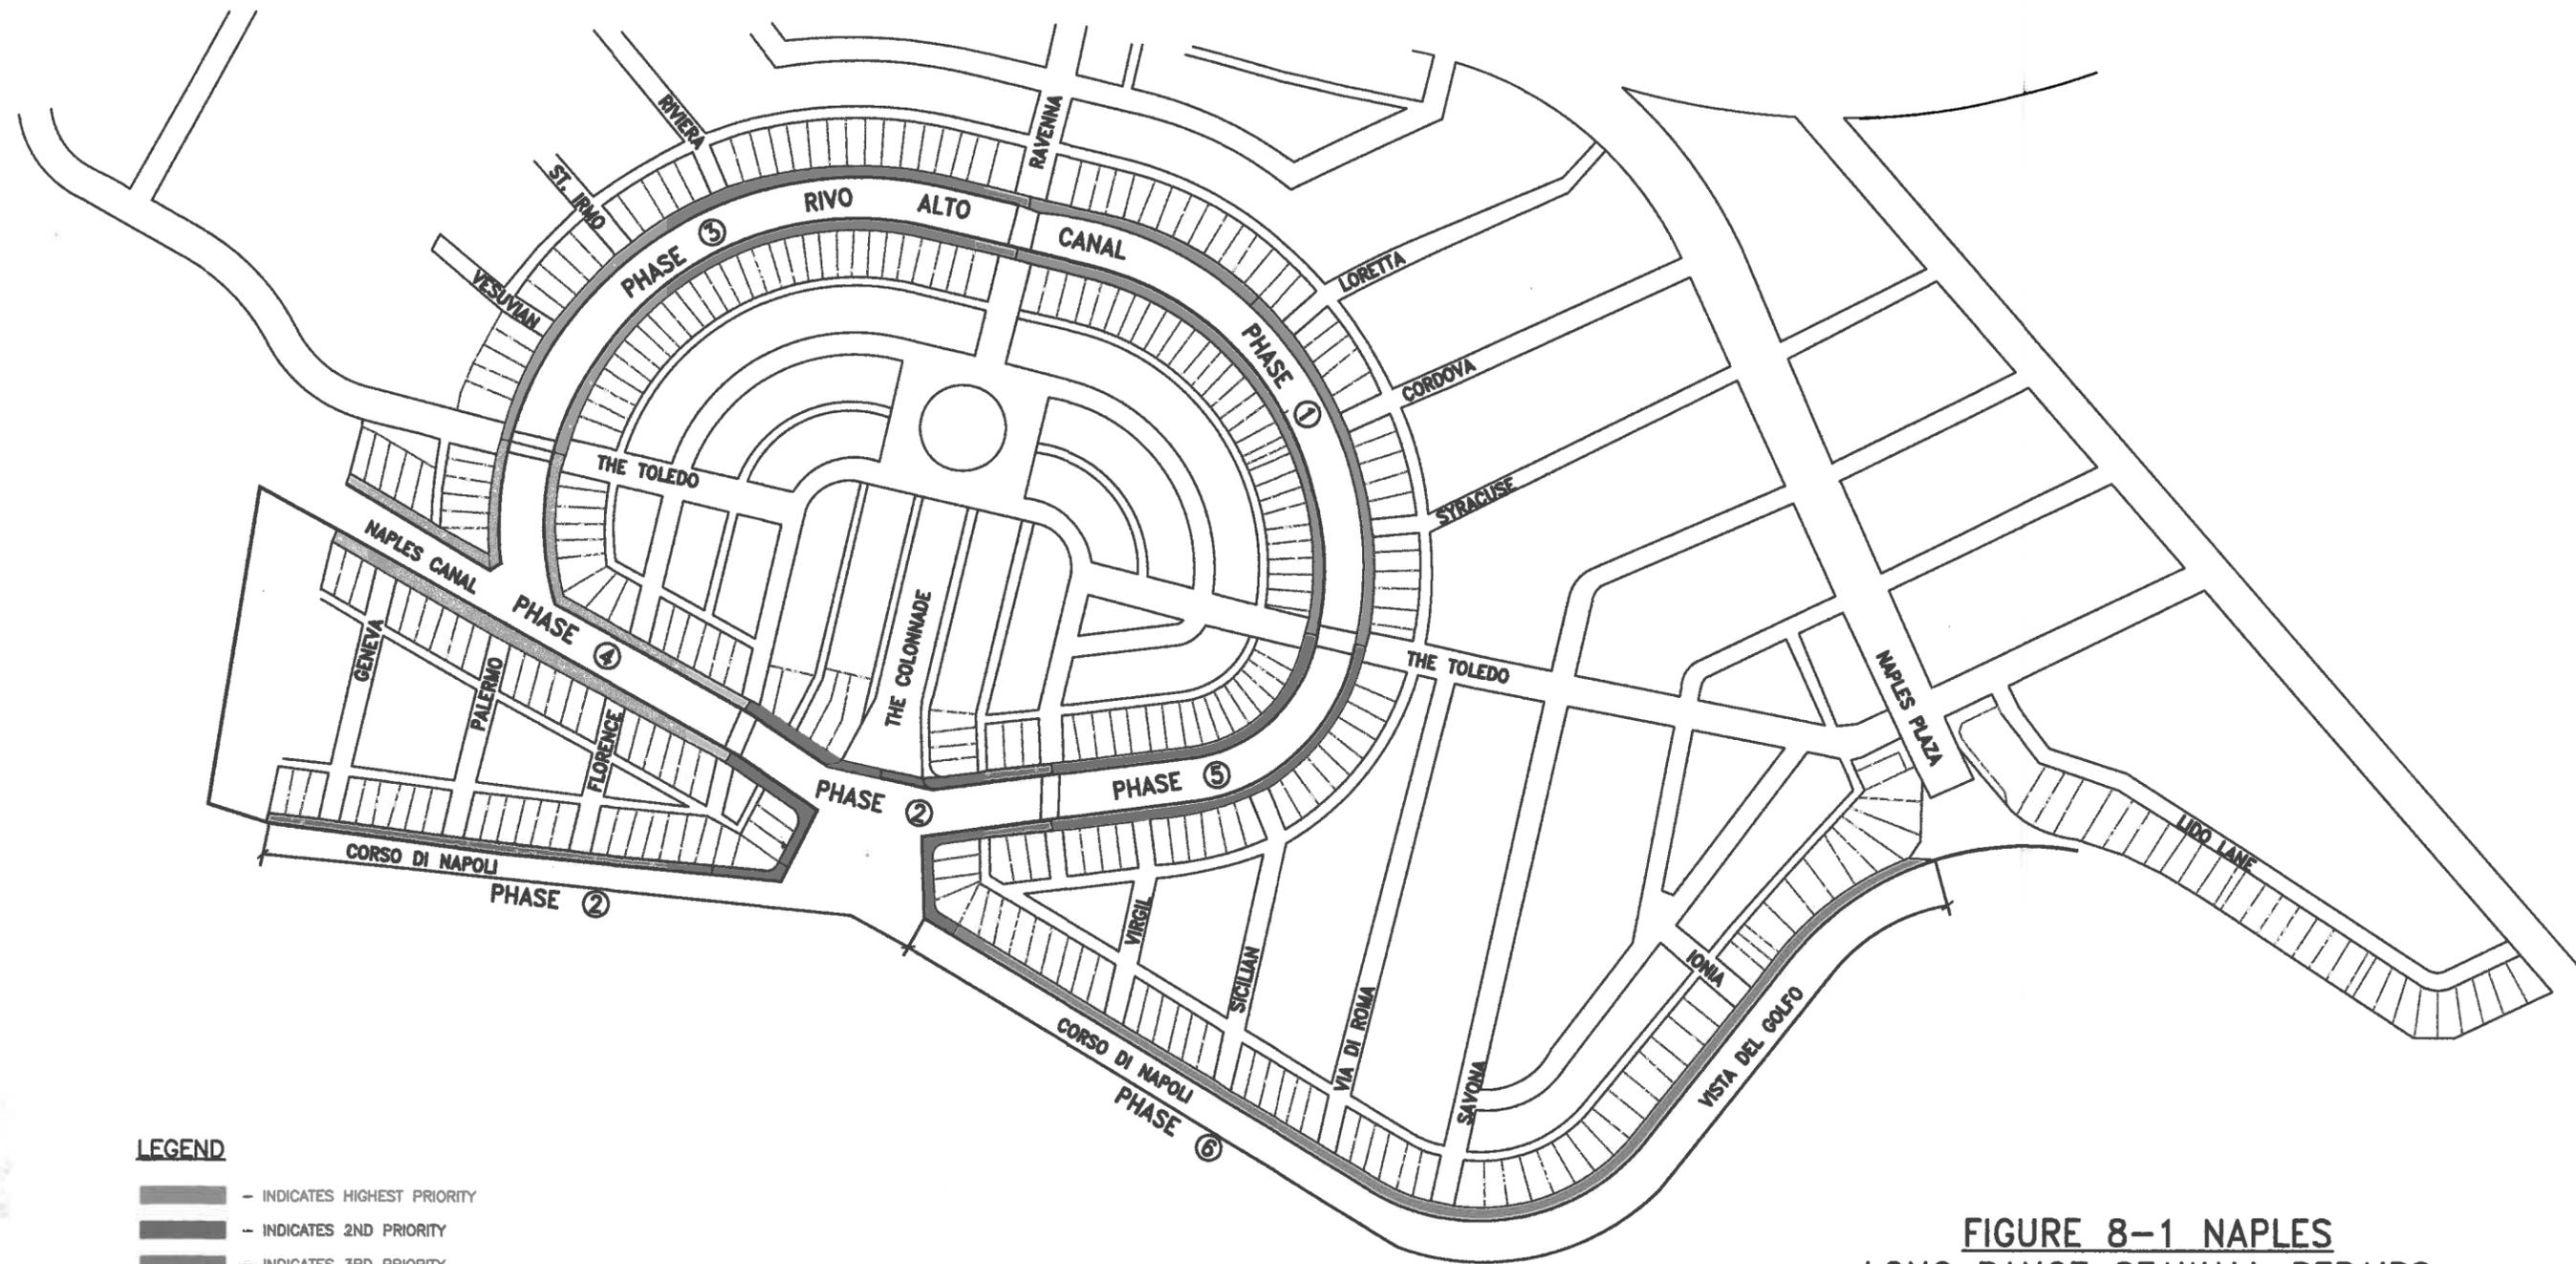
FIGURE 8-1

1. Sulfate Deterioration of the concrete sheet piling below the waterline, (see Figure 4-7, page 4-40). The northeast quarter of Rivo Alto Canal, colored in Figure 4-7 relates to the severity of the concrete deterioration observed by the inspection team. A few hundred feet of these walls are considered to be in "serious", marked in red and bending failures are "probable" anytime within the next 5 years and "expected" should the site experience a moderate earthquake before the sheet piling can be replaced. For this reason this area is ranked as the number 1 priority shown in red on Figure 8-1, Phasing Plan. The Naples Island walls in this quadrant are at slightly less risk than the landside walls due to the installation of the newer tie-back rods which shorten the bending span of the sheet pile approx 13%. If sub prioritization is needed to match funding, the Landside regions marked in red should precede the Naples Island red regions.

2. There is one area of moderate scour near the main channel entrance, (see Figure 6-2 on page 6-2). It is marked in red on Figure 6-2. The lower mudline has the effect of increasing the bending and tieback loads on the sheet pile system and reducing the embedment into the soil. Based upon the results of the Seawall Stability Analysis, page 7-8, the channel entrance is also an area at greater risk of failure during an earthquake. If a major earthquake were to occur near or in Long Beach, these sheets may slide out rapidly into the canal, as happened during the 1933 earthquake. The West Bayside Segment, if added to the Channel Entrance works into an efficient size project for a contractor. The West Bayside seawalls have a risk of failure in an earthquake, second only to the Channel Entrance seawalls. Since they are both in the same work space, the combined area shown in brown on Figure 8-1, Phasing Plan, is ranked as the number 2 priority.

3. Minor sulfate deterioration was also observed in the northwest quarter of Rivo Alto Canal, colored green in Figure 4-7, page 4-40, but this deterioration is currently limited to the outer 1/2" of the sheet pile surface and no areas of major erosion or rebar loss is evidenced yet so it is anticipated that this is okay for static loads but that it presents a weak section which will fail under a lesser earthquake the balance of the canal walls. For this reason the west quarter of Rivo Alto Canal is rated as priority number 3, colored purple on Figure 8-1, Phasing Plan.

4. The Naples Island segment is almost completely encompassed by a system of recently installed tiebacks and wales. Since these tiebacks are designed to carry 100% of the lateral load requirement, the Island is considered less susceptible to failure than areas without this work. For this reason Naples Island was generally ranked as a 4th or 5th priority.

(Phase 4 and Phase 5 are relatively equal in ranking and either one could go first. Refer to Figure 8-1, light blue and dark blue colors.)

5. Phase 6 is overall in the best condition and the mudline is consistent with no areas of any significant scour and only a very uniform loss of 0.3 to 0.5 feet of material. This segment has an estimated remaining service life of 20 years; while by comparison, priority 1 has an estimated 0 to 5 year remaining service life. It is believed that the sheets are a couple feet longer, along the bayfront properties to account for the possibility of deeper water conditions and this extra pile length increases the Factor of Safety for this Phase a few percentage points above the others, See Figure 7-2, page 7-8. For these reasons, the East Bayside is ranked 6th priority, colored in green on Figure 8-1. If this Phase needs to wait the longest for replacement, it may be appropriate to consider chemical grouting the couple sink holes identified on Figure 2-10, page 2-46.

Emergency repairs typically have a very high unit cost and have no master planning for continuity for future repair interfacing. Since this structure is currently 70 year old, it is recommended that the City and Homeowner's consider the timing of a replacement program and wisely appropriate future funds in consideration of the limited remaining service life. The magnitude of a complete wall replacement project is on the order of \$56 Million dollars and expected to require phasing construction and raising bonds to cover a construction period of 6 years, (see Cost Estimates in Section 9.0 and Figure 8-1, Phasing Plan on page 8-19).

To best direct the limited annual funding for Seawall Maintenance and Repair, the following list of problems is compiled and ranked purely on structural need and public safety.
