PEER REVIEW REPORT
OCEAN BOULEVARD EROSION AND ENHANCEMENT
PHASE 2 PROJECT
CITY OF LONG BEACH, CALIFORNIA

CITY OF LONG BEACH
Tidelands Capital Improvement Division

June 23, 2014

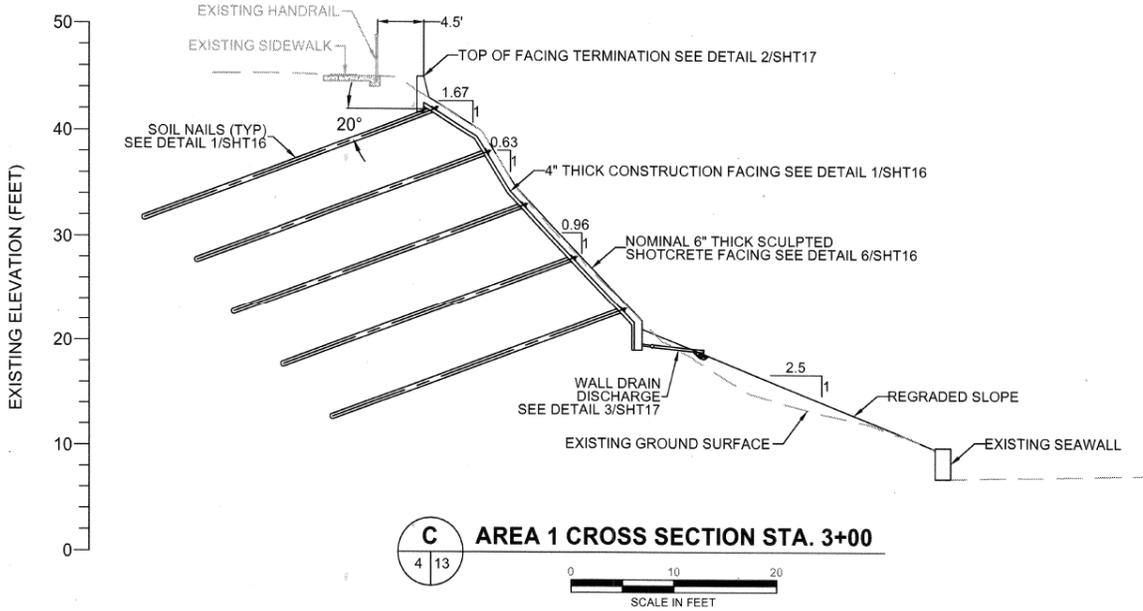
Figure 1 - Design Cross-Section of Soil Nailing

- Soil nails that enhance the deep-seated stability of the bluff under static and dynamic conditions (Figure 1) and locally support portions of the sidewalk; and
- A shotcrete facing (Figure 1) that protects the slope surface from weathering and erosion caused by surface water, and enhances the surficial stability.

The shotcrete facing will be sculpted to blend in with the surrounding landscape. At specific locations, the shotcrete facing has planter pockets that allow vegetation to grow on the slope and with time will partially cover the shotcrete surface, as exemplified in Figure 2. The design contemplates having open-bottom planters that allow infiltration into the slope. Failure of sprinklers and/or the irrigation pipes may result in a concentrated influx of water directly into the slope which is undesirable. The design includes irrigation PVC pipes embedded into the shotcrete to drain excess irrigation water.

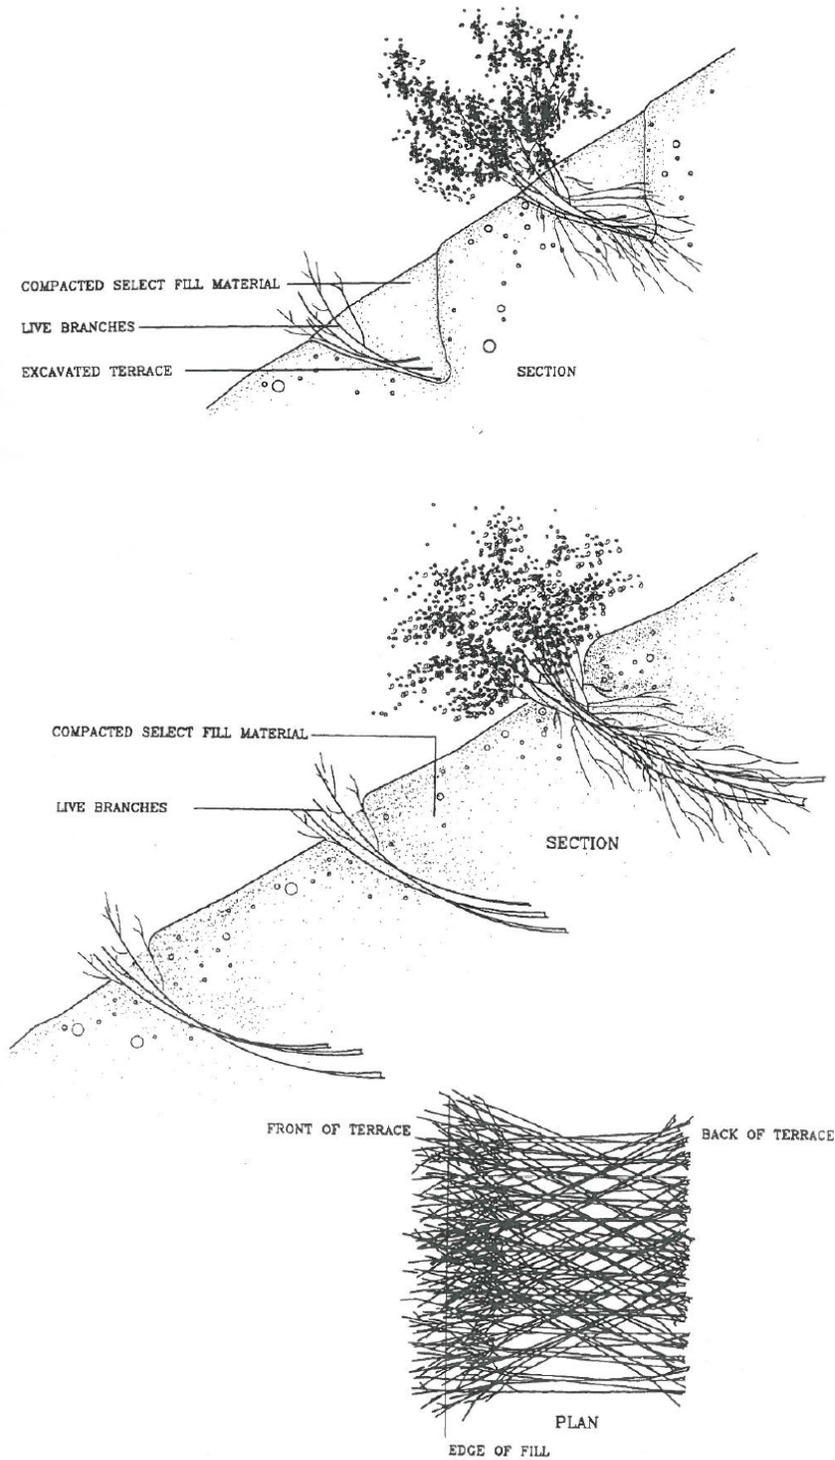
Figure 3 – Example of Deep-Rooted Vegetation

Figure 7-21. Schematic diagram of an established growing fill slope brushlayer installation showing alternating layers of live cut brush inserted between lifts of soil.

- Deep rooted vegetation as depicted in Figure 3;
- Deep rooted vegetation in combination with geogrid or timber grid used to hold topsoil and slope plantings as shown in Figure 4; and
- Live slope grating where a lattice-like array of vertical and horizontal timbers are fastened or anchored to a steep slope and the openings in the structure are filled with suitable backfill material and layers of live branch cuttings (see Figure 5).

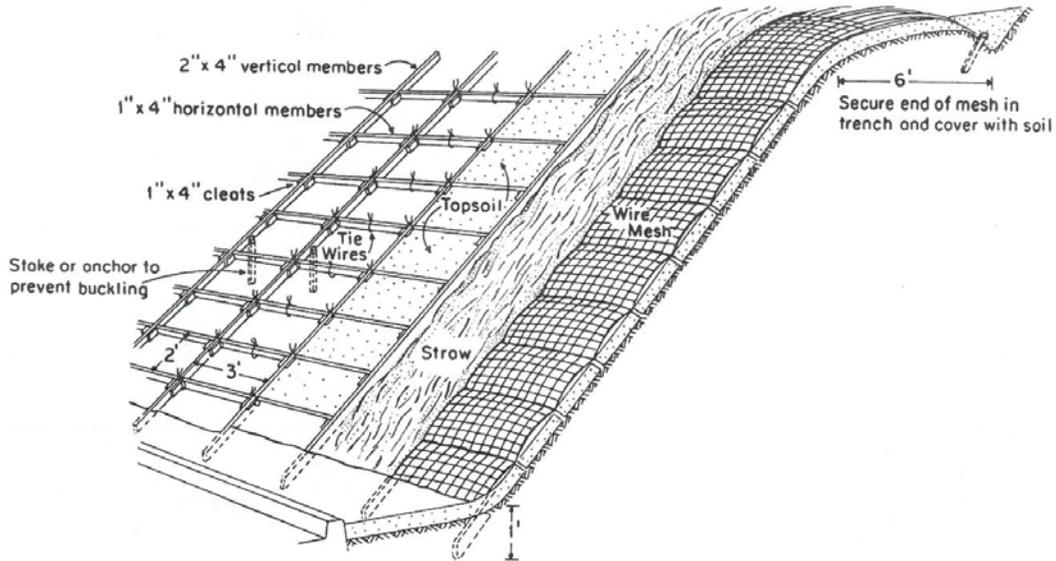
Figure 4 – Example of Deep-Rooted Vegetation with Timber Grid

Figure 8-18. Anchored timber grid used to hold topsoil and slope plantings.
