Wrigley Historic District Design Guidelines

This section of the Long Beach Historic District Design Guidelines is part of a larger document created as a planning tool for the City's **historic districts**. The guidelines are intended to provide recommendations, inspiration, and advice as part of an instructive framework that will help guide sensitive changes to historic properties and encourage rehabilitation. By their nature, design guidelines are flexible. As such, outcomes may depend on the resource, the surrounding district, and the goals of the proposed project.

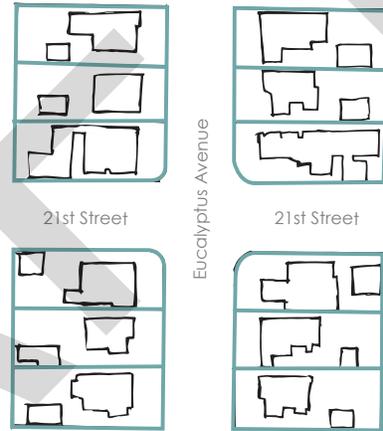
The lot sizes in the Wrigley Historic District are all rectangular, approximately 50' by 127', with the narrow end facing the street. Combining lots together could result in the loss of a district contributor or create a disruption to the historic character of the district. Lot splitting is not permitted by the City's zoning laws.

The lot sizes and shapes in the Wrigley Historic District are generally uniform.

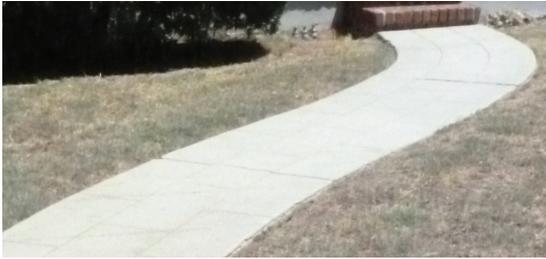
An existing walkway in the Wrigley Historic District.

Each of the properties in the Wrigley Historic District has a centralized walkway leading to the front porch or entry from the sidewalk. Many of the walkways are curved, which appears to be the historic configuration, although some are now straight.

In the event that an existing walkway requires replacement, it should be replaced in the same location and executed in a visually compatible material. Concrete, or concrete-like permeable paving materials with a comparable color, texture, and appearance are acceptable.

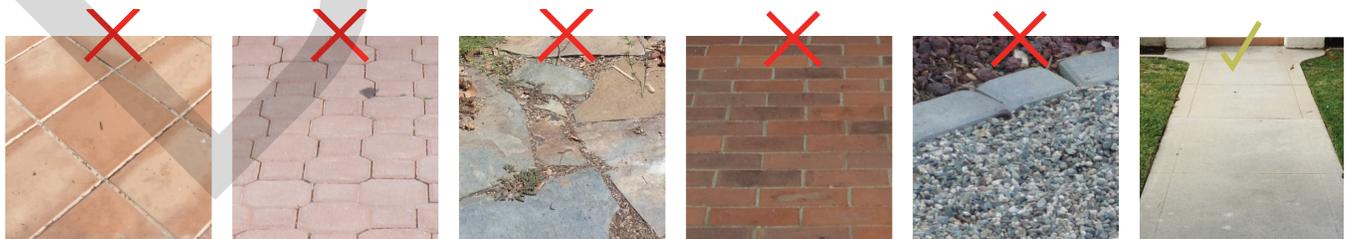
Concrete with scored joints is the recommended material for walkways and driveways.

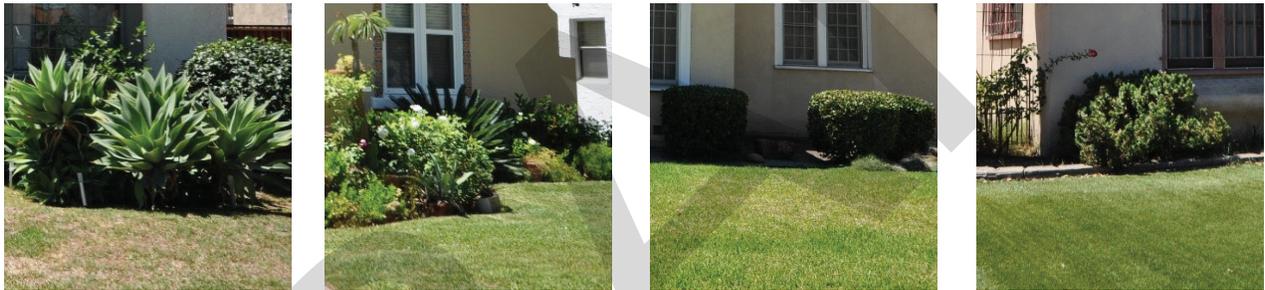
Each of the properties in the Wrigley Historic District has a shallow front yard. The majority of these yards consist of grass lawn, some with gardens and trees, although others have been replaced with drought-tolerant landscaping. Retaining the existing planting area, yard configuration, and layout will help maintain the historic character of each property.

Existing landscaping in the Wrigley Historic District.

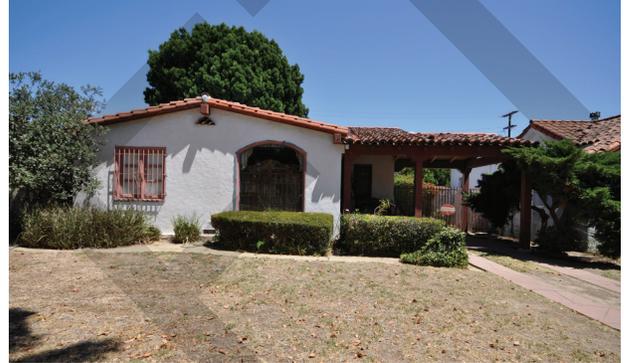
An existing porte-cochère in the Wrigley Historic District.

Many contributing properties in the Wrigley Historic District have porte-cochères that are typically an extension of the main roofline. They project from the side elevation and span over the side driveway. As these features are characteristic of the district, the addition of a sensitively designed porte-cochère at the side elevation would not be visually disruptive.

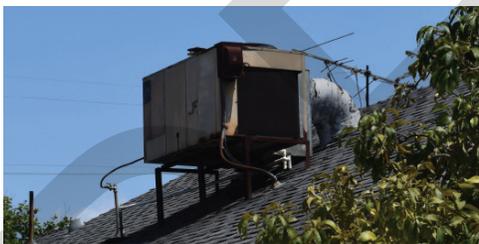
Large equipment installed on a roof is visually obtrusive and can detract from the historic character of the district.

- Larger equipment, such as HVAC condensers, should be installed at ground level.

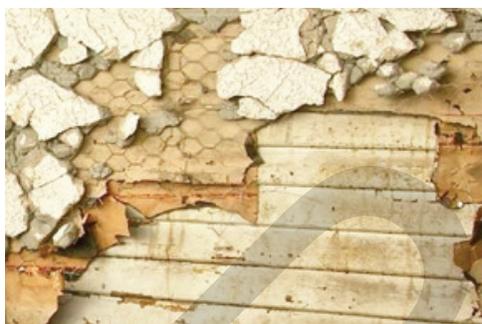
This image shows original wood siding that was incompatibly covered in stucco.

Original wood siding should never be replaced or covered with a new or different material that did not exist historically, such as brick or stucco. Where wood siding has been replaced or covered with a new building material, property owners are encouraged to restore historically appropriate wood siding when the existing cladding has reached the end of its useful life, rather than replacing or repairing the non-original material.

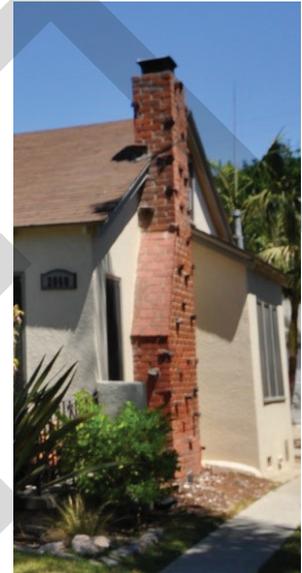
An original masonry chimney in the Wrigley Historic District.

The existing material should not be covered with any other material. For example, a masonry chimney should not be covered in stucco or stone veneer.

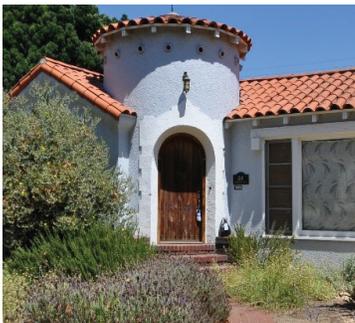
(A)

There are a variety of porch and entryway styles seen on the contributors of the Wrigley Historic District. The predominant entryway style consists of a slightly recessed entryway without a roof or shelter covering (A), and a full or partial-width projecting porch with wood supports that often extends into a porte-cochère (B).

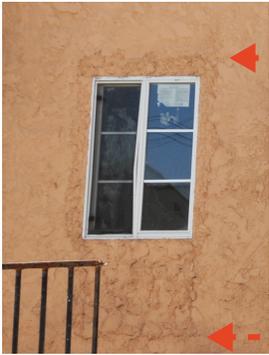
Changing window openings can leave “scars” on the exterior of a building. Red arrows indicate the original extent of the opening.

Windows are a key feature on a historic building, and these alterations would drastically affect the historic character. Property owners are encouraged to retain the original window opening sizes and locations on all elevations, particularly if they are original. Changing the size and number of window openings on the front elevation is not permitted.

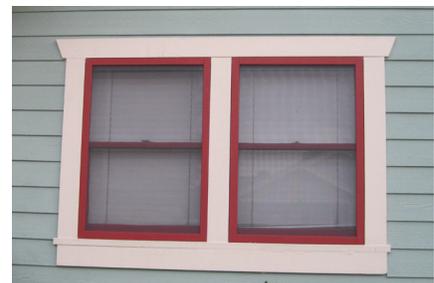
This compatible window screen is sized to the window and has a narrow wood frame painted to match the building’s trim.

Window screens sized to match the original windows that have narrow, wood frames and are painted to correspond with the building’s trim are recommended. The screen itself should be relatively transparent, and should not obscure the window behind it. Retractable screens may also be acceptable. Vinyl and aluminum framed screens are not permitted.

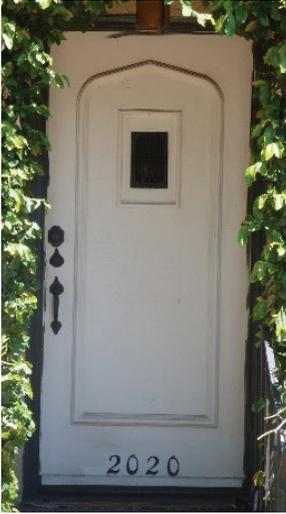
An original door in the Wrigley Historic District.

Several front doors on the contributing properties in the Wrigley Historic District are obscured behind metal security doors. Of the doors that are visible, the most frequently seen type is a partially-**glazed** wood doors.

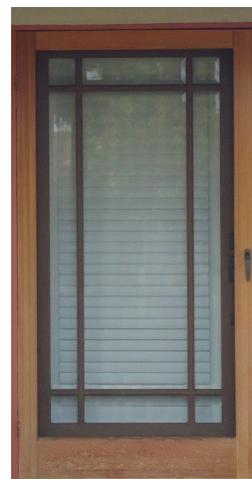
This is an excellent example of a compatible screen door. The narrow wood frame is stained in a neutral color and the mesh enclosure is transparent enough that it does not obscure the door beneath it.

Installing a **storm door** (glass enclosure) or **screen door** (mesh enclosure) may be acceptable if the feature is sensitively designed and carefully installed. Storm or screen doors that are sized to match the original door, have narrow, wood frames, and are painted to correspond with the building's trim or primary door are recommended. The screen or glass itself should be relatively transparent, and should not obscure the door behind it. Metal-framed screen or storm doors are not recommended.

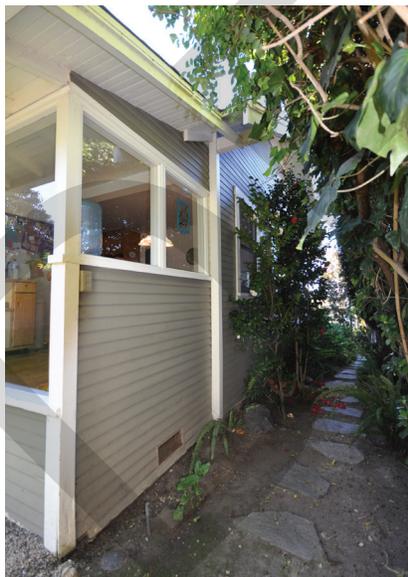
This compatible addition is differentiated from the main house by fixed single-light windows and a vertical strip of trim.

A compatible addition to a stucco-clad building may be differentiated from the original building through the use of a setback from the original wall plane, a lower roof height, and slightly different windows. For example, if the primary residence has multi-light wood **casement** windows, consider single-light wood casement windows for the addition.

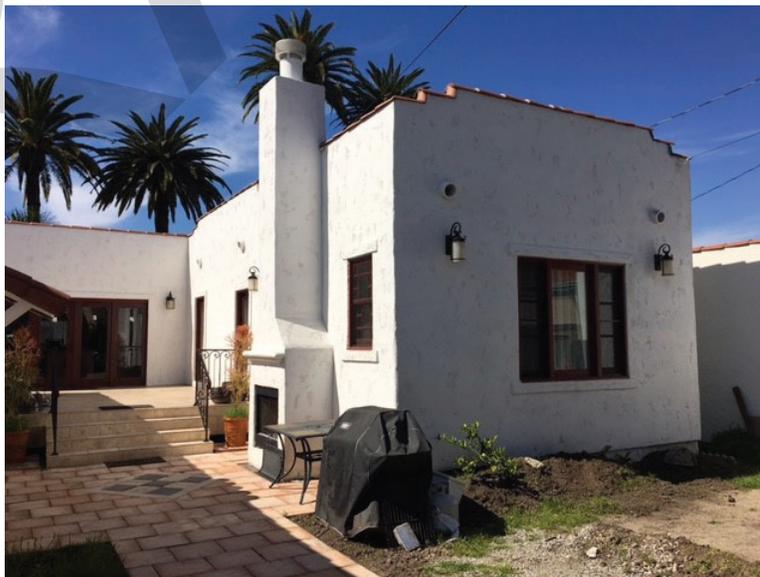
A compatible Spanish Colonial Revival addition to the rear.

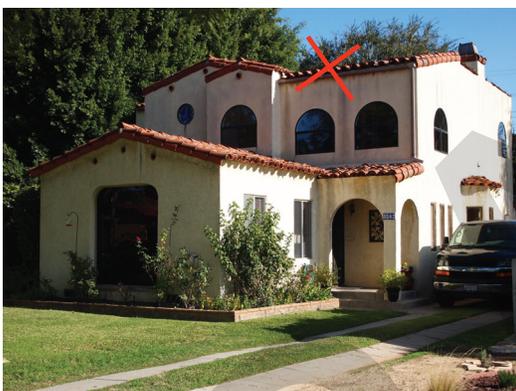
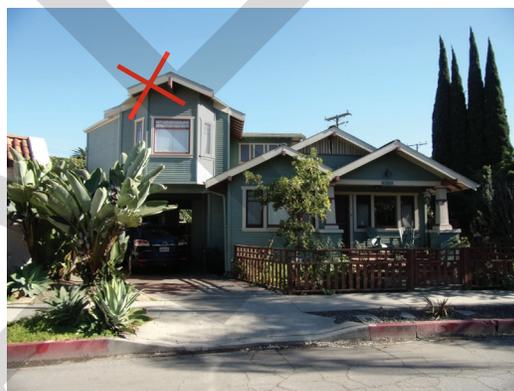
The additions shown above would not be permitted. They are arranged near the front of the building, making them highly visible from the street and detracting from the original historic home.

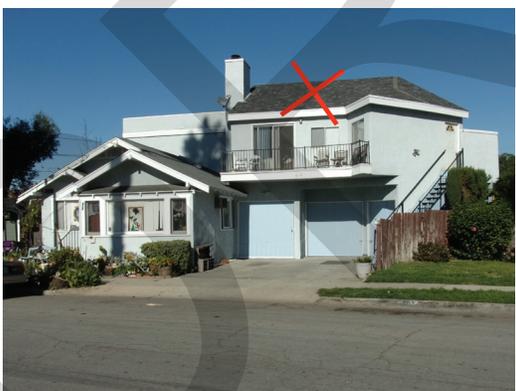
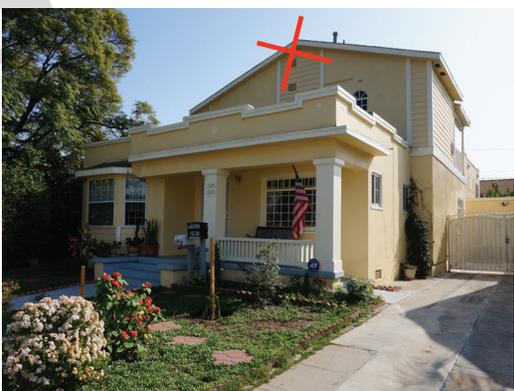
The additions shown above would not be permitted. They are arranged near the front of the building, and introduce an incompatible roofline that is not in keeping with the original house form.

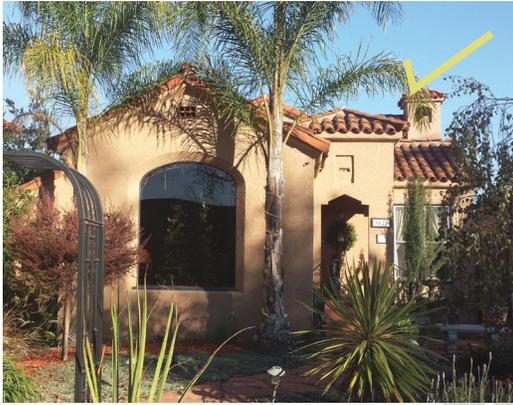
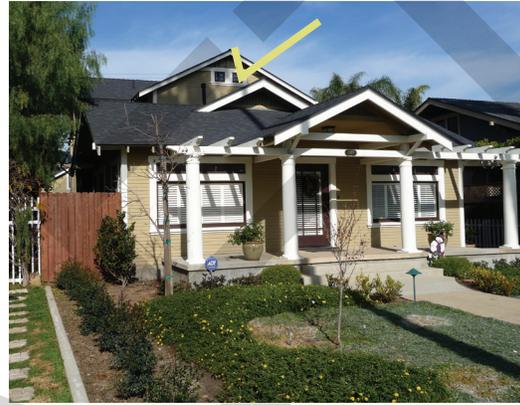
The additions shown above are acceptable. They are oriented towards the rear of the building and complement the original house form, making them less visible from the street and more compatible.

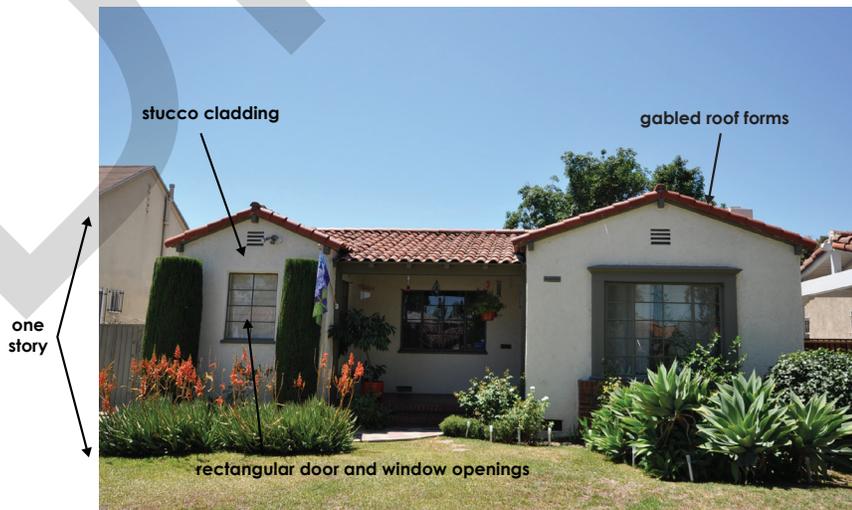
The contributing residences within the Wrigley Historic District are varied in style, but they are generally one story in height with gabled roofs, or gabled or pent roof forms near the front of an otherwise flat roof. Property owners planning new construction should consider including features like a gabled or pitched roof, stucco cladding, and rectangular or arched window and door openings in their design, and drawing inspiration from the various Period Revival styles present in the district for decorative features and accents. Property owners should anticipate conforming to the prevailing height and setback in the district, especially that of contributing properties immediately adjacent to the proposed new construction. See below for a diagram of these features.
